FINAL REPORT

Caledon Road Improvements EA – Geomorphic Assessment

Date: May 2014

Client: HDR Inc.

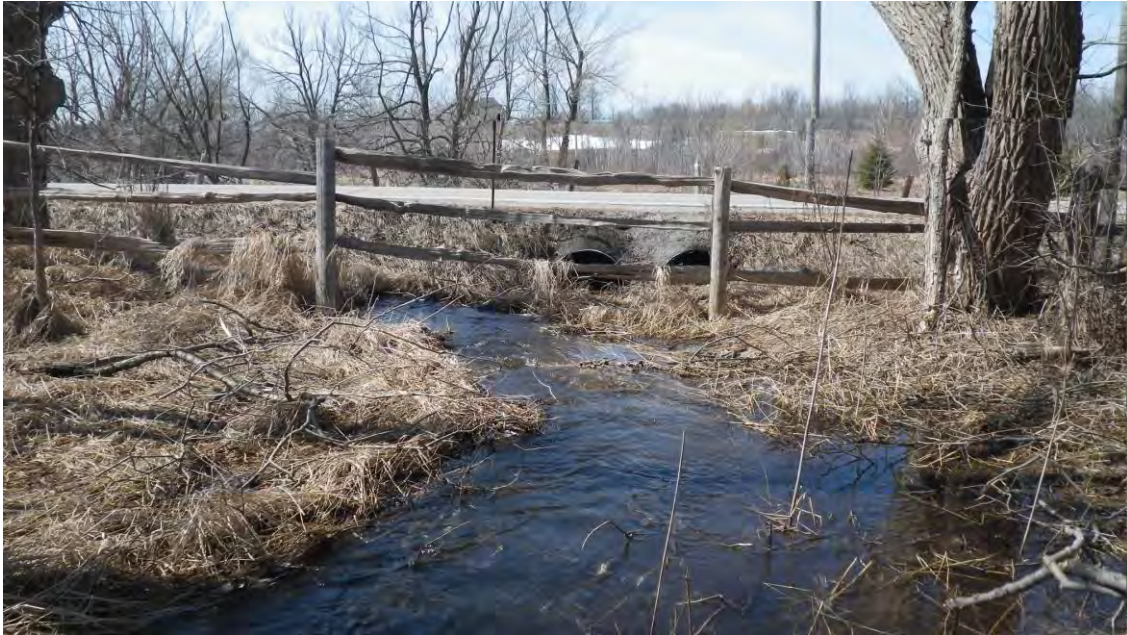
Crossing: 44

At this stream crossing, Mississauga Road runs ovetop of a twin culvert (CSP) where a stream drains a pond 20m upstream and outlets to a marshy area characterized by cattails, eventually connecting with another online pond 40m downstream of the outlet. Upstream, the channel is slightly sinuous with a width of 3.2m, with a depth around 0.37m and is well connected to the floodplain. This steepens within the right of way upon approach to the inlet of the culvert(s). Downstream of the road, the channel widens into a marshy area and backwatering occurs into the culvert outlet. Channel substrates are coarse gravels and cobbles upstream, with finer gravels and sands downstream. Wood debris is present throughout, and a fence crosses the channel at the property line upstream. Than channel was found to be relatively stable (in regime), with a score of 0.19, which is close to entering a state of transition. Its primary form of adjustment is in the planform as it becomes a multi thread channel downstream through the wetter area. The stream health is moderate with an RSAT score of 32.

Photo 1: View looking downstream towards twin corrugated steel pipe culvert inlets.

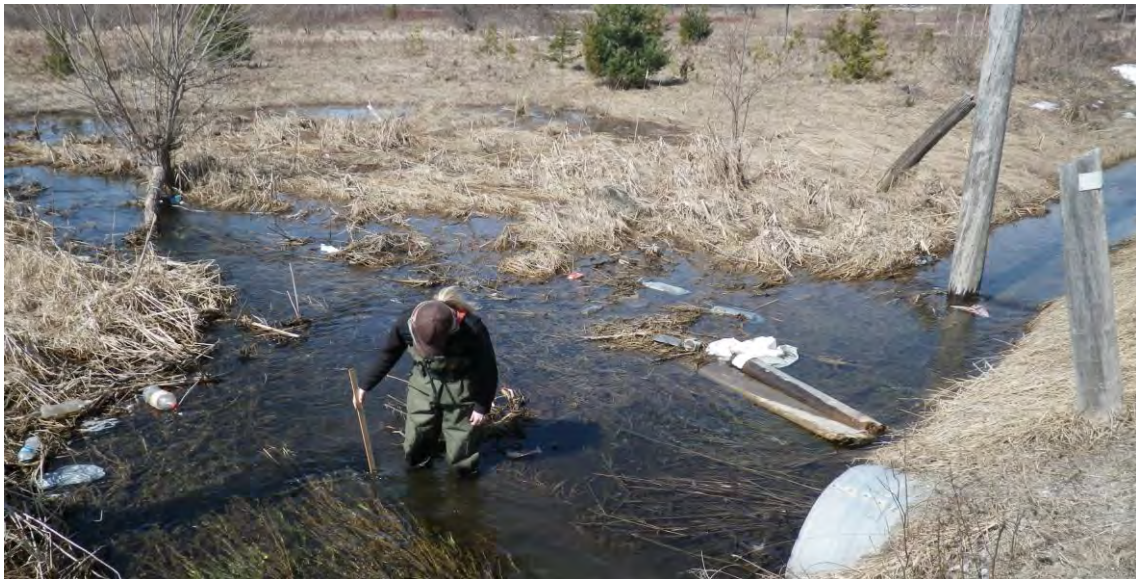
Photo 2: View looking downstream of culvert outlet towards marshy area.

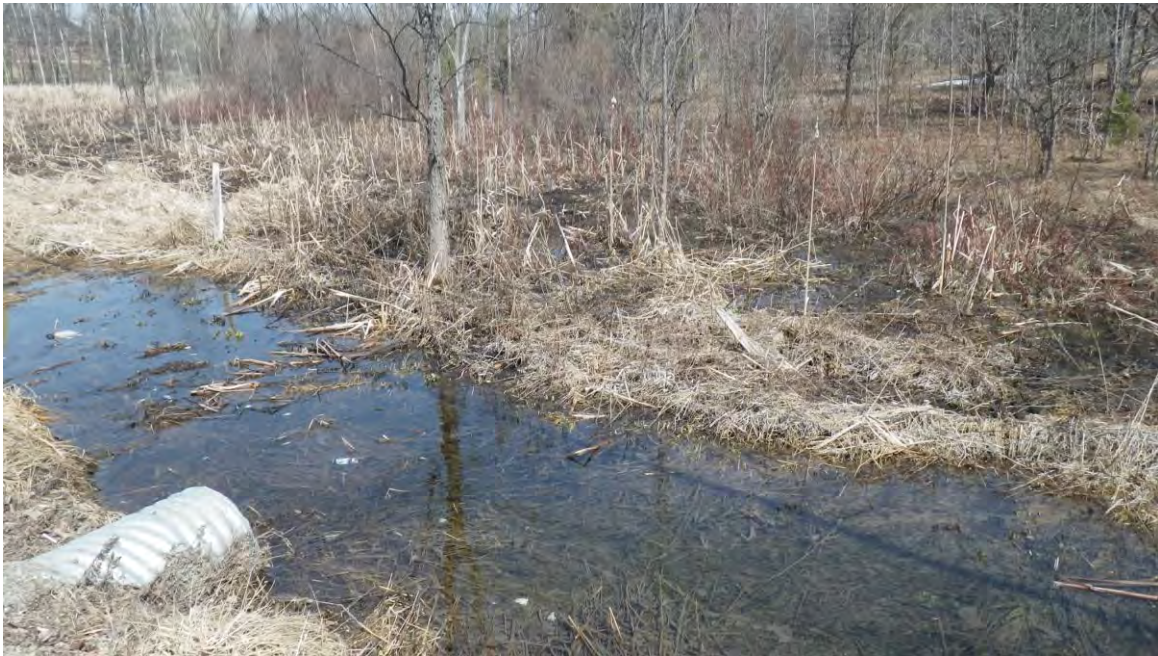
Crossing: 48

This culvert was bound by wetland marshes with an undefined main channel, with the upstream side identified as a wetland by CVC. Substrates were characteristically fine and the surrounding land was dominated by wetland grasses and deciduous trees and shrubs. Rapid assessments could not be undertaken as a result, and a define channel could only accurately be identified approximately 100m downstream of the culvert outlet.

Photo 3: View looking downstream from culvert inlet where channel is undefined.

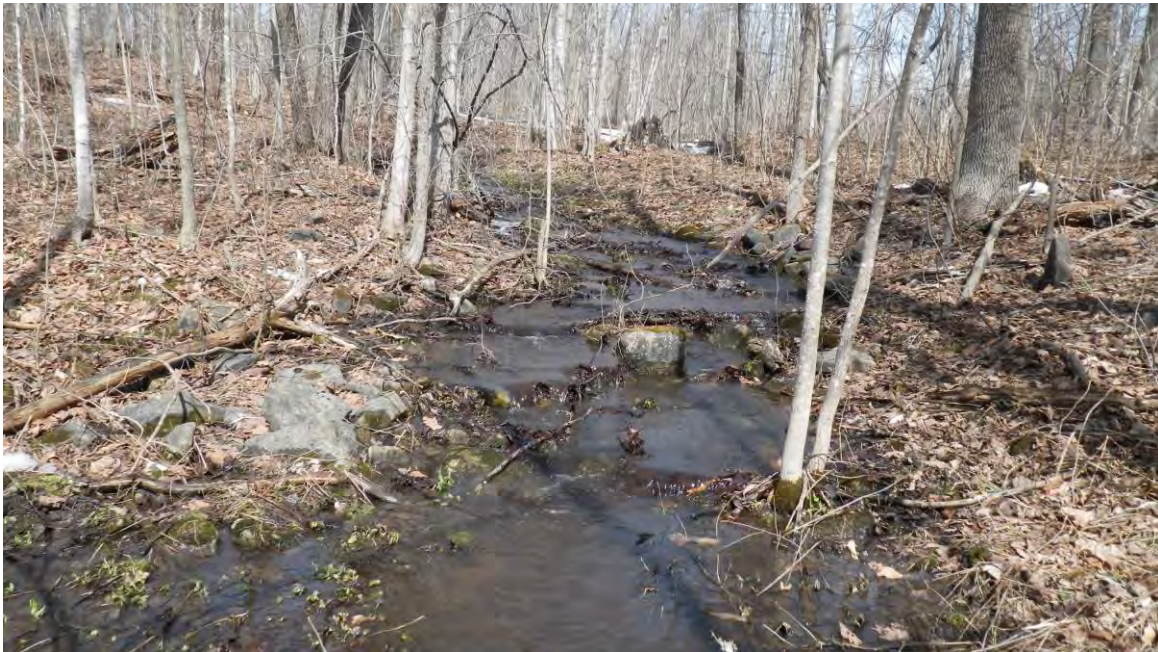
Photo 4: View looking upstream. Channel becomes more defined approximately 100metres downstream of culvert crossing.

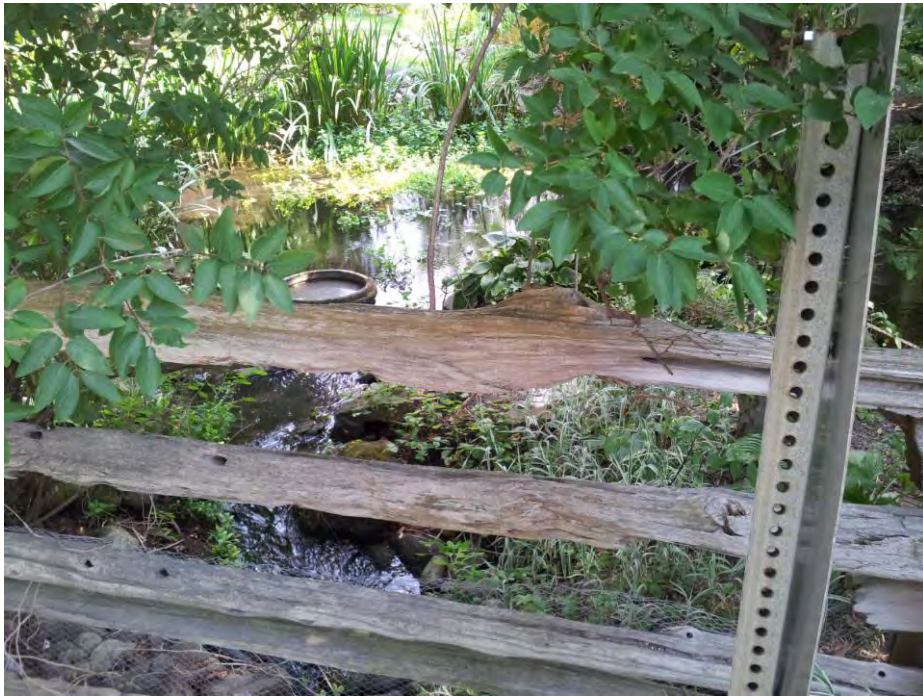
Crossing: 10

Property access was not gained for this crossing, and rapid assessments were limited to what could be seen within and from the right of way, and in this case, could not be completed. Upstream of the road the watercourse is connected to a landscaped pond and flows into a plastic pipe underneath Bush Street. At the outlet and downstream, cobbles and boulders line the bed and banks, and the channel width is approximately 1.5m up to 2.75m, with a depth of approximately 0.25m.

Photo 5: View looking upstream of culvert crossing at online pond.

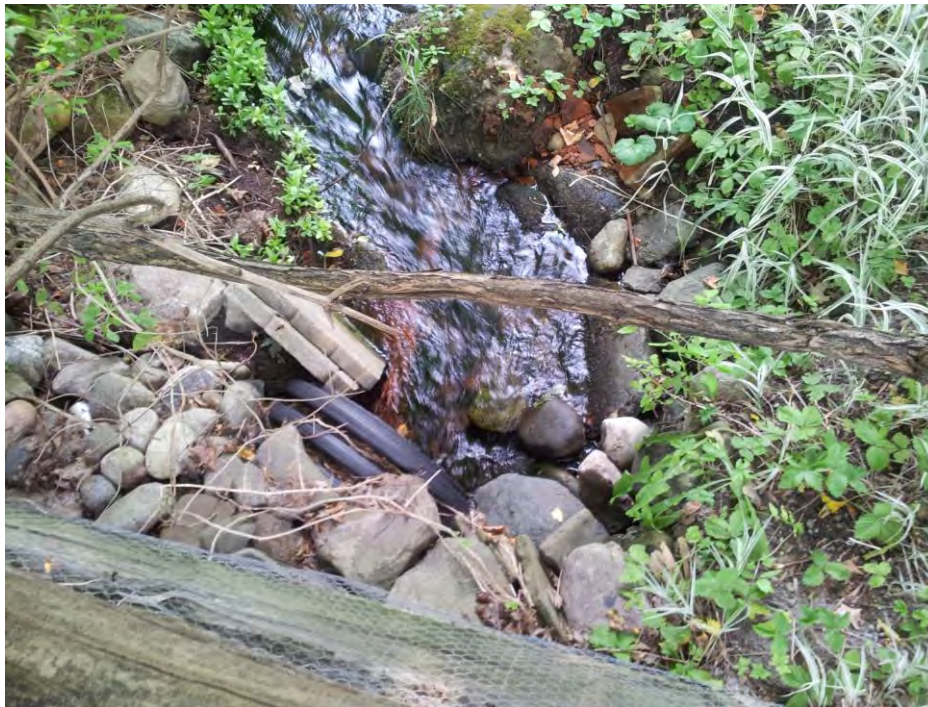
Photo 6: View looking just downstream of the online pond at culvert inlet.

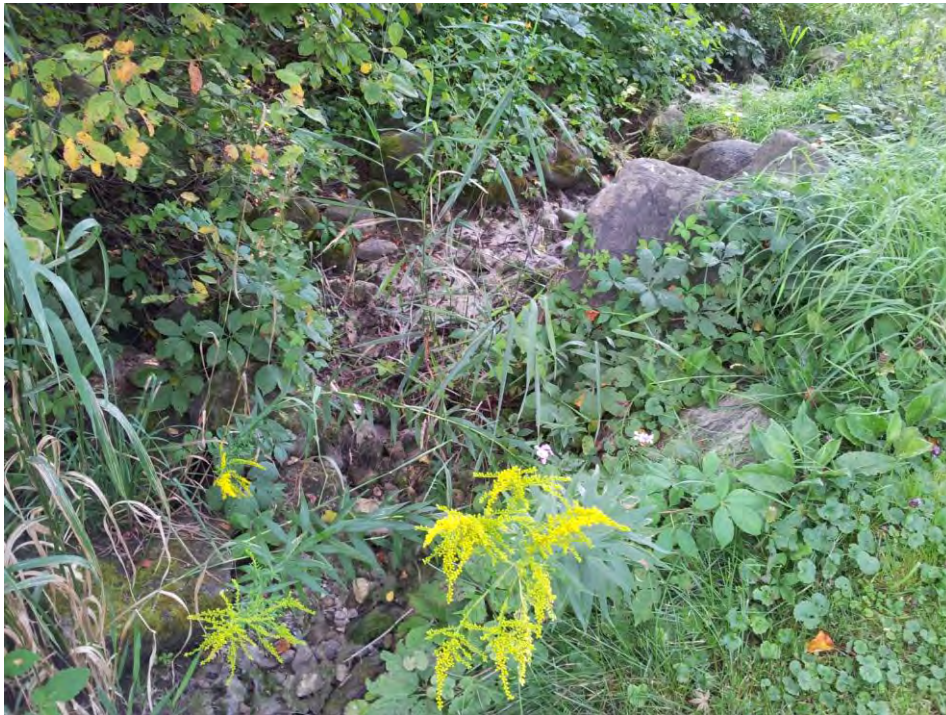
Crossing: 14

corresponding depths ranging from 0.2 to 0.3m, between the upstream and downstream portions of the reach. Upstream the channel is steep and artificially lined with coarse gravels and cobbles. Downstream, the channel resembles that downstream of Culvert 10, being steep and consisting of cobbles, gravels and boulders. Tree roots were exposed and bank heights increased downstream, indicative of some channel degradation. However, this reach was found to be in regime (stable) with a low RGA score of 0.10. The RSAT could not be completed as it was a dry channel with limited access.

Photo 7: View looking upstream of culvert crossing at dry, steep, artificial channel.

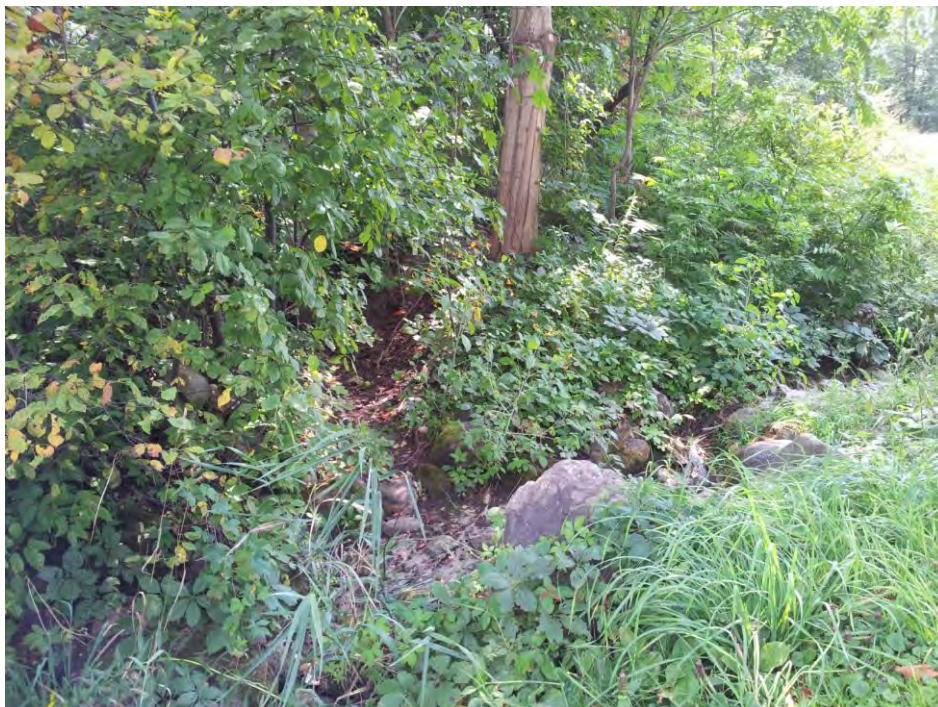
Photo 8: View looking downstream of culvert crossing at dry, steep channel.

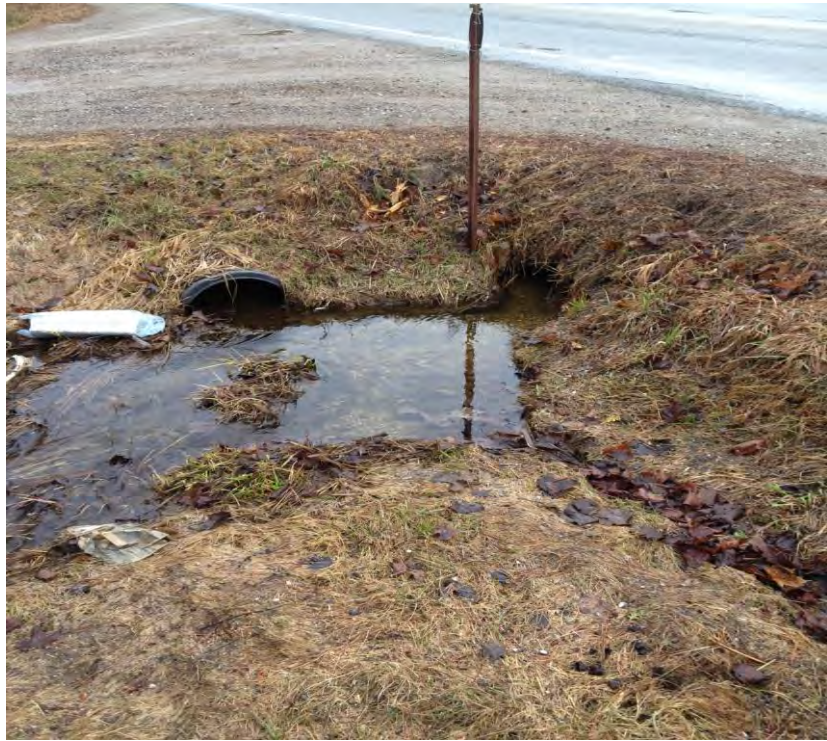
Crossing: WCB-06

Rapid assessments could not be undertaken for this reach. The upstream side lacked channel definition and has been mapped by CVC as a wetland. Downstream of the culvert outlet, a small stream filled with grasses exists as a ditch for only 15-20m before it is piped through a corrugated steel pipe beneath the property to the West.

Photo 9: View looking upstream at culvert outlets.

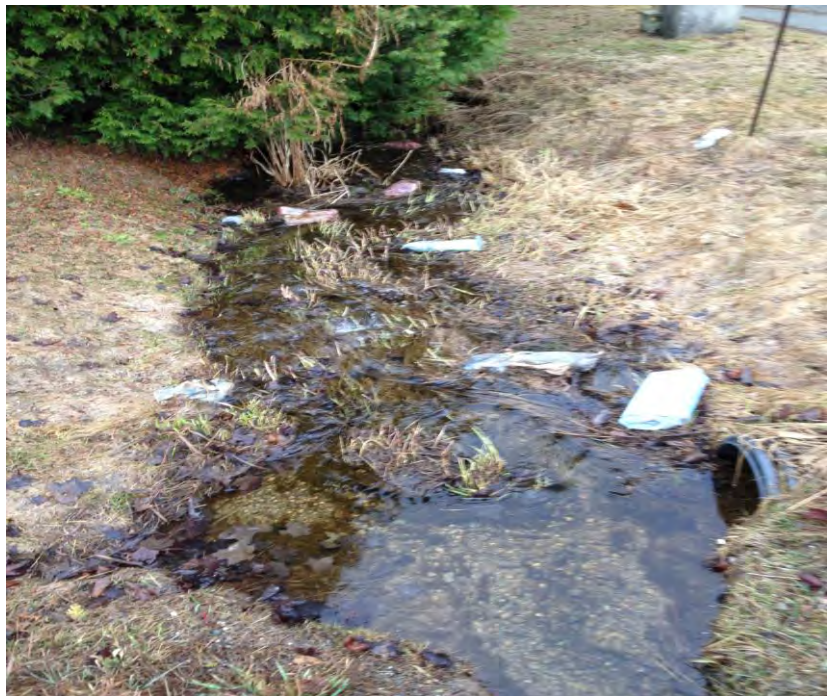
Photo 10: View looking downstream of culvert.

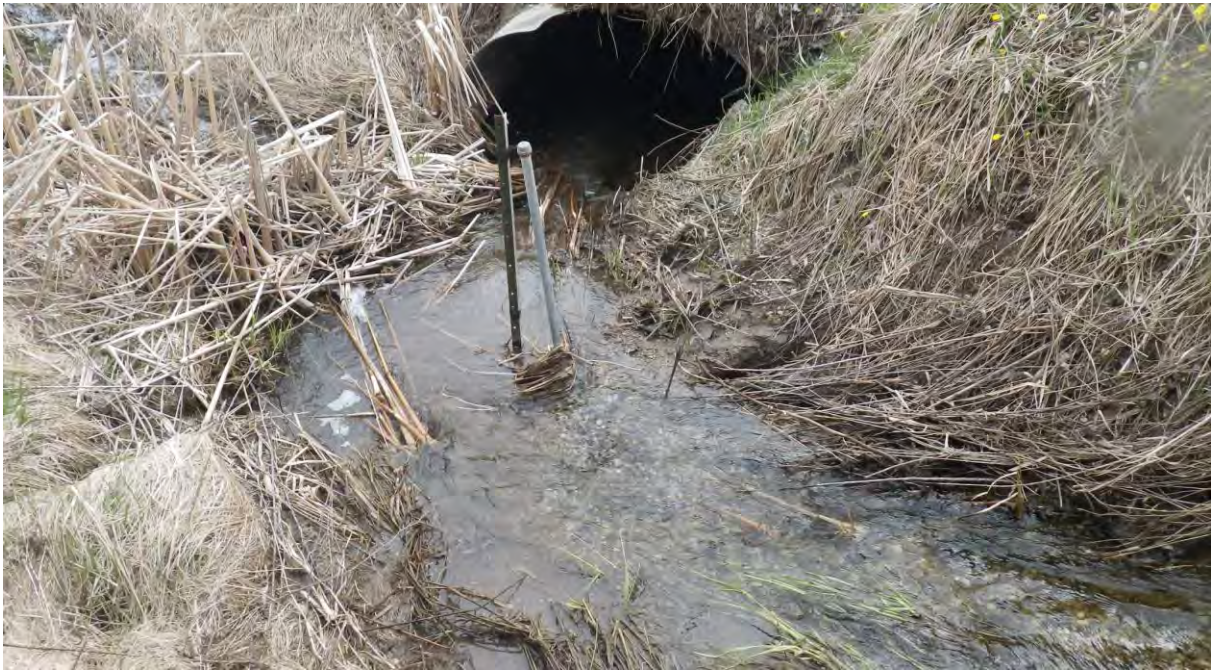
Crossing: WCB-09

This reach is primarily located within the roadside ditch flowing from the East side of Winston Churchill Boulevard, to the West side in a Southerly direction. It drains agricultural land east of the road through a tributary which leads into the ditch 10m upstream of the culvert inlet. It was apparent upon multiple visits that a natural channel is forming within the roadside ditch which is steep and straight. However, within the constraints of the ditch geometry, a series of knickpoints and alternating zones of bank erosion indicate that the channel is trying to regain some length, and reduce energy (slope). Bankfull widths ranged from 2 to 2.2m, and depths from 0.3 to 0.95m, as bank heights increased downstream but widths were confined to the ditch geometry. Riffles and pools were developing with substrates comprised of medium gravel and coarse sand in the riffles, and silt and sand in the pools. A few lateral bars had also formed, also composed of medium gravel, likely from road fill. Overall, the bed was relatively soft and unconsolidated. At the downstream end of the reach along Sideroad 5, the channel widens and shallows as confinement is reduced where the channel width is 3.35m with a depth of 0.57m. The culvert beneath Winston Churchill runs perpendicular with respect to the flow direction of the ditch, creating some sharp bends at either end. This reach was found to be in a state of transition with an RGA score of 0.30, and degradation as the primary form of adjustment. The stream was found to be moderately healthy with an RSAT score of 25.

Photo 11: View looking downstream towards culvert inlet. Level logger is present just upstream of culvert.

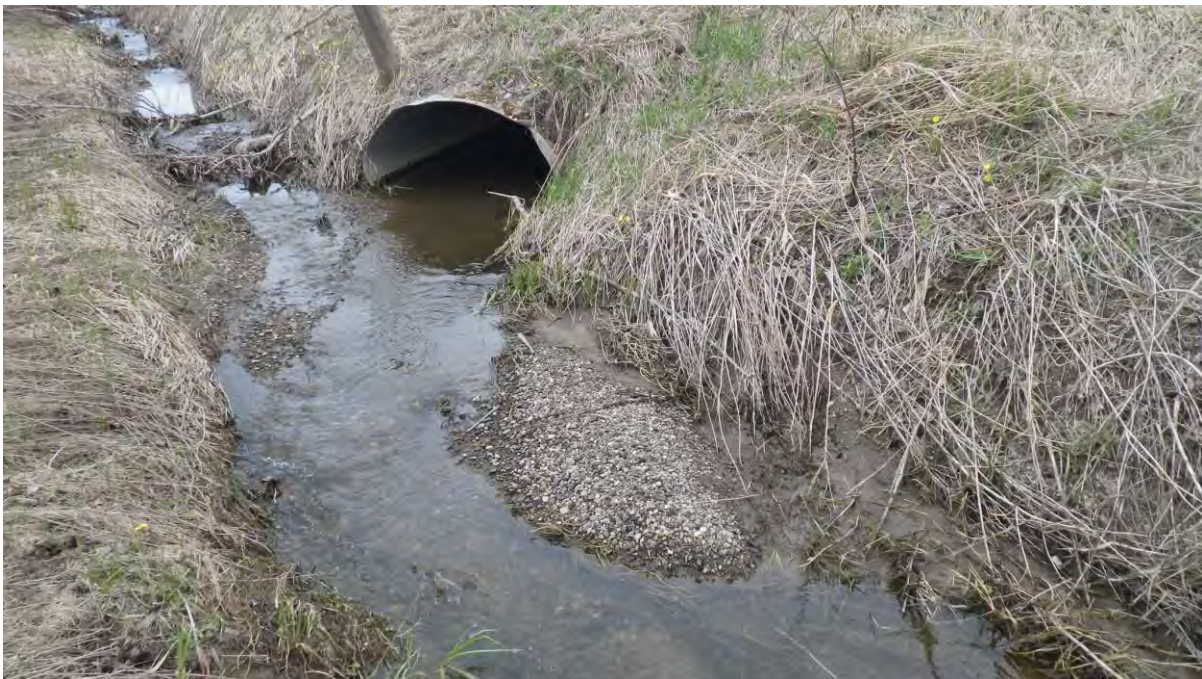
Photo 12: View looking upstream towards culvert outlet.

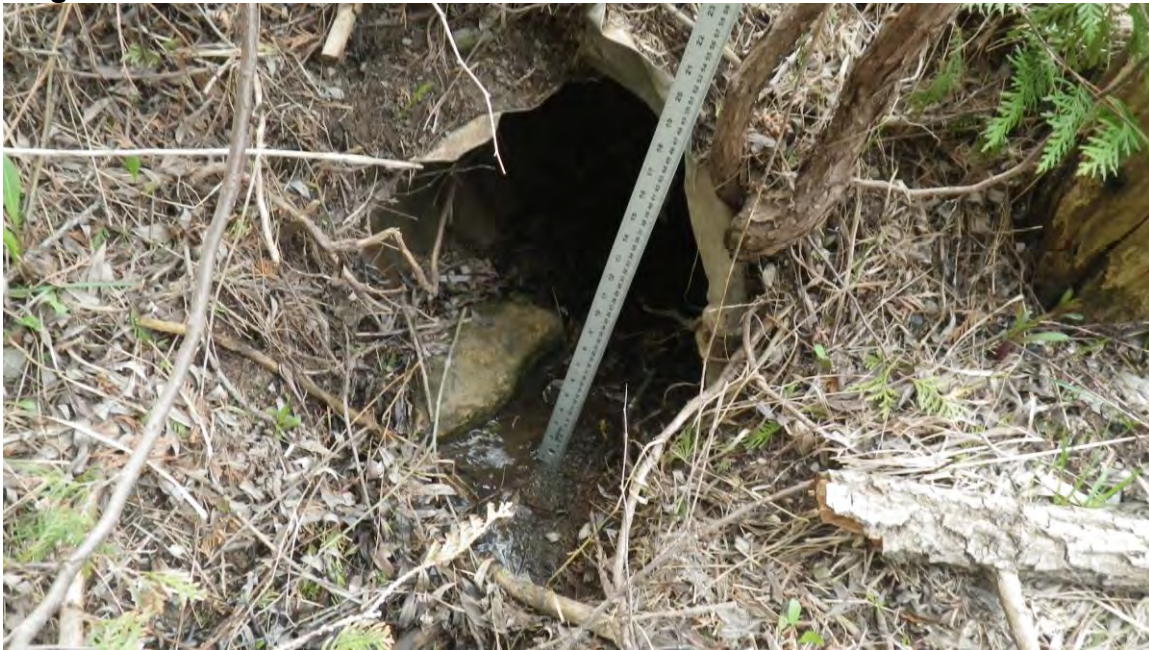
Crossing: WCB-14

Rapid assessments could not be undertaken for this reach. The upstream side was not flowing during the survey and was poorly defined, and downstream was backwatered with its base level being controlled by an online pond. Although the channel was poorly defined upstream, a width and depth could be estimated 5m upstream of the inlet with a width of

Photo 13: View looking downstream towards culvert inlet. Culvert appears to be collapsing.

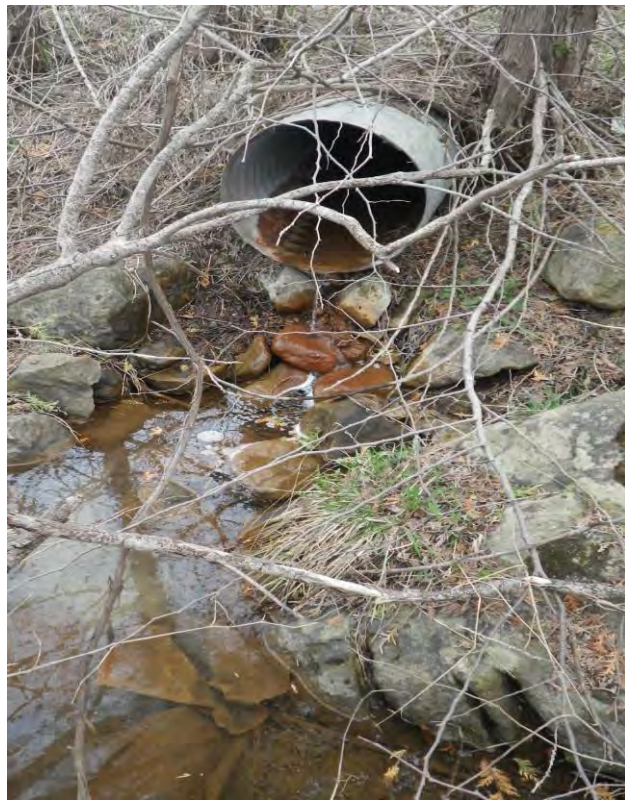
0.63m and a depth of 0.12m. Erosion was evident at the downstream side as the culvert was perched above the water surface by almost 0.5m, and the channel became much wider and deeper: 1.9m and 0.35m, respectively. Rip rap was utilized to stabilize this undercut. There is a notable difference in elevation between the inlet and outlet which likely increases the stream power and velocity under high flow conditions, creating the wider and deeper channel geometry downstream.

Photo 14: View looking upstream towards the perched culvert outlet.

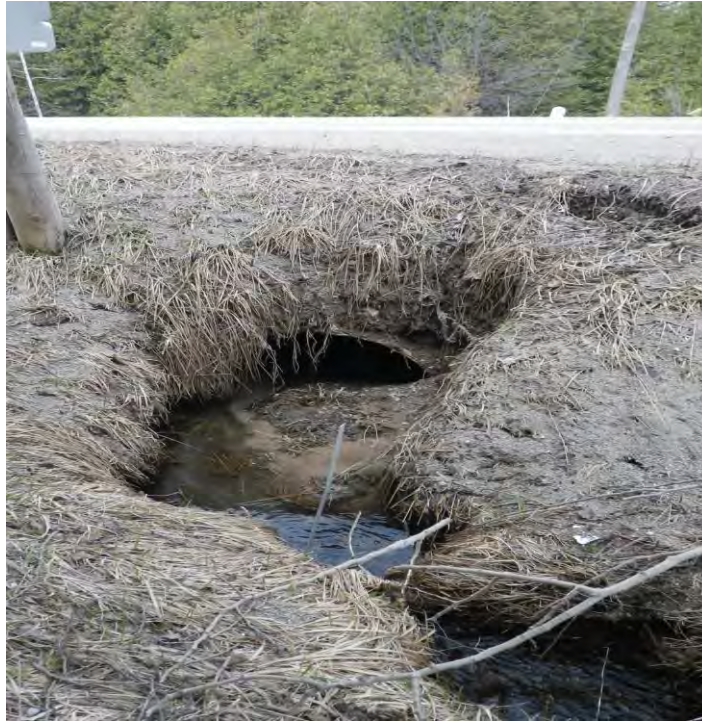
Crossing: WCB-16

Similar to WCB-09, this reach is primarily located within the roadside ditch, with the culvert perpendicular to the prevailing flow. However, it is draining a smaller area, and initiates in a cedar swamp immediately upstream of the road, resulting in a smaller, more stable channel form. A small, deep channel exists for 2.5m upstream of the culvert, with a steep gradient and two steps and pools as it enters the culvert. The bank along the inlet has failed creating a small deposit, interrupting flow. At the outlet, the channel takes a sharp turn to the north through the drainage ditch, and a lateral bar has developed consisting of pebbles and fine to medium gravels. The channel is only confined along the left bank by the road, and the right there is connection of higher flows to a small marshy area and an online pond further downstream. At the downstream end of the reach (20m down from the outlet) there is a Bell phone utility box with a cobble step 0.3m high in the channel which would likely prevent fish migration upstream. This reach is relatively stable, and in regime, with evidence of aggradation mostly occurring due to the soft, unconsolidated bed. However, the score of 0.2 suggests that this reach may become more unstable and reach a state of transition. The RSAT score was moderate but rather low with a score of 21.

Photo 15: View looking upstream towards culvert inlet which is being compromised by the failing bank.

Upon detailed design, it is recommended that these minimum crossing spans are utilized using concrete culverts with an open-bottom, functional design. Improved culvert skew and/or channel realignment should be undertaken for those reaches in which flow is primarily restricted to the roadside drainage ditch (WCB-09 and WCB-16).

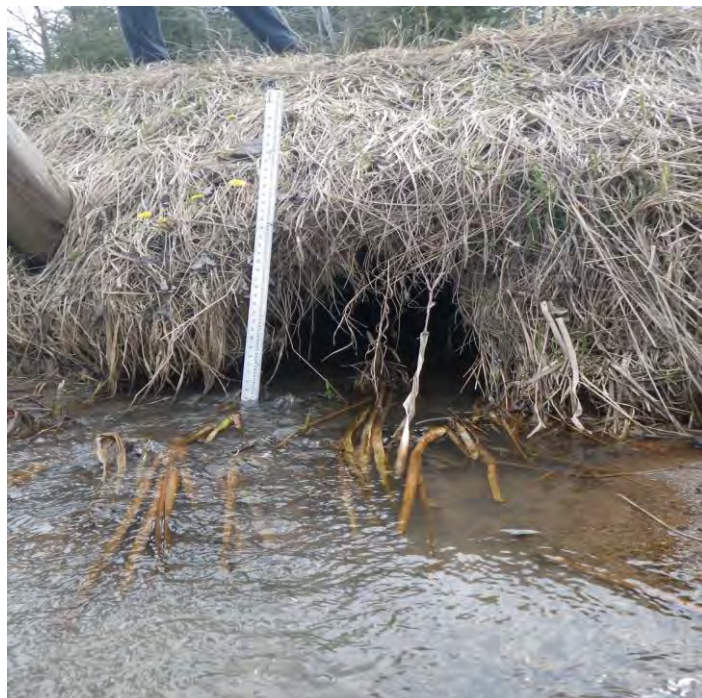
Photo 16: View looking upstream towards culvert outlet which is being compromised due to slumping bank.

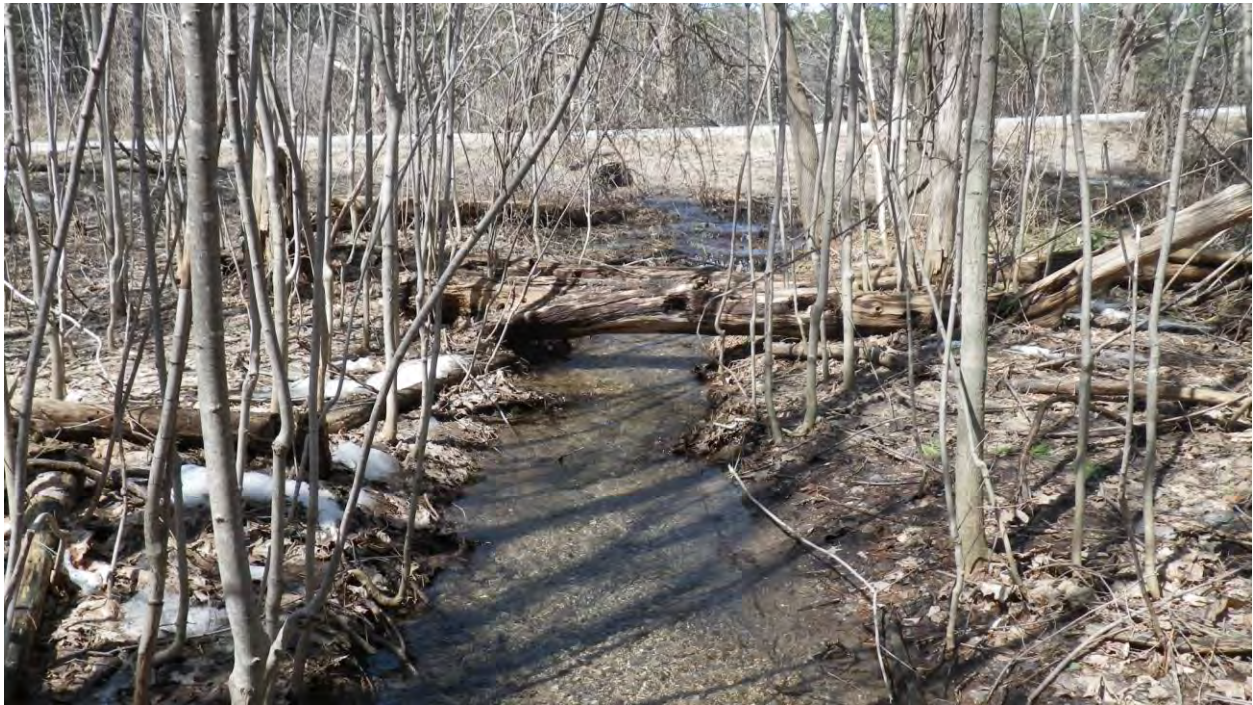
Crossing: OBL-02

Upstream of the crossing, a pond had developed amongst some deciduous trees presumably due to recent melt. The channel remained undefined for approximately 100m upstream where a width of 1.5m and depth of 0.25m were measurable. On the downstream side, the channel grade steepened upon exiting the culvert into a single thread channel flowing over carbonate cobbles and boulders, forming a series of steps, characteristic of many streams on the Niagara Escarpment. Approximately 200m downstream the channel became multi-threaded through a cedar swamp. The substrate was comprised of silt, pebbles, and gravel, with cobbles occurring throughout. The stream was found to be in a transitional state with an RGA score of 0.26, with evidence of all forms of adjustment occurring. Aggradation was found upstream, and degradation, widening, and planform adjustment downstream of the culvert. Stream health (RSAT) scores were moderate with a value of 31.

Photo 17: View looking upstream towards culvert outlet.

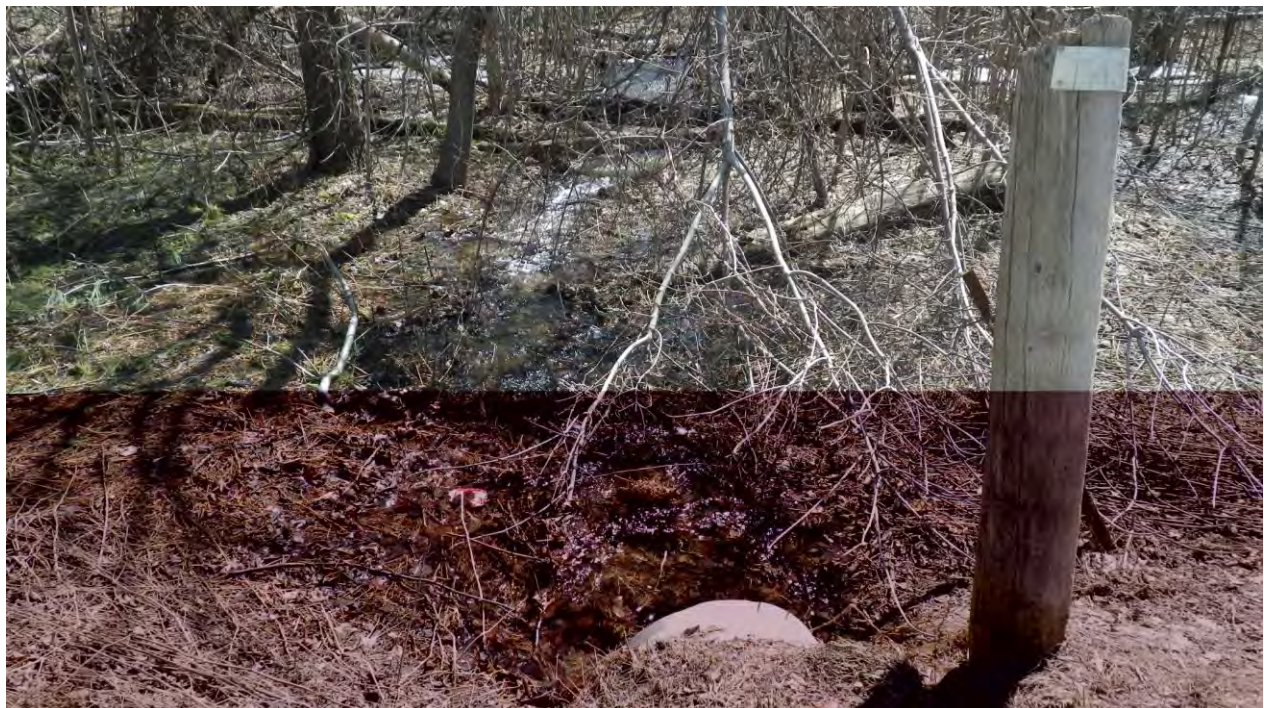
Photo 18: View looking upstream of culvert inlet.

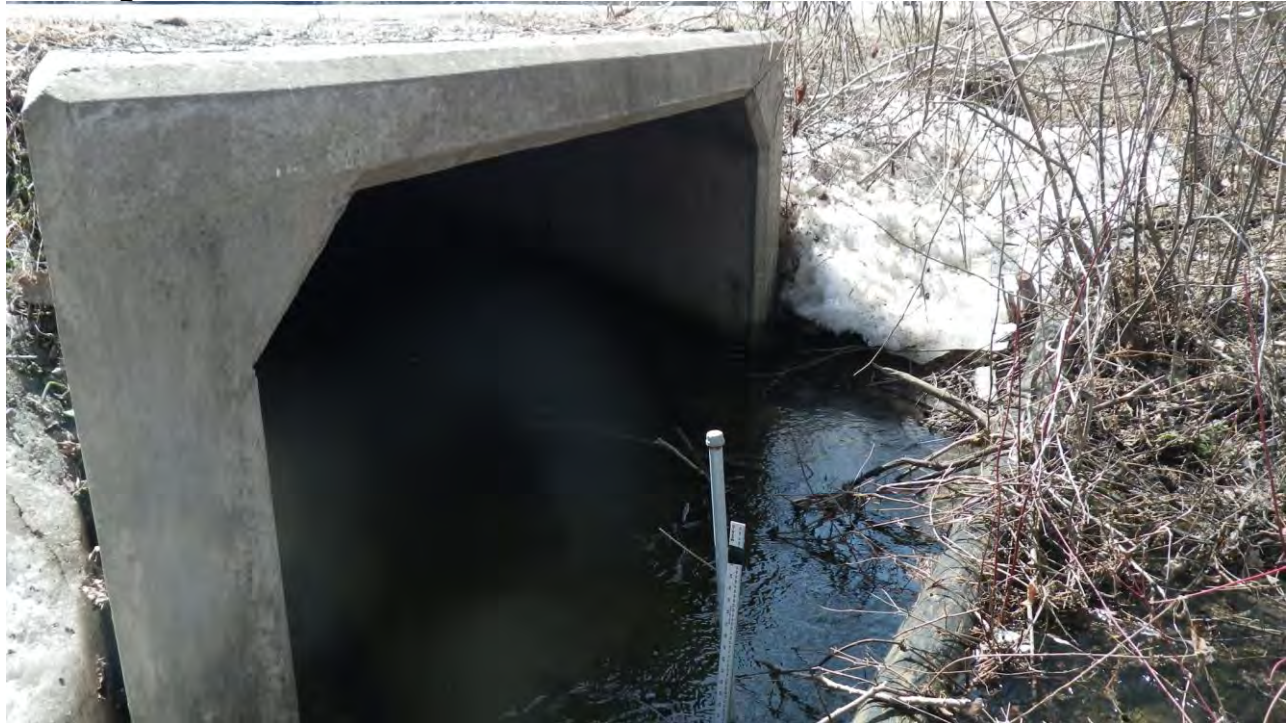
Crossing: OBL-04

Within the study area, this reach is one of the more significant watercourses, with water permanently flowing, and a concrete box culvert with a span of over 3m. The channel form is relatively straight, intersecting with Olde Base Line Road at approximately a 45° angle. It flows between a grassy field and a private pond, with deciduous trees lining the banks. Major woody debris occurs throughout and the bedform is dominated by a series of pools and jams, with unconsolidated gravels, sands, and silt depositing along the bed. Bankfull widths ranged from 1.8-4m, and depths from 0.33 to 0.71m. Bank heights increased downstream towards the road, and gravelly substrate lines the bed of the channel through the concrete culvert structure. The form and function of the channel can be identified as being in a state of transition with an RGA score of 0.31 and aggradation as the primary form of adjustment. Stream health was determined to be moderate with a score of 28.

Photo 19: View looking downstream at culvert inlet. Level logger is present just upstream of culvert.

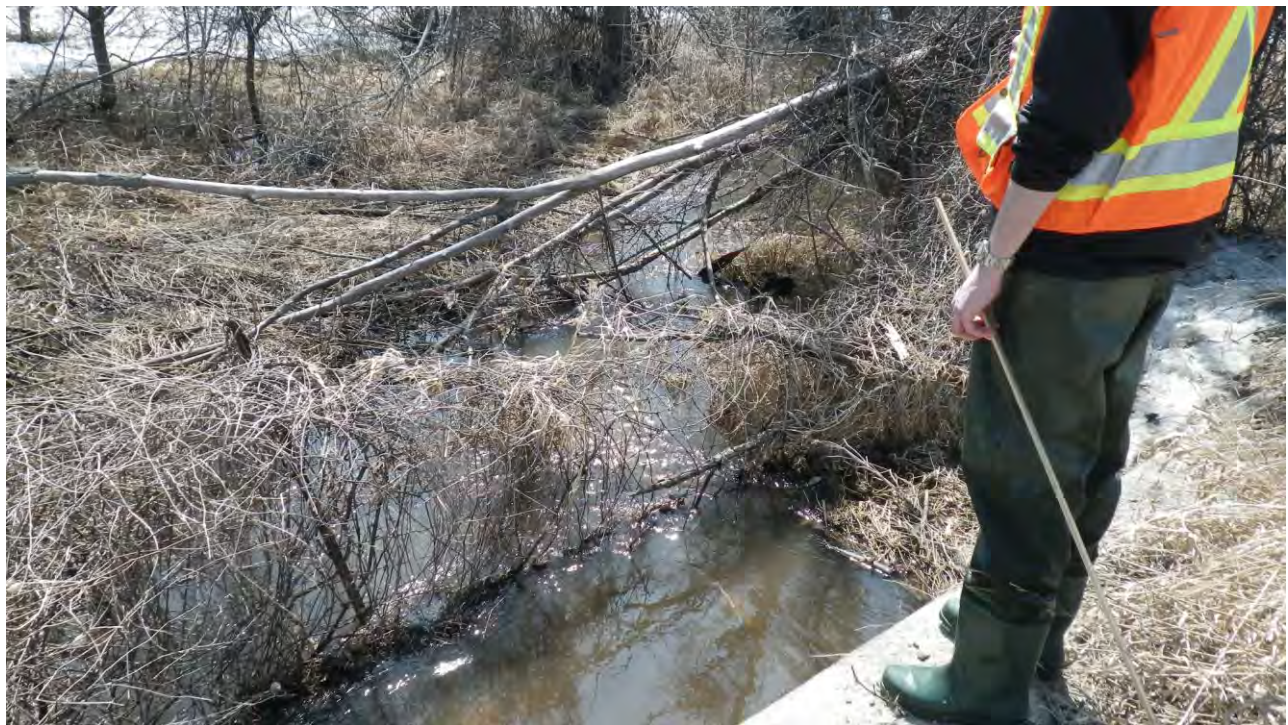
Photo 20: View looking downstream from culvert outlet.

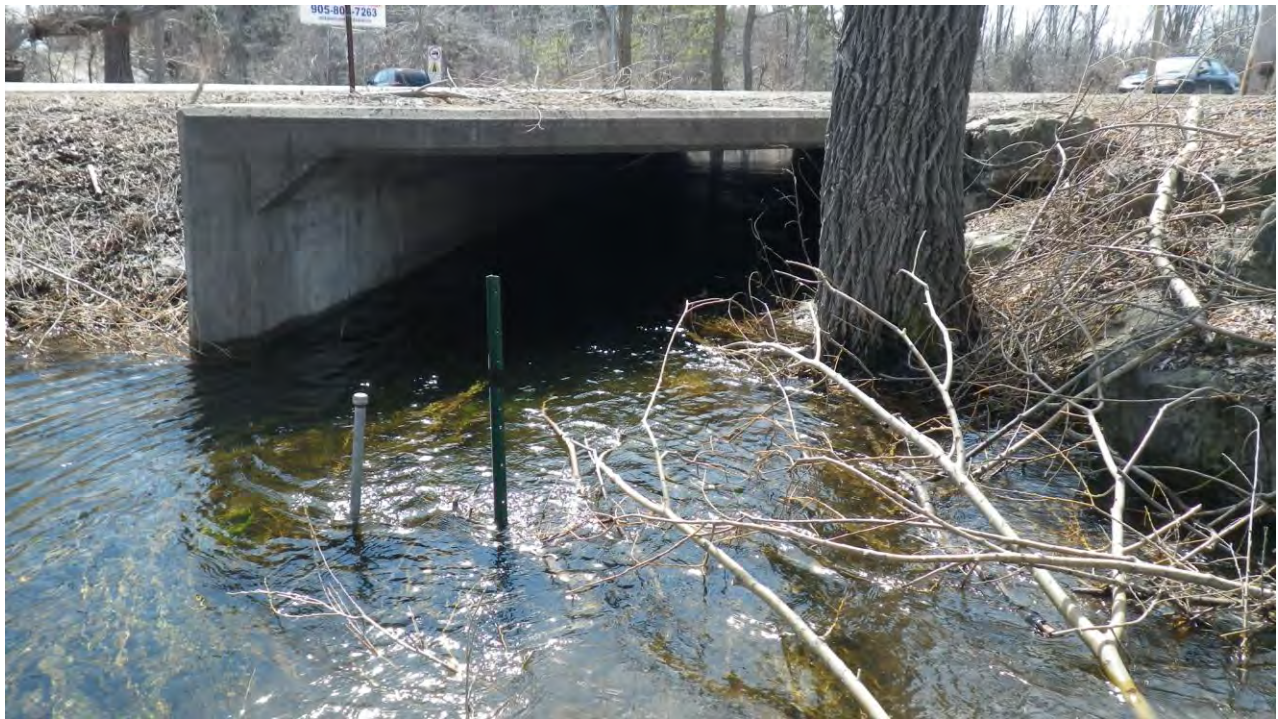
Crossing OBL-08

This watercourse was the only other within the study area that was major enough to require a relatively large crossing span (4.5m), also a concrete box culvert structure. It flows out of an online pond at the upstream end through a riparian zone dominated by deciduous trees,

with major wood debris occurring. At the time of the survey, a late spring freshet was underway, creating overbank flooding. Despite this, bankfull features were visible below the water surface and inflections within the cross-section could be felt in order to estimate the bankfull channel dimensions. Bankfull widths were in the 3m range, and depths around 0.31m. Like OBL-04, the bed was comprised of unconsolidated gravels and sands. This reach is also in a state of transition with aggradation as the primary form of adjustment with an RGA score of 0.24. Stream health was determined to be moderate with a score of 28.

Photo 21: View looking downstream towards culvert inlet. Level logger is present just upstream of culvert.

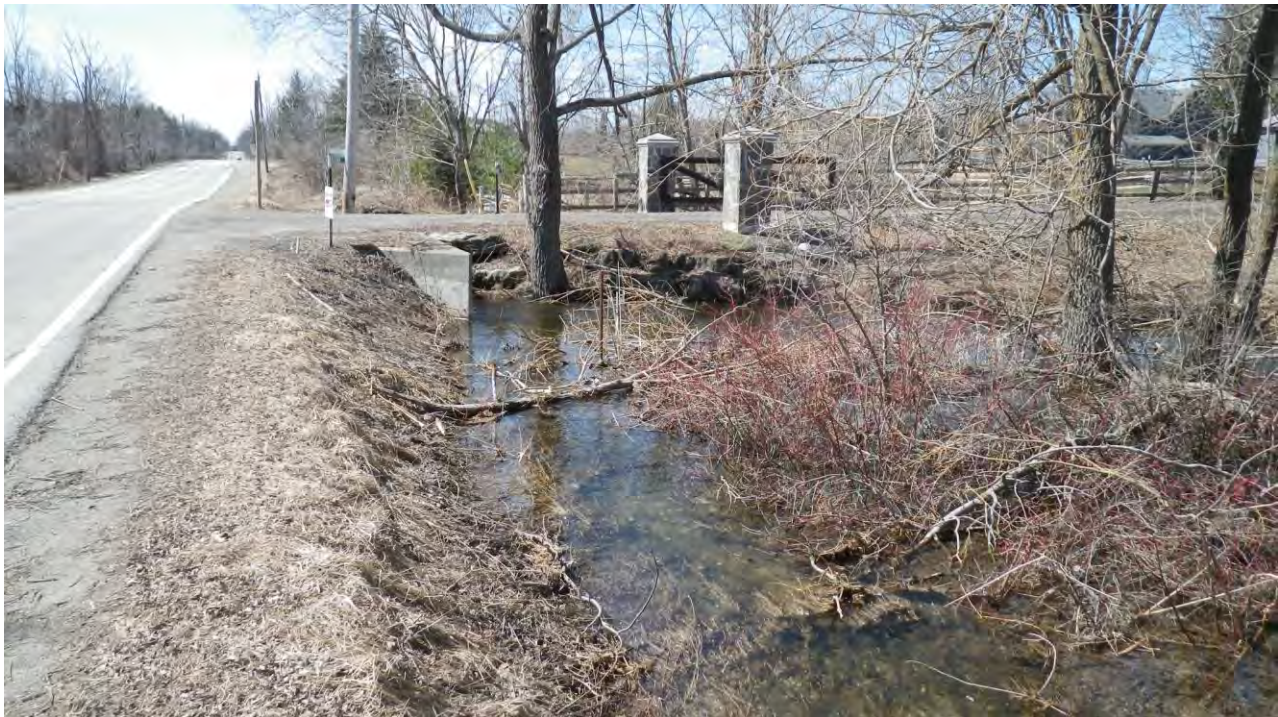
Photo 22: View looking downstream of roadside ditch which drains into culvert inlet.
