NINTH LINE STREAM MORPHOLOGY INTERIM REPORT
137960 - 20947 - 522

Report Prepared for:
AMEC FOSTER WHEELER

Prepared by:
PARISH AQUATIC SERVICES
A DIVISION OF MATRIX SOLUTIONS

June 2016
Mississauga, Ontario

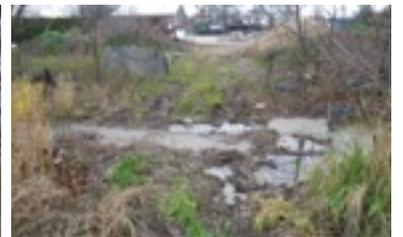
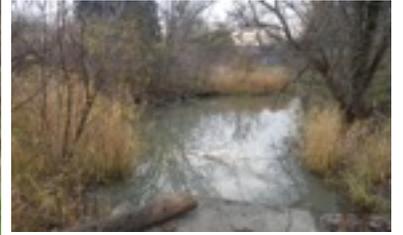
Backwatering & poor flow/sediment conveyance resulting from the small concrete crossing at the downstream survey extent.

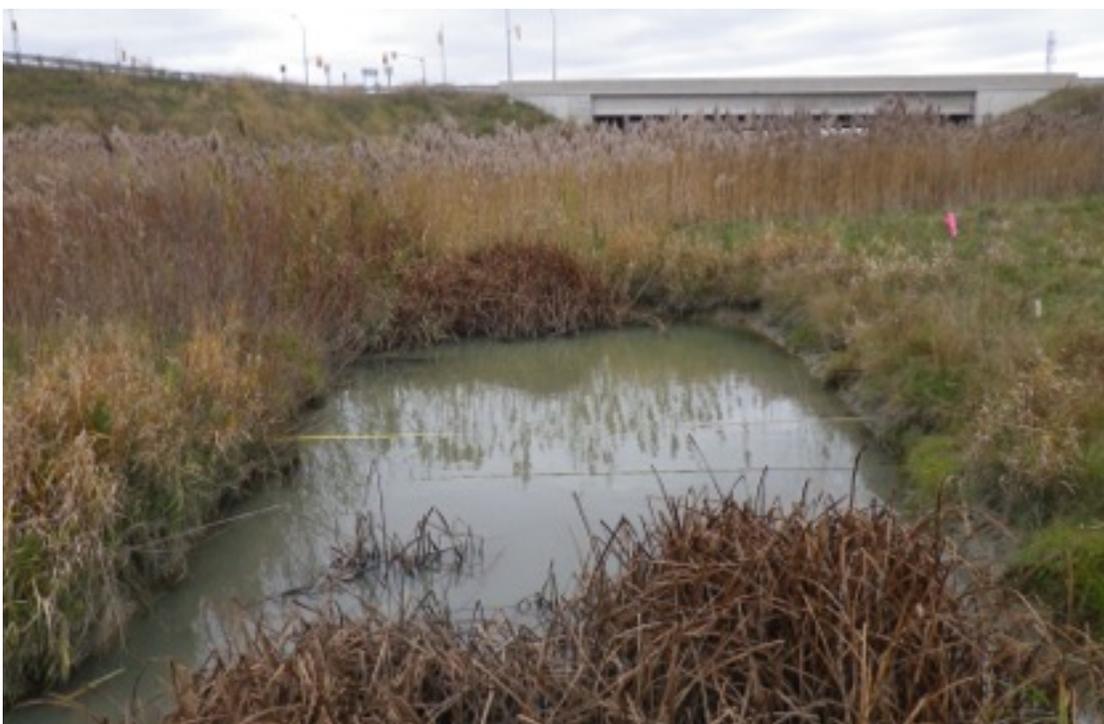
Typical channel cross-section displaying shallow banks which frequently overtop onto the broad, flat floodplain. The floodplain is vegetated with short to long grasses and some shrubs. Note the Britannia Bridge crossing in the bottom photo delineating the upstream reach extent. Ninth Line and HWY 407 confine the watercourse to the east and west delineating the Ninth Line Corridor.

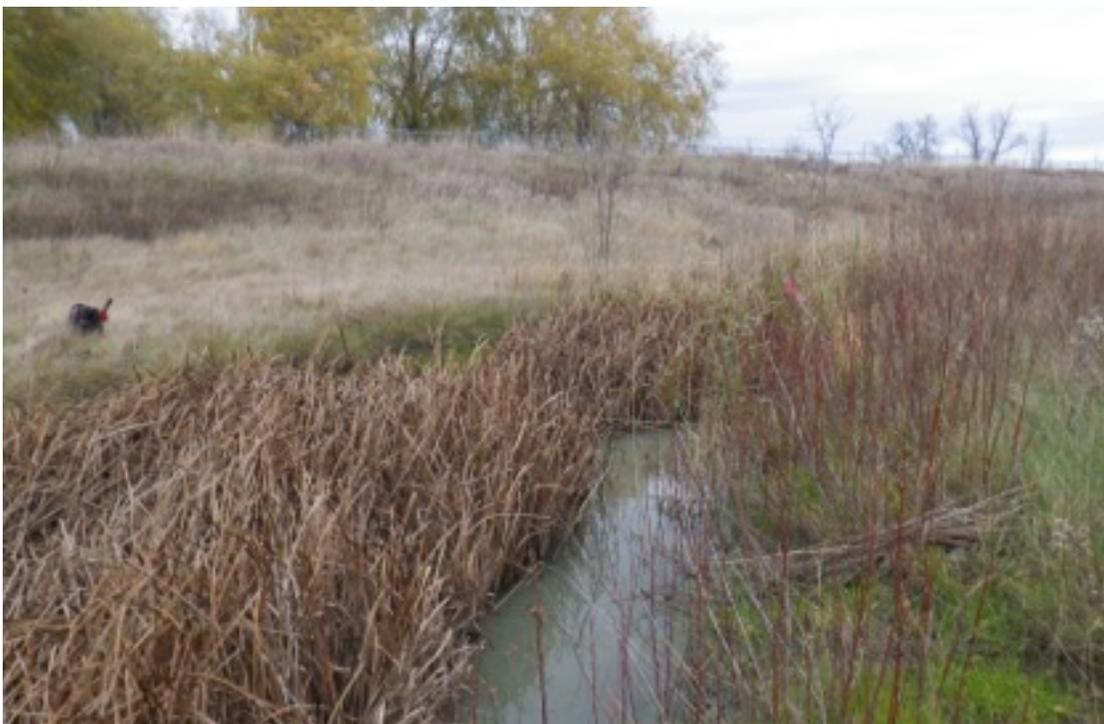
The presence of instream vegetation was typically observed within the watercourse, commonly found in mid channel areas. Wet meadow grasses and cattails were the dominant types of instream vegetation noted.

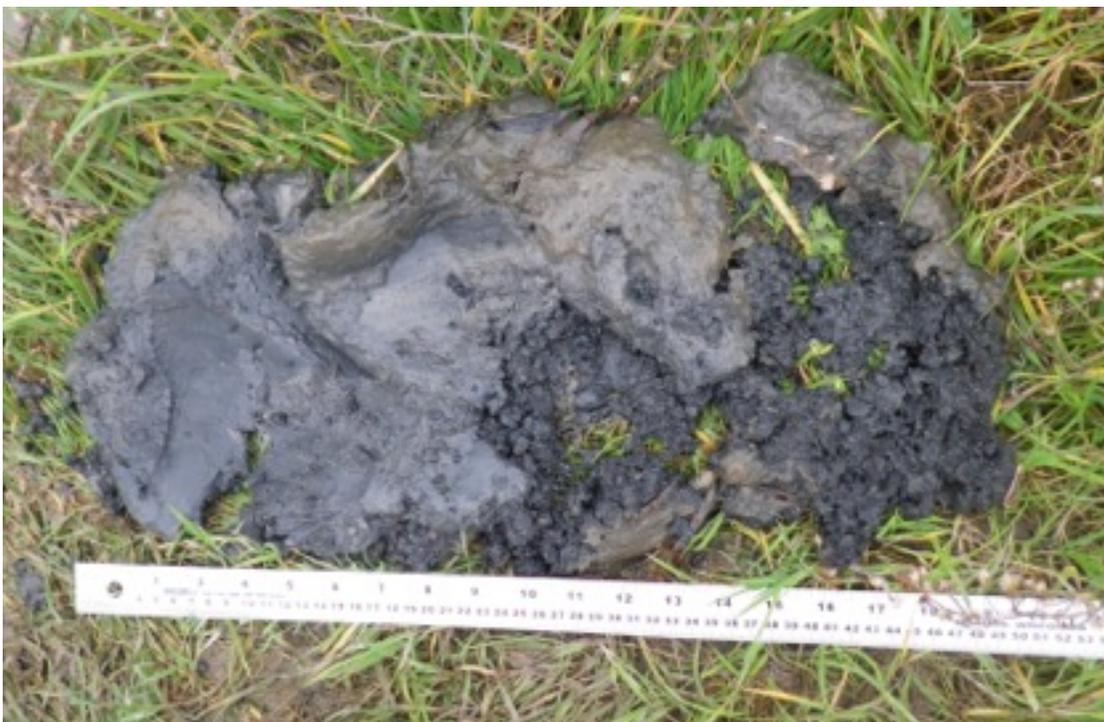
Channel bed substrate was soft and unconsolidated with high organic content. The substrate consists of fine textured materials (silt, clay, fine sand) with inclusions of coarser materials (coarse sand, pebbles and small gravels) found within the mix. The subpavement is representative of the typical geology of the area consisting of stiff silty-clay till.
