D-2 SAFETY REVIEW OF EXISTING CONDITIONS

City of Brampton

**Environmental
Assessment Study of
Arterial Roads Within
Highway 427 Industrial
Secondary Plan Area
(Area 47)
Safety Review of Existing
Conditions**

March 2016

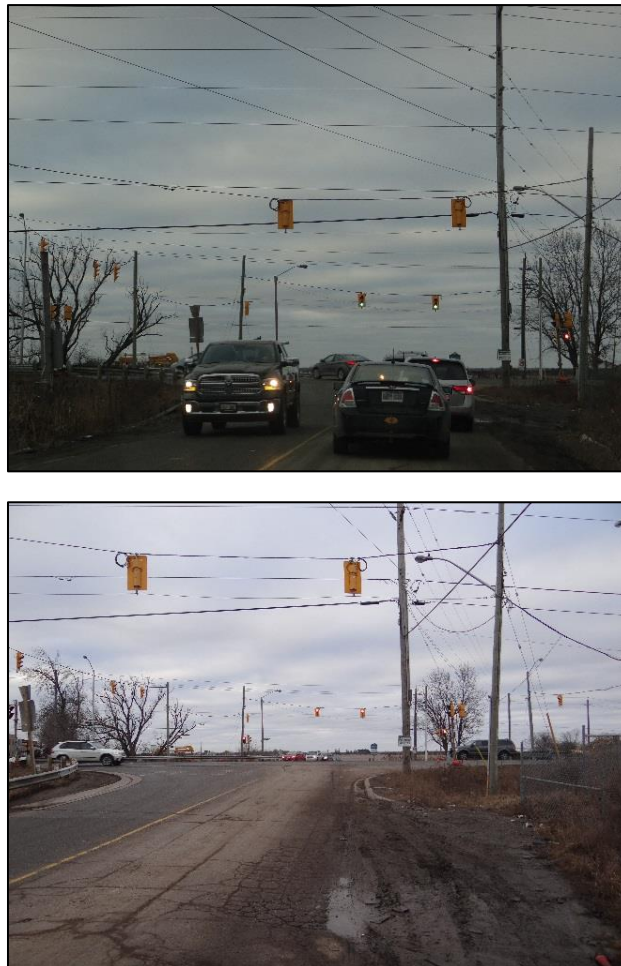
Figure 1: Elevated Intersection (Coleraine Drive and Region Road 50)

The intersection of Coleraine Drive and Regional Road 50 is elevated for motorists travelling in the eastbound and westbound directions. The presence of this condition reduces visibility to upcoming traffic for vehicles turning left from both eastbound and westbound directions or going through the intersection during the green phase as illustrated in Figure 1.

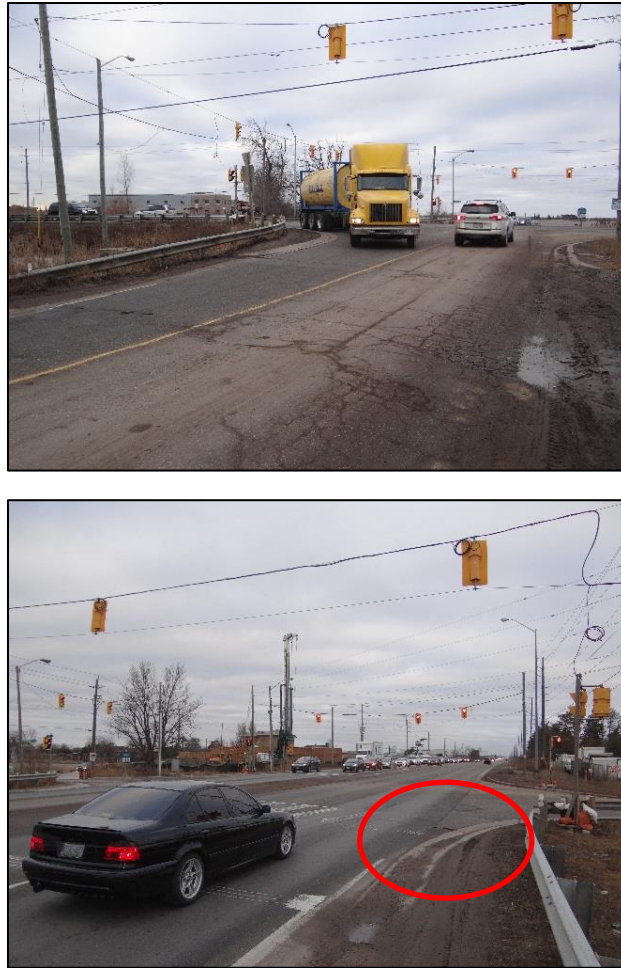
Figure 2: Limited Turning Radius (Coleraine Drive and Region Road 50)

At the intersection of Coleraine Drive and Region Road 50, heavy vehicles attempting to make a right turn are forced to drive over the sidewalk due to the limited available turning radius. This situation creates a potential safety hazard for pedestrians at the intersection. For illustration purposes, Figure 2 shows eroded surface along with a heavy vehicle clipping the shoulder due to the limited turning radius.

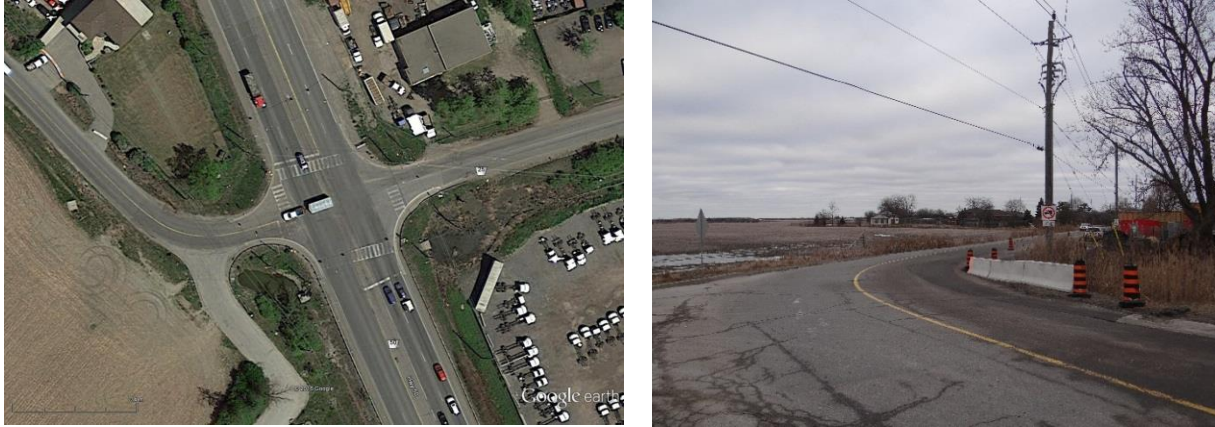
Figure 3: Skewed Intersection (Colerain Drive and Region Road 50)

The eastbound approach of Coleraine Drive is aligned with Regional Road 50 is at a 90-degree angle for approximately 30 metres from the intersection, where it turns towards the north. This situation creates a potential safety hazard of running off the road for unfamiliar motorists due to the sudden change in road alignment. This situation is illustrated in Figure 3.

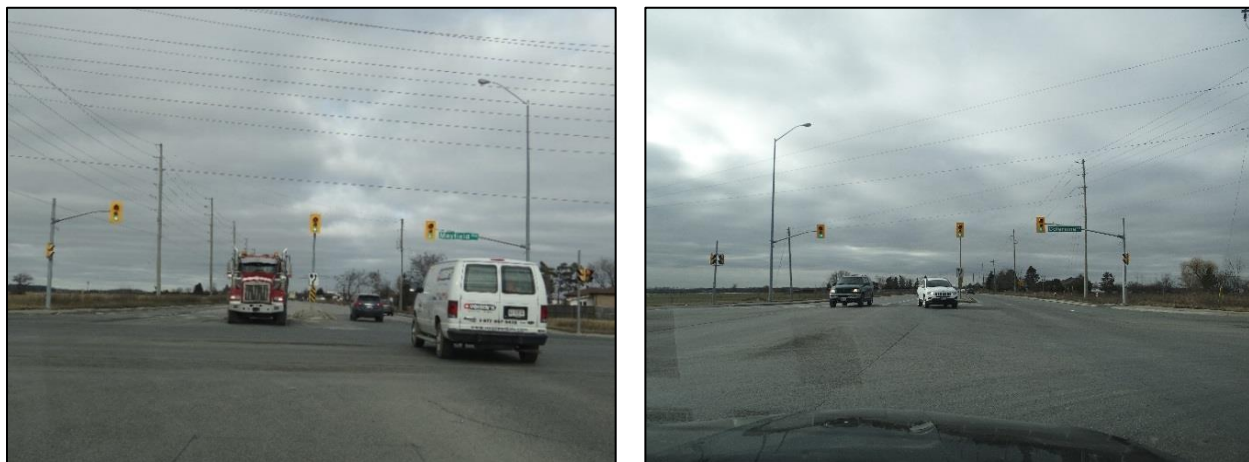
Figure 4: Offset Intersection Approaches (Colerain Drive and Region Road 50)

Existing left-turn lanes in all directions at the intersection of Coleraine Drive at Mayfield Road presents negative offsets. This configuration can create visibility restrictions to drivers attempting to turn left during the permissive phase when drivers in the opposite direction are attempting to perform the same manoeuver. This is aggravated when large vehicles, such as trucks, or in some cases large pick-up trucks, are in the opposing left-turn lanes as illustrated in Figure 4. This could be a contributing factor to turning movement collisions.

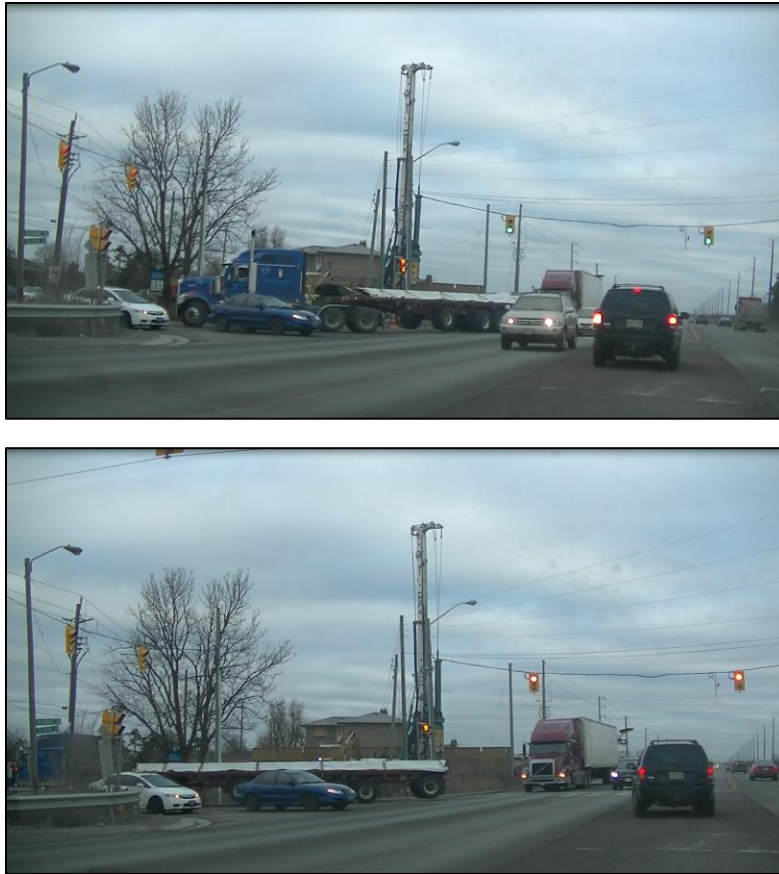
Figure 5: Access to Private Driveway (Colerain Drive and Region Road 50)

A large warehouse driveway is in close proximity of the intersection of Coleraine Drive and Regional Road 50. During peak hours, heavy vehicles turning into Coleraine Drive from Regional Road 50 are attempting to access the private driveway, which may end up blocking the intersection. Motorists queued in the east leg of the intersection block access to the private driveway during the all red phase. Heavy vehicles are required to stop and wait for a gap in-between these queued motorists to enter the property. Due to the close proximity of the private driveway and intersection, this scenario may cause queue spill back onto Regional Road 50 and increase the potential turning on red for the waiting vehicles in Figure 5.

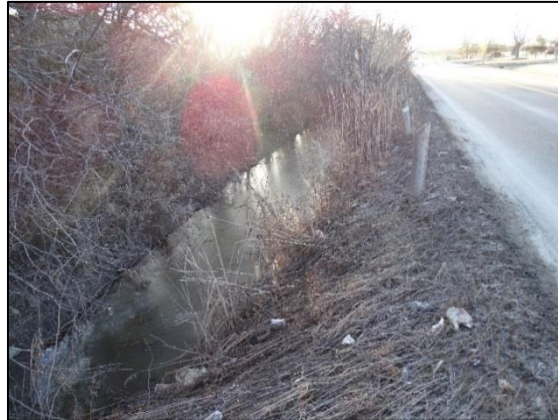
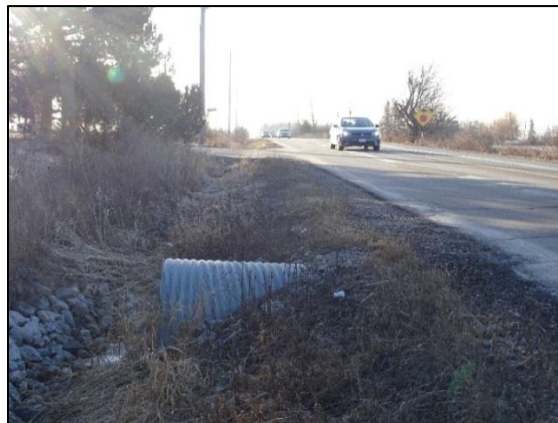
Figure 7: Side Slopes along the Coleraine Drive Corridor

slopes may not be able to recover and at some locations are likely to overturn. Recoverable slopes are generally the slopes flatter than 4:1 on which a driver can retain or regain the control of the vehicle in a run-off the road event. Non recoverable slopes are generally the slopes from 4:1 to 3:1. These slopes may be traversable, but the vehicle will continue to the bottom. Slopes steeper than 3:1 are known as critical slopes and are considered outside of the recovery zone. Vehicles encroaching on these slopes are likely to overturn. TAC notes that if critical slopes begin within the clear zone distance, a traffic barrier may be warranted if the slope cannot be readily flattened². Figure 7 illustrates a typical roadside slope within the clear zone.

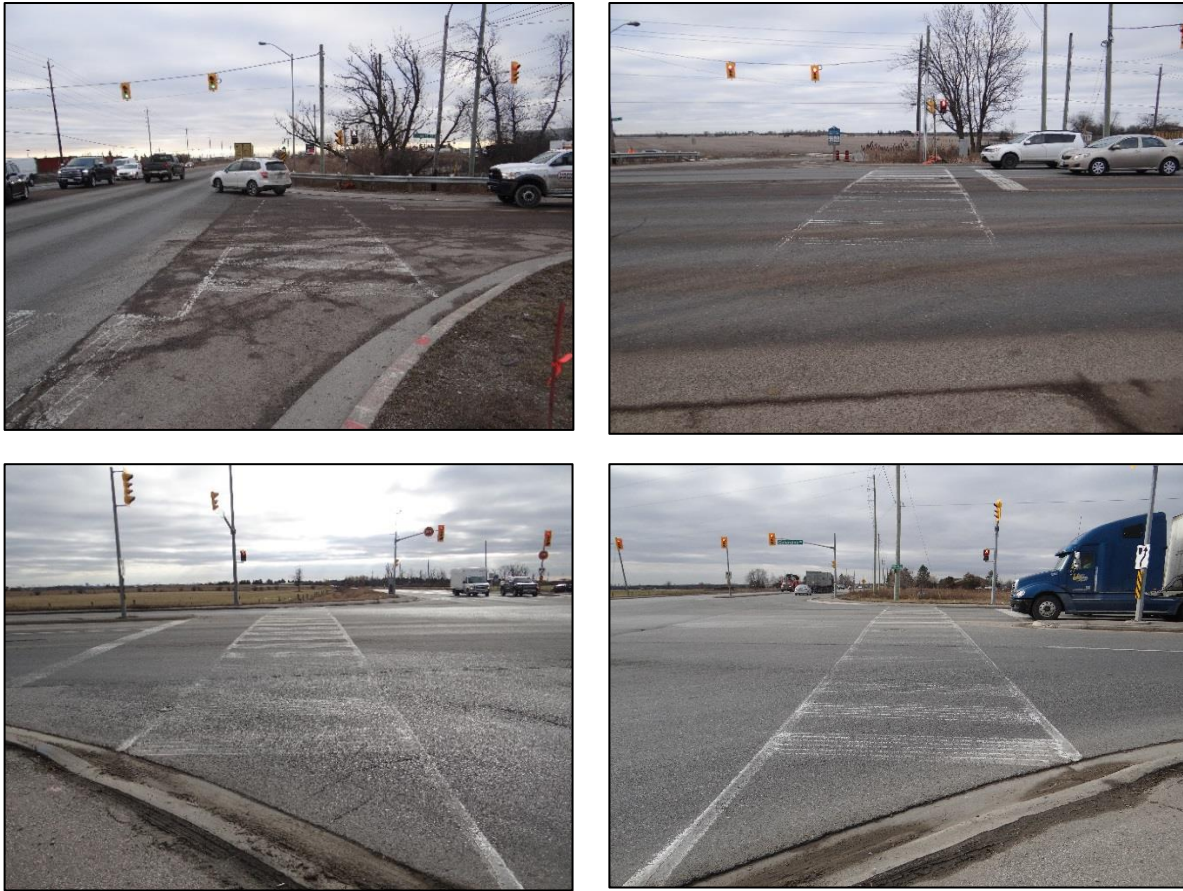
Figure 9: Offset Pedestrian Signals

Existing pedestrian signal heads at two intersections of Coleraine Drive and Regional Road 50 and Coleraine Drive and Mayfield Road are not properly aligned with the existing painted pedestrian crosswalks and sidewalks as illustrated in Figure 9.

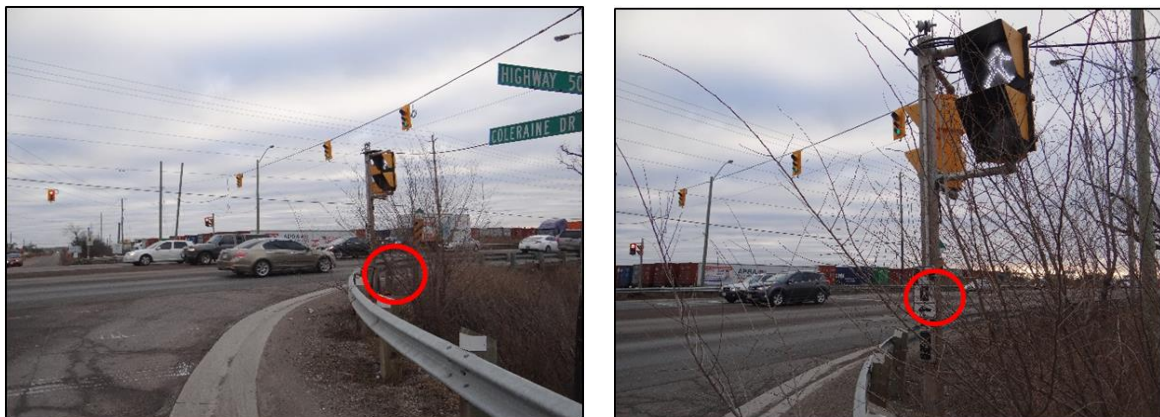
Figure 10: Obstructed Pedestrian Push Button (Coleraine Drive and Regional Road 50)

The pedestrian pushbutton located at the southwest corner of the intersection of Coleraine Drive and Regional Road 50 is obstructed by tree branches. During the spring and summer seasons once branches bloom, it may be difficult for pedestrians to locate the push button and safely operate the intersection as shown in Figure 10.

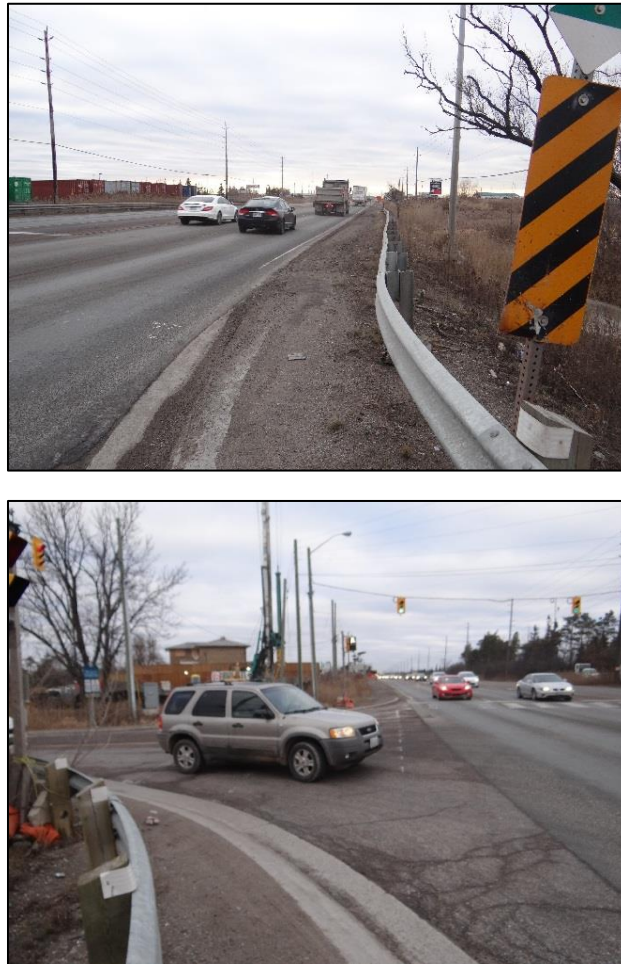
Figure 11: Pedestrian Sidewalks (Coleraine Drive and Regional Road 50)

At the intersection of Coleraine Drive and Regional Road 50, existing pedestrian signal heads and painted crosswalks located on all four approaches of the intersection do not contain any pedestrian sidewalks for accessibility of the intersection and approaches. Existing road shoulders for Regional Road 50 and Colerain Drive are used as sidewalks by pedestrians attempting to cross any of the approaches of the intersection which are approximately 1 meter in width with mountable curbs. The existing geometry of the intersection creates a potential safety hazard for pedestrian at all legs of the intersection attempting to cross. This issue is due to the lack of sidewalks and the possibility of heavy vehicles encroaching the mountable shoulders due to the limited turning radius as demonstrated in Figure 11.

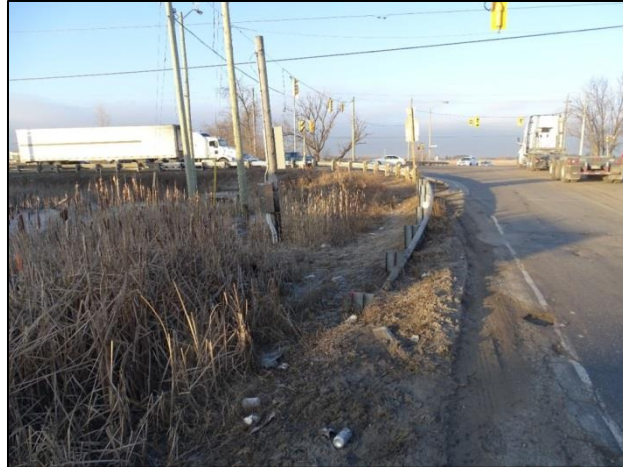
Figure 12: Turned Down Approach Treatment Colerain Drive and Region Road 50

At the intersection of Coleraine Drive and Region Road 50, the culverts and the corresponding ditch located on both sides of the roadway are protected by steel beam guide rails. The steel beam guide rail on the southeast corner has a turned down approach end, as illustrated in Figure 12, which can become a vaulting hazard to errant vehicles.

The field investigation noted some existing steel beam guide rail without energy attenuators at approach and/or leaving-ends. Energy attenuators should be provided to reduce the severity of potential collisions with the guide rail ends, which may result in spearing or vaulting the vehicles.

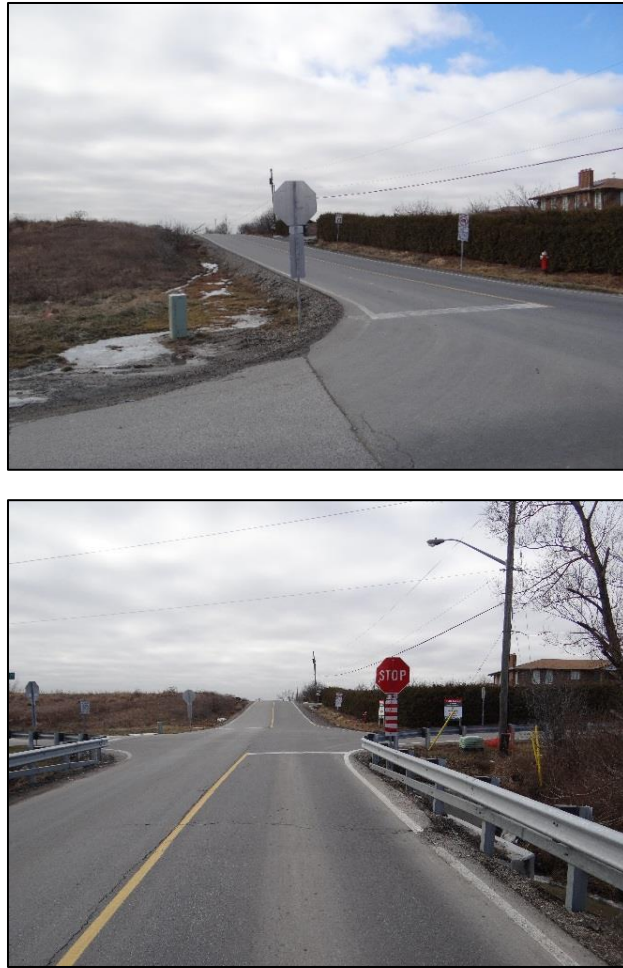
Figure 13: Intersection at Clarkway Drive and Countryside Drive

The northbound, southbound and eastbound directions at the intersection of Clarkway Drive at Countryside Drive present a downgrade on approaches to the intersection. The presence of downgrade on approaches to the intersection could be a potential contributing factor to rear end and angle collisions due to potentially higher speeds. Also, the presence of the crest vertical curve in the north and south legs could restrict the sightlines to upcoming traffic or stopping vehicles while departing the intersection. The intersection is demonstrated in Figure 13. It should be noted that the collision history review indicated one rear-end and one angle collision at this intersection.

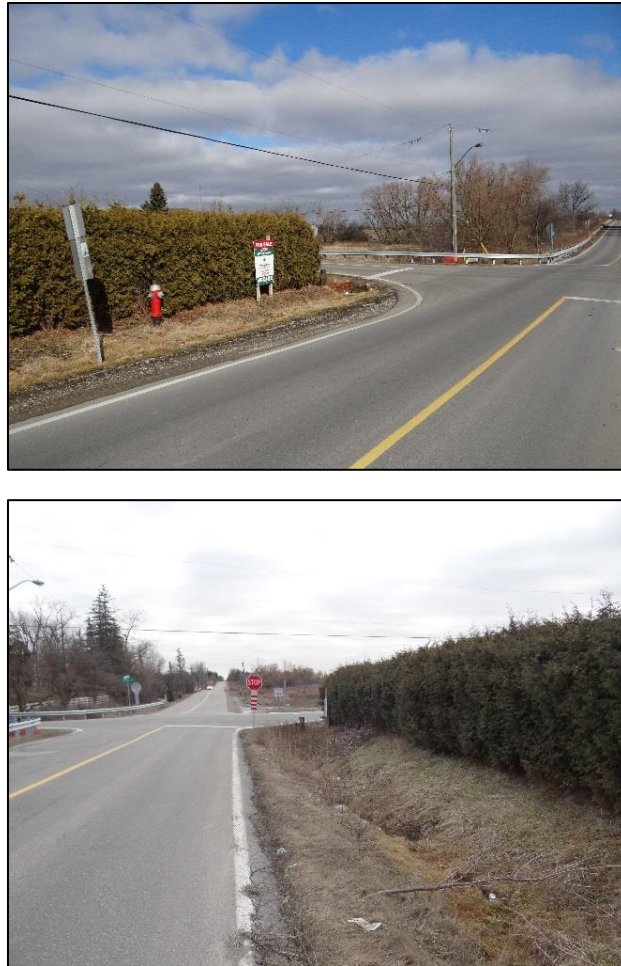
Figure 14: Limited Sight Triangles (Clarkway Drive and Countryside Drive)

Existing vegetation located on the northwest corner of Clarkway Drive and Countryside Drive reduces sight triangles for motorists travelling in the southbound and eastbound directions as shown in Figure 14. It should be noted that the subject intersection is all-way stop control and the requirement for clear sight triangles is not applicable for this type of intersection.

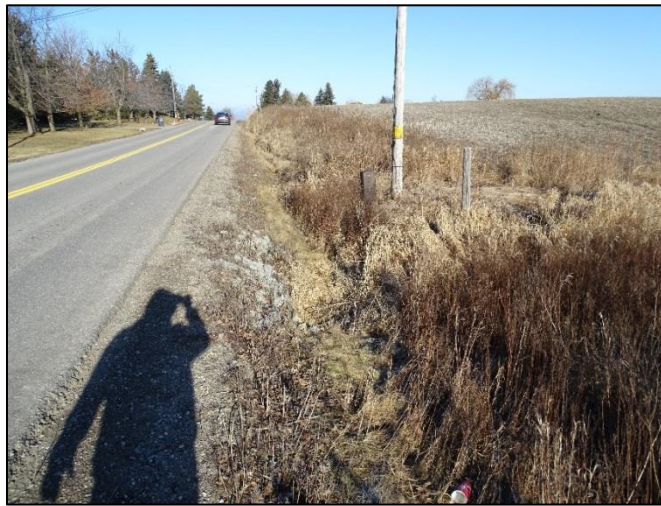
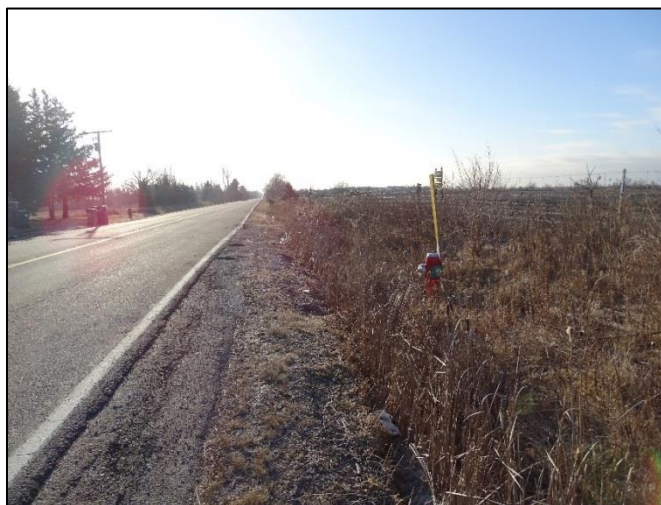
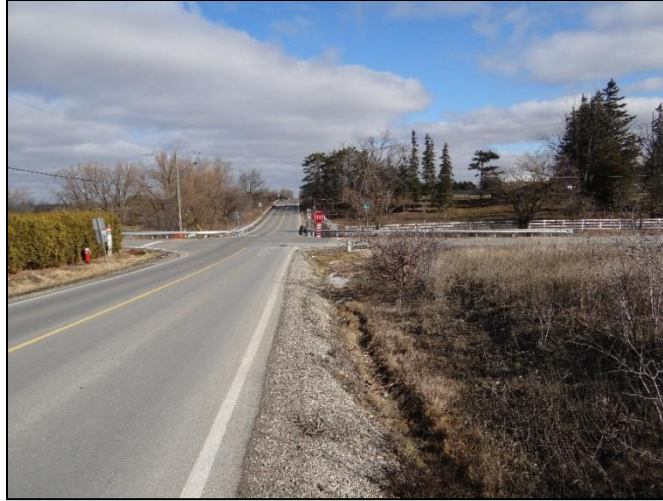
Figure 16: Side Slopes along the Clarkway Drive Corridor

- + **Side Slopes:** The side slopes of the roadway generally were found to be irregular. Slopes appeared to be steep and unrecoverable within clear zone at some locations. Vehicles encroaching on these slopes may not be able to recover and at some locations are likely to overturn. Recoverable slopes are generally the slopes flatter than 4:1 on which a driver can retain or regain the control of the vehicle in a run-off the road event. Non recoverable slopes are generally the slopes from 4:1 to 3:1. These slopes may be traversable, but the vehicle will continue to the bottom. Slopes steeper than 3:1 are known as critical slopes and are considered outside of the recovery zone. Vehicles encroaching on these slopes are likely to overturn. TAC notes that if critical slopes begin within the clear zone distance, a traffic barrier may be warranted if the slope cannot be readily flattened⁴. A typical roadside slope within the clear zone is illustrated in Figure 16.

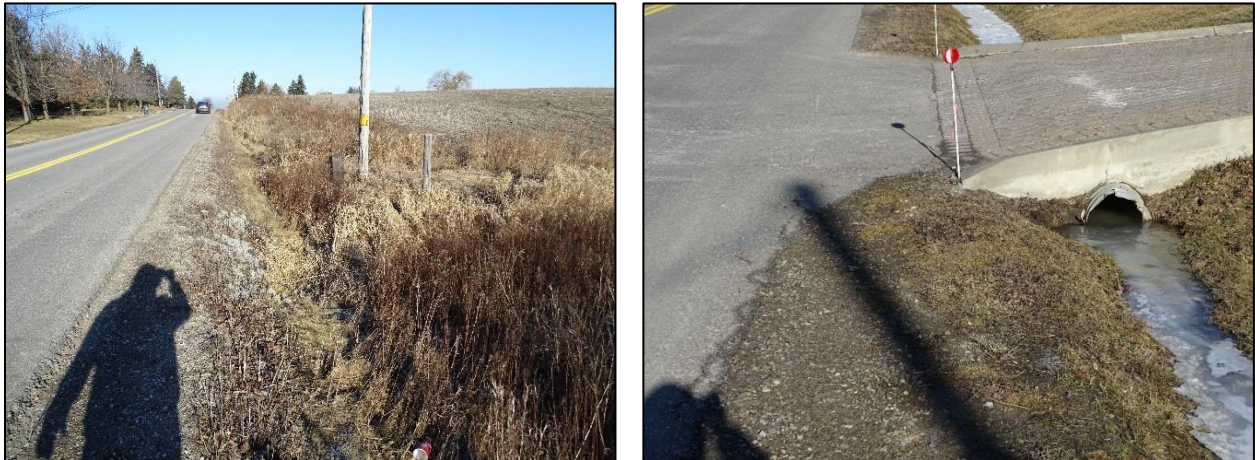
Figure 17: Fixed Objects along the Clarkway Drive Corridor

- + **Fixed Objects:** CIMA examined fixed objects along the roadside and found that a significant number of non-breakaway utility poles that do not meet the clear zone requirement. Additionally, other objects such as a culvert headwalls of private driveways and some breakaway fire hydrant were found to be located within the clear zone. A non-breakaway wood pole, a culvert headwall, and fire hydrant within the clear zone is illustrated in Figure 17.

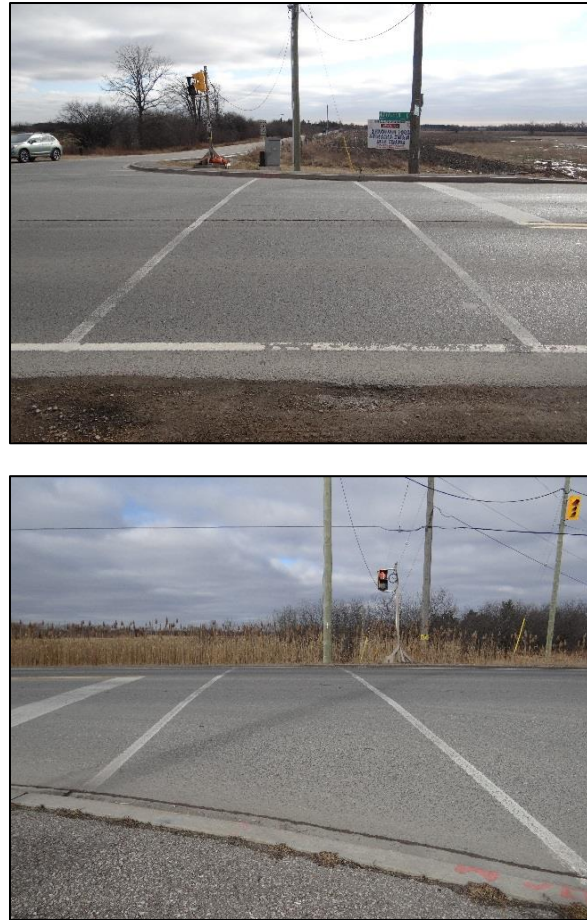
Figure 18: Offset Signal Heads (Clarkway Drive and Mayfield Road)

Existing pedestrian signal heads on all approaches located at Clarkway Drive and Mayfield Road are not properly aligned with the existing pedestrian crosswalks and sidewalks as demonstrated in Figure 18.

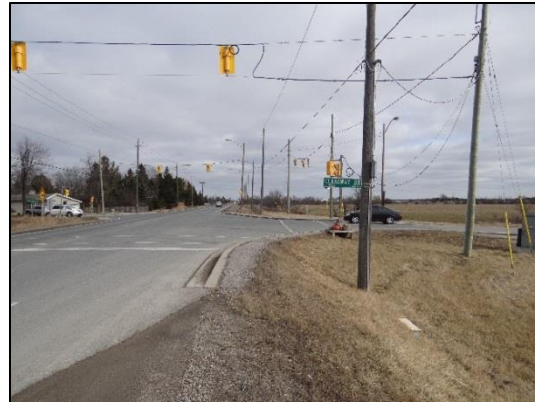
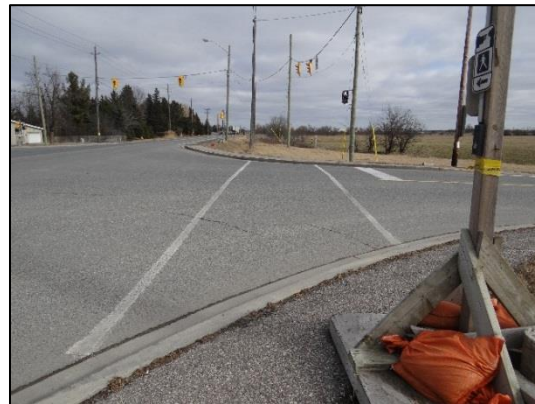
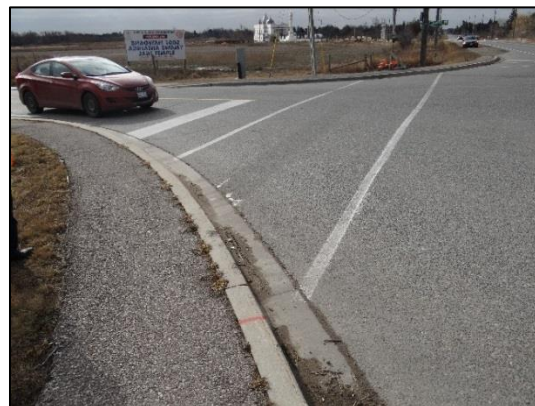
Figure 19: Lack of Pedestrian Infrastructure (Clarkway Drive and Mayfield Road)

Existing pedestrian sidewalks do not have a mountable curb to assist pedestrians with disabilities to access the sidewalks and painted pedestrian crosswalks, and therefore do not meet the Accessibility for Ontarians with Disabilities Act (AODA) as demonstrated in Figure 19.

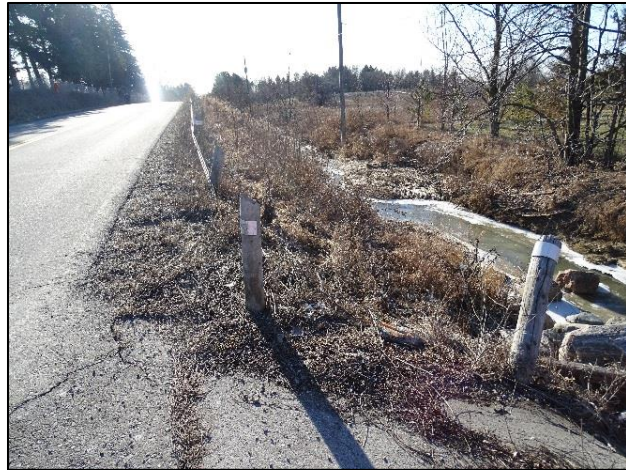
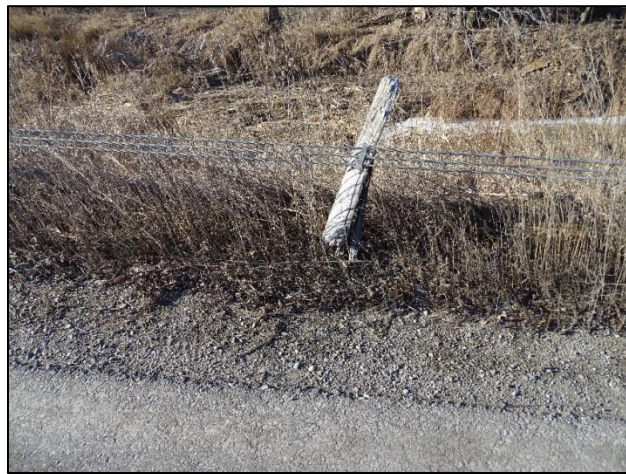
Figure 20: Damaged Cable Guide Rail along the Clarkway Drive

Sections of 3-Cable guide rail systems were found to be installed within the corridor. Most 3-Cable guide rail systems present within the corridor appeared to be old and damaged. The 3-Cable was installed to protect vehicles from the water body hazards and the deep slope. The damaged 3-cable is illustrated in Figure 20.

The field investigation noted the presence of some 3-cable guide rail system. These systems are outdated and should be replaced, where possible, by steel beam guide rails.

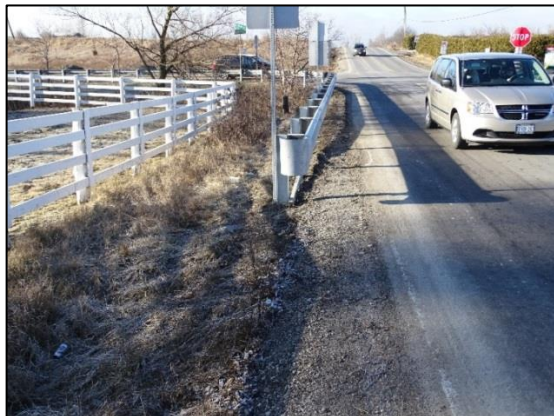
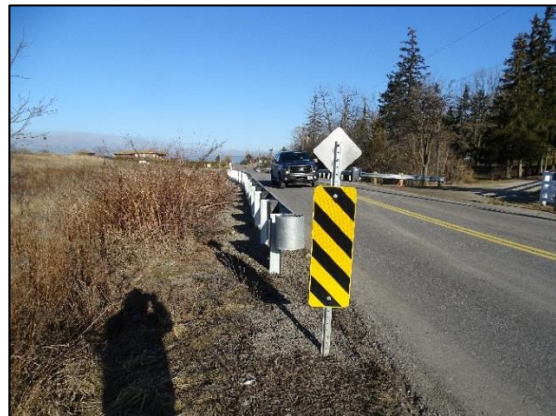
Figure 21: Steel Guide Rail Leaving-End (Clarkway Drive and Countryside Drive)

The leaving-end of the existing steel beam guide rail is located within the clear zone for vehicles in the opposite direction of travel. The leaving-end is missing an energy attenuator, as illustrated in Figure 21. An improper end treatment may pose a spearing hazard in the event of a head-on collision with the guide rail.

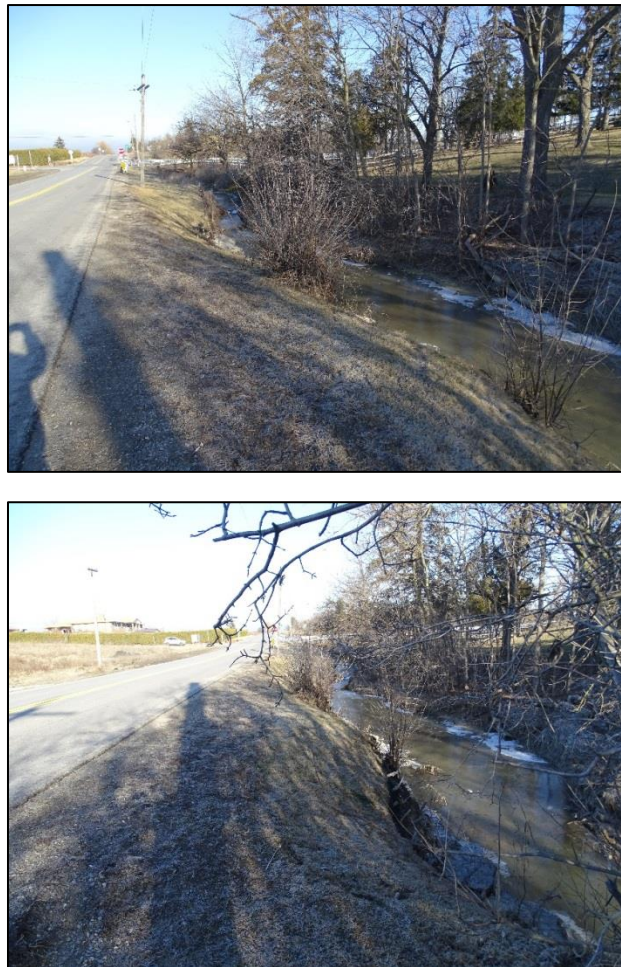
Figure 22: Inadequate Steel Beam Length along the Clarkway Drive

The steel beam guide rail is lacking in length of need (LON) as shown in Figure 22. According to the MTO standard⁵ for protection of water body hazards with barrier, the installation length of the barrier shall be the maximum encroachment distance.

The field review revealed that the length of need (LON) for existing steel beam guide rails are not adequate. The guide rail should be extended during the upcoming road widening to protect the vehicles from the water body hazards. It is noted that the need for guide rails in the long term should be evaluated during the design stages of the upcoming road widening. By widening the road, clear zones will be laterally shifted and may include new hazards requiring protection, or currently existing hazards may be eliminated, either by removal or by introducing proper cross section design.

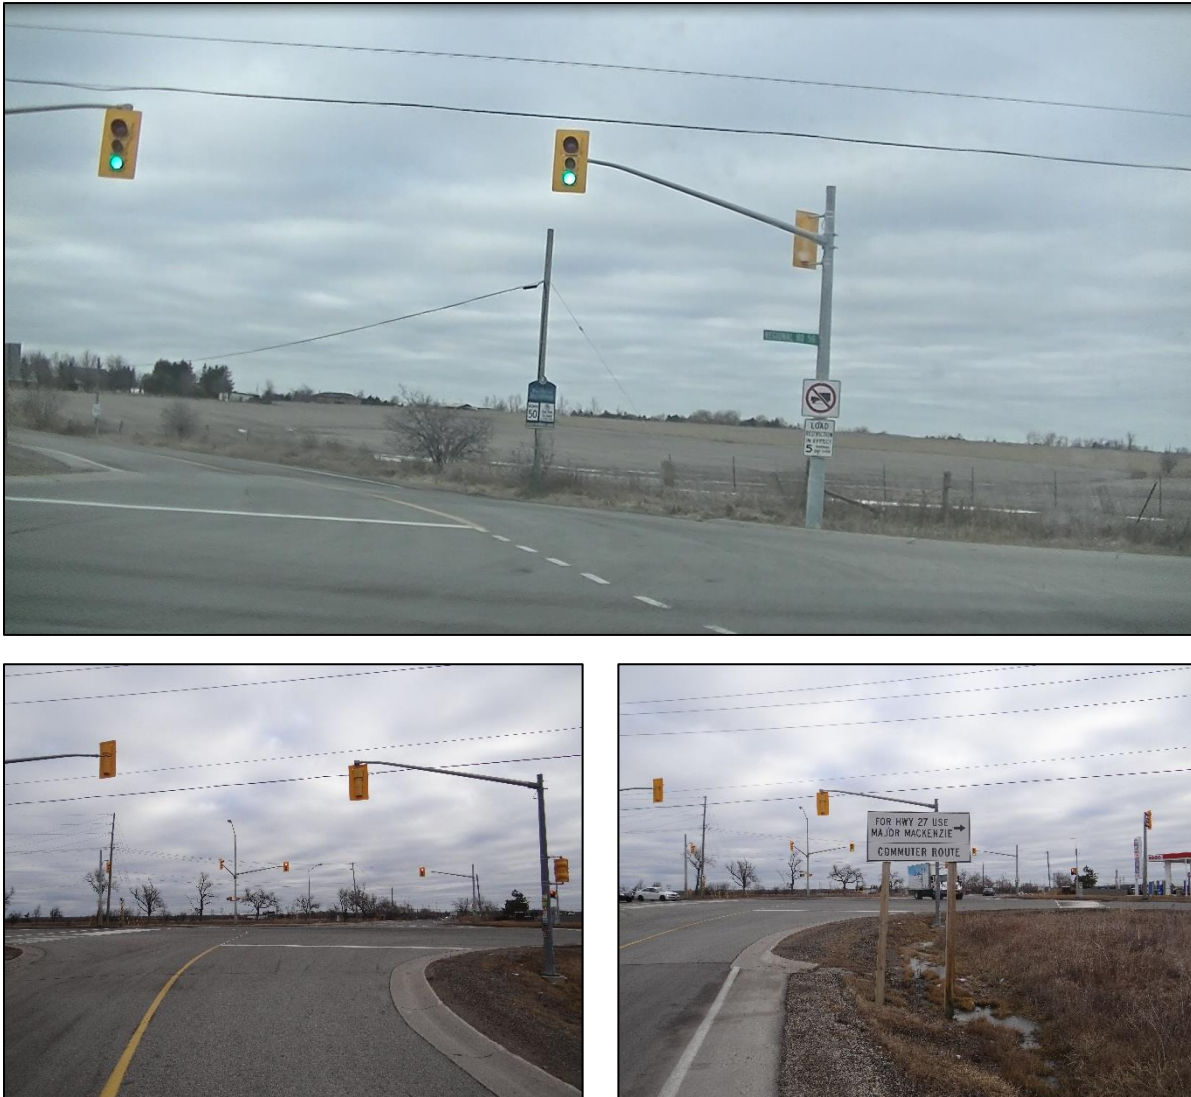
Figure 23: Skewed Intersection Approach (Countryside Drive and Regional Road 50)

receiving lane downstream of the intersection. This situation creates a potential safety hazard for motorists who are unfamiliar with the approach due to the sudden change in road alignment. In addition, the existing configuration can create visibility restrictions to drivers attempting to turn left or right during the permissive phase when drivers in the opposite direction are attempting to perform the same maneuver. This is aggravated when large vehicles, such as trucks, or in some cases large pick-up trucks, are in the opposing left-turn lanes as demonstrated in Figure 23. This may be a potential contributing factor to turning movement collision located at this intersection.

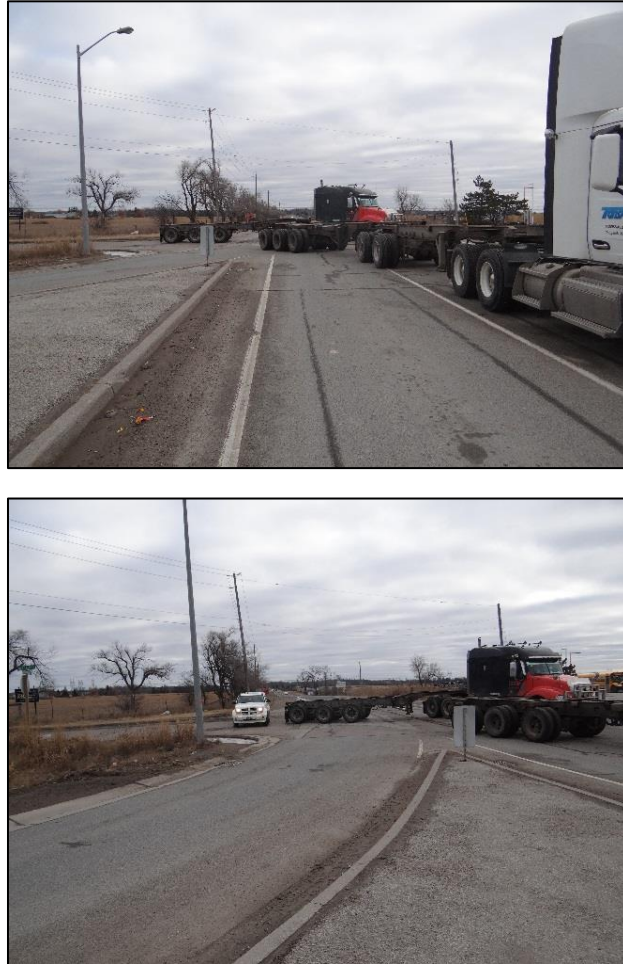
Figure 24: Proximity of the Two Intersections (Cold Creek Drive at Nashville Road and Countryside Drive at Regional Drive 50)

of Countryside Drive and Regional Road 50. The through and right turn vehicles will use the shoulder and/or the north leg of Cold Creek Drive intersection to make the maneuvers around the trucks. This may be a potential safety concern due to the reduced sightlines created by heavy vehicles blocking the through and right turn lanes and impatient motorists stuck behind the heavy vehicles as shown in Figure 24.

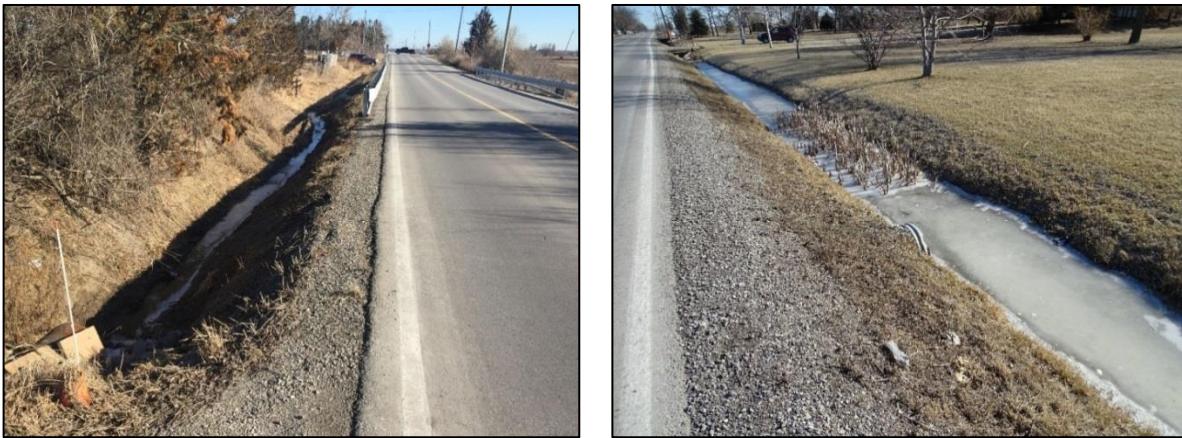
Figure 26: Side Slopes along Countryside Drive

- Side Slopes:** The side slopes of the roadway generally were found to be irregular. Slopes appeared to be steep and unrecoverable within clear zone at some locations. Vehicles encroaching on these slopes may not be able to recover and at some locations are likely to overturn. Recoverable slopes are generally the slopes flatter than 4:1 on which a driver can retain or regain the control of the vehicle in a run-off the road event. Non recoverable slopes are generally the slopes from 4:1 to 3:1. These slopes may be traversable, but the vehicle will continue to the bottom. Slopes steeper than 3:1 are known as critical slopes and are considered outside of the recovery zone. Vehicles encroaching on these slopes are likely to overturn. TAC notes that if critical slopes begin within the clear zone distance, a traffic barrier may be warranted if the slope cannot be readily flattened⁷. A typical roadside slope within the clear zone is illustrated in Figure 26.

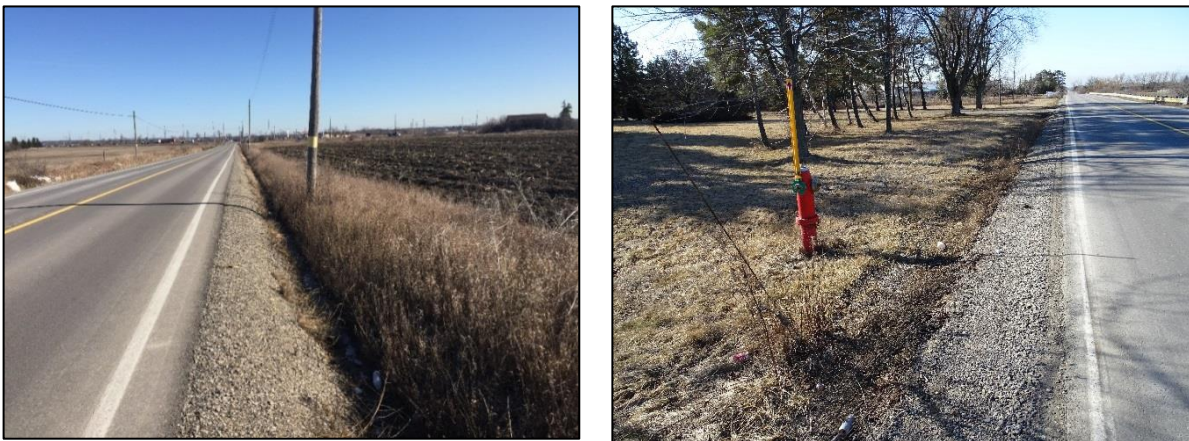
Figure 27: Fixed Objects along Countryside Drive

- Fixed Objects:** CIMA examined fixed objects along the roadside and found that a significant number of non-breakaway utility poles that do not meet the clear zone requirement. Additionally, other objects such as a culvert headwalls of private driveways and breakaway fire hydrant were found to be located within the clear zone. A non-breakaway wood pole, a culvert headwall, and fire hydrant within the clear zone is illustrated in Figure 27.

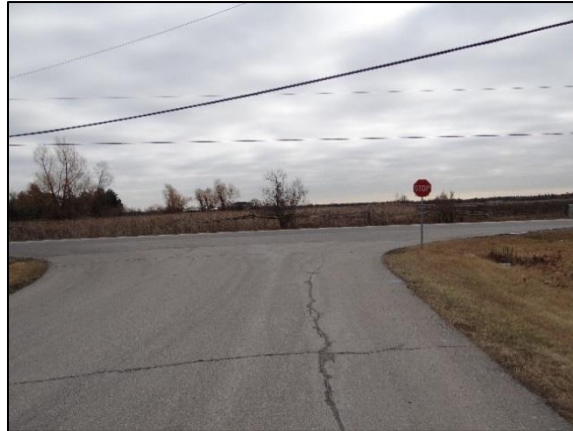
Figure 28: Missing Checkerboard Sign (Countryside Drive and St. Johns Road)

The intersection of Countryside Drive and St. Johns Road is missing a Checkerboard sign (Wa-8LR) for motorists travelling southbound on St. Johns Road. The checkerboard sign must be used where a road terminates, and there is no option to proceed straight ahead, but there are options to proceed to the left or to the right as illustrated in Figure 28. The sign should be used where posted speed is 60 km/h or less.

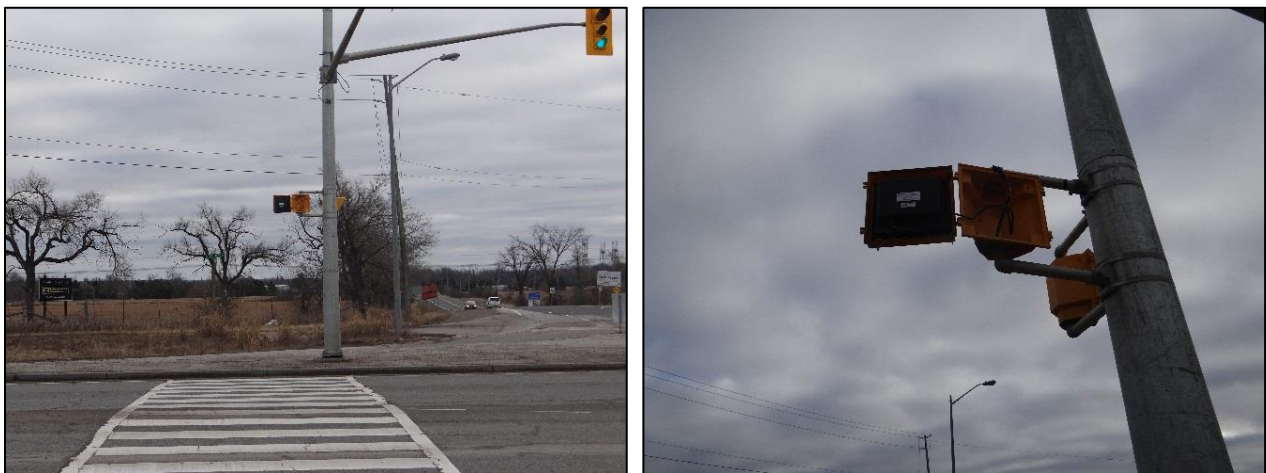
Figure 29: Broken Pedestrian Signal Head (Countryside Drive and Regional Road 50)

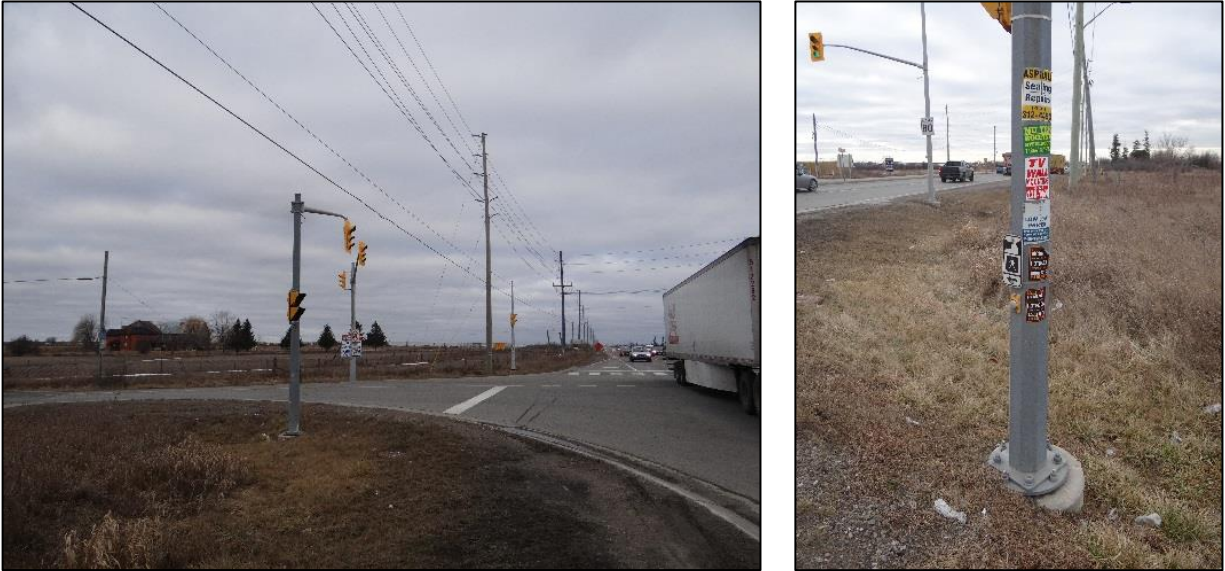
Figure 30: Accessibility of Pedestrian Push Button (Countryside Drive and Regional Road)

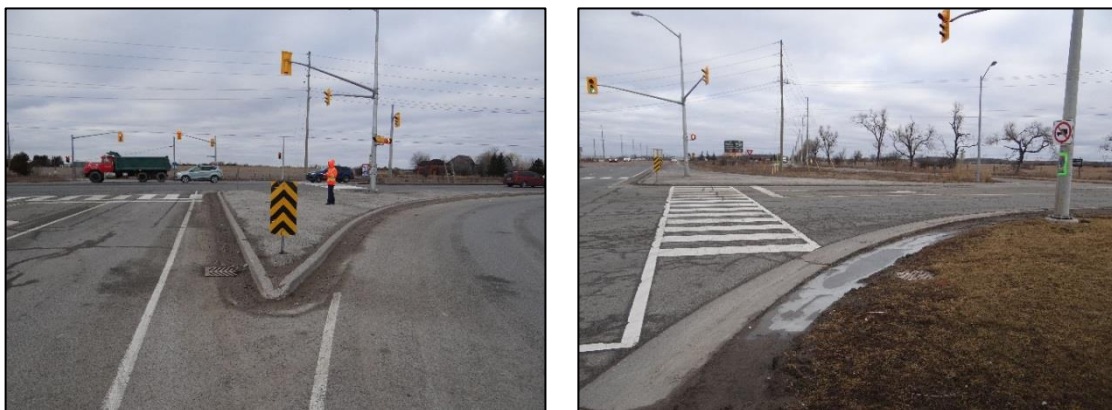
Figure 31: Lack of Pedestrian Infrastructure (Countryside Drive and Regional Road 50)

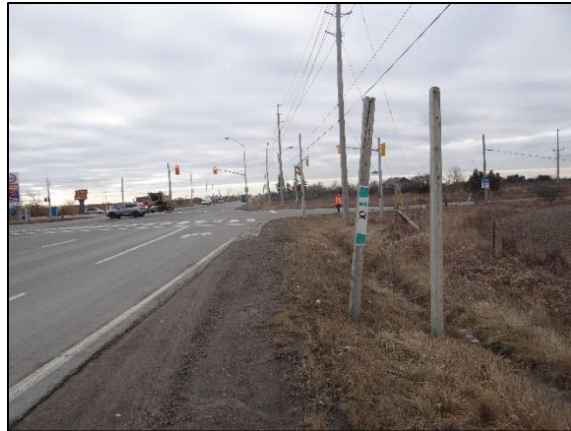
Figure 32: Limited Bus Stop Access (Countryside Drive and Regional Road 50)

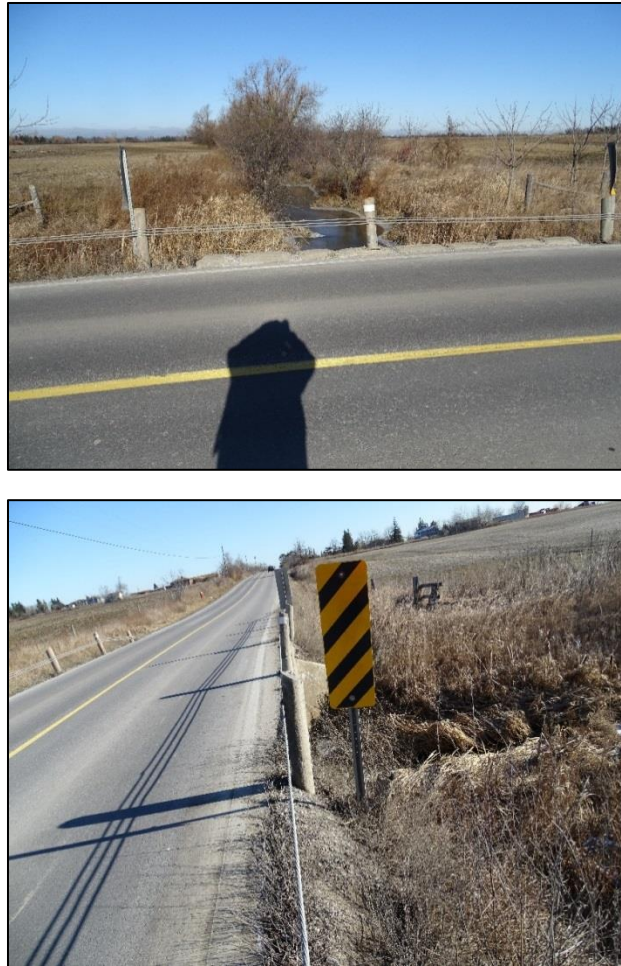
Figure 33: 3-Cable Guide Rail along Countryside Drive

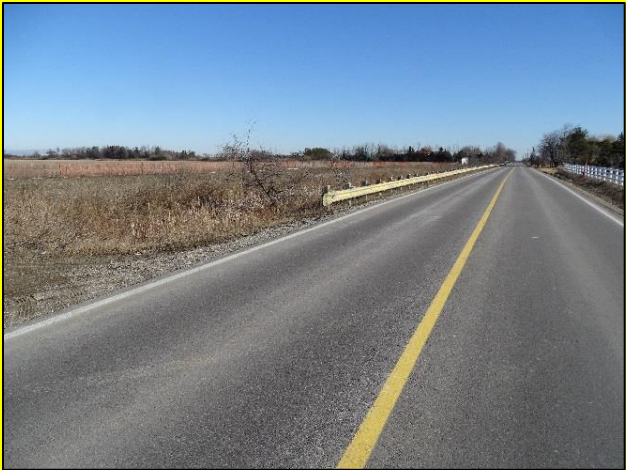
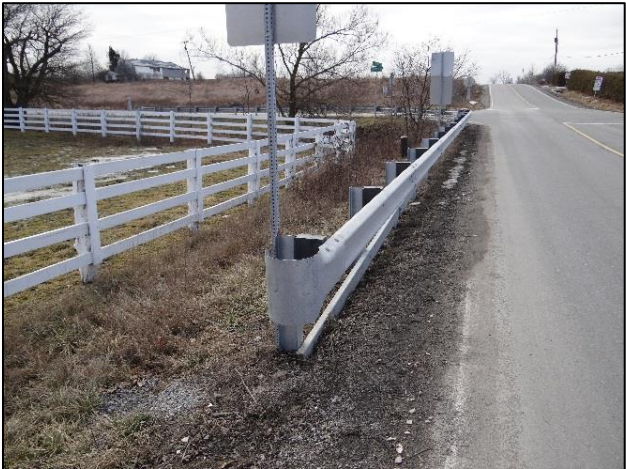
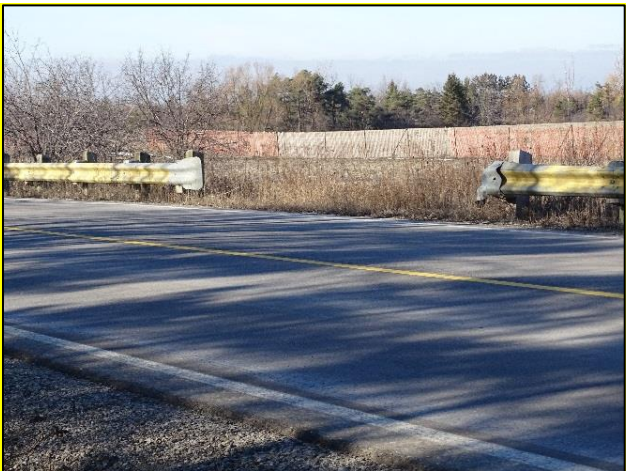
Figure 34: Steel Guide Rail Leaving-End along Countryside Drive

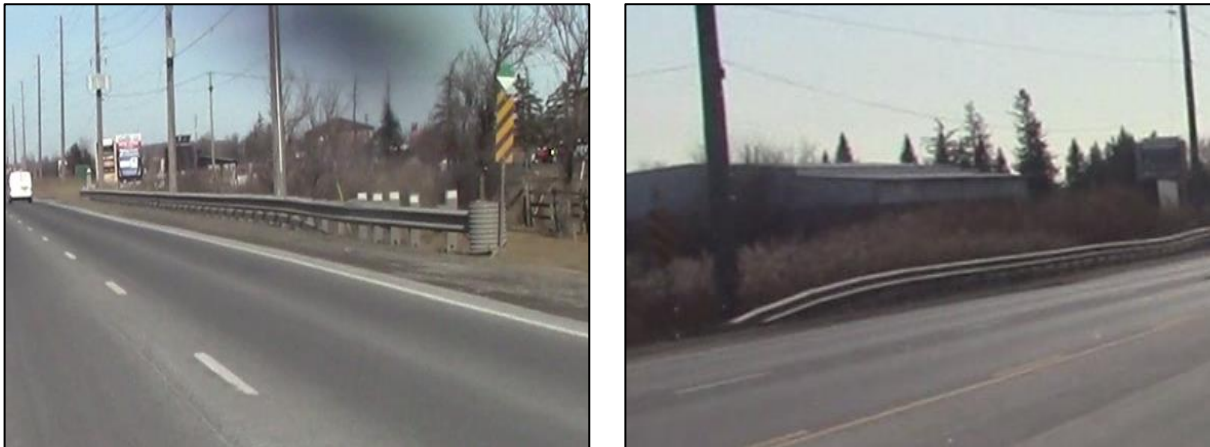
Figure 35: Missing Crash Cushion along Regional Road 50
