# RIVERSTONE

March 4, 2020  
RS# 2016-008

**SUBJECT: Tree Inventory and Preservation Plan – Cawthra Rd. Improvements (Eastgate Parkway to South Service Road, Region of Peel).**

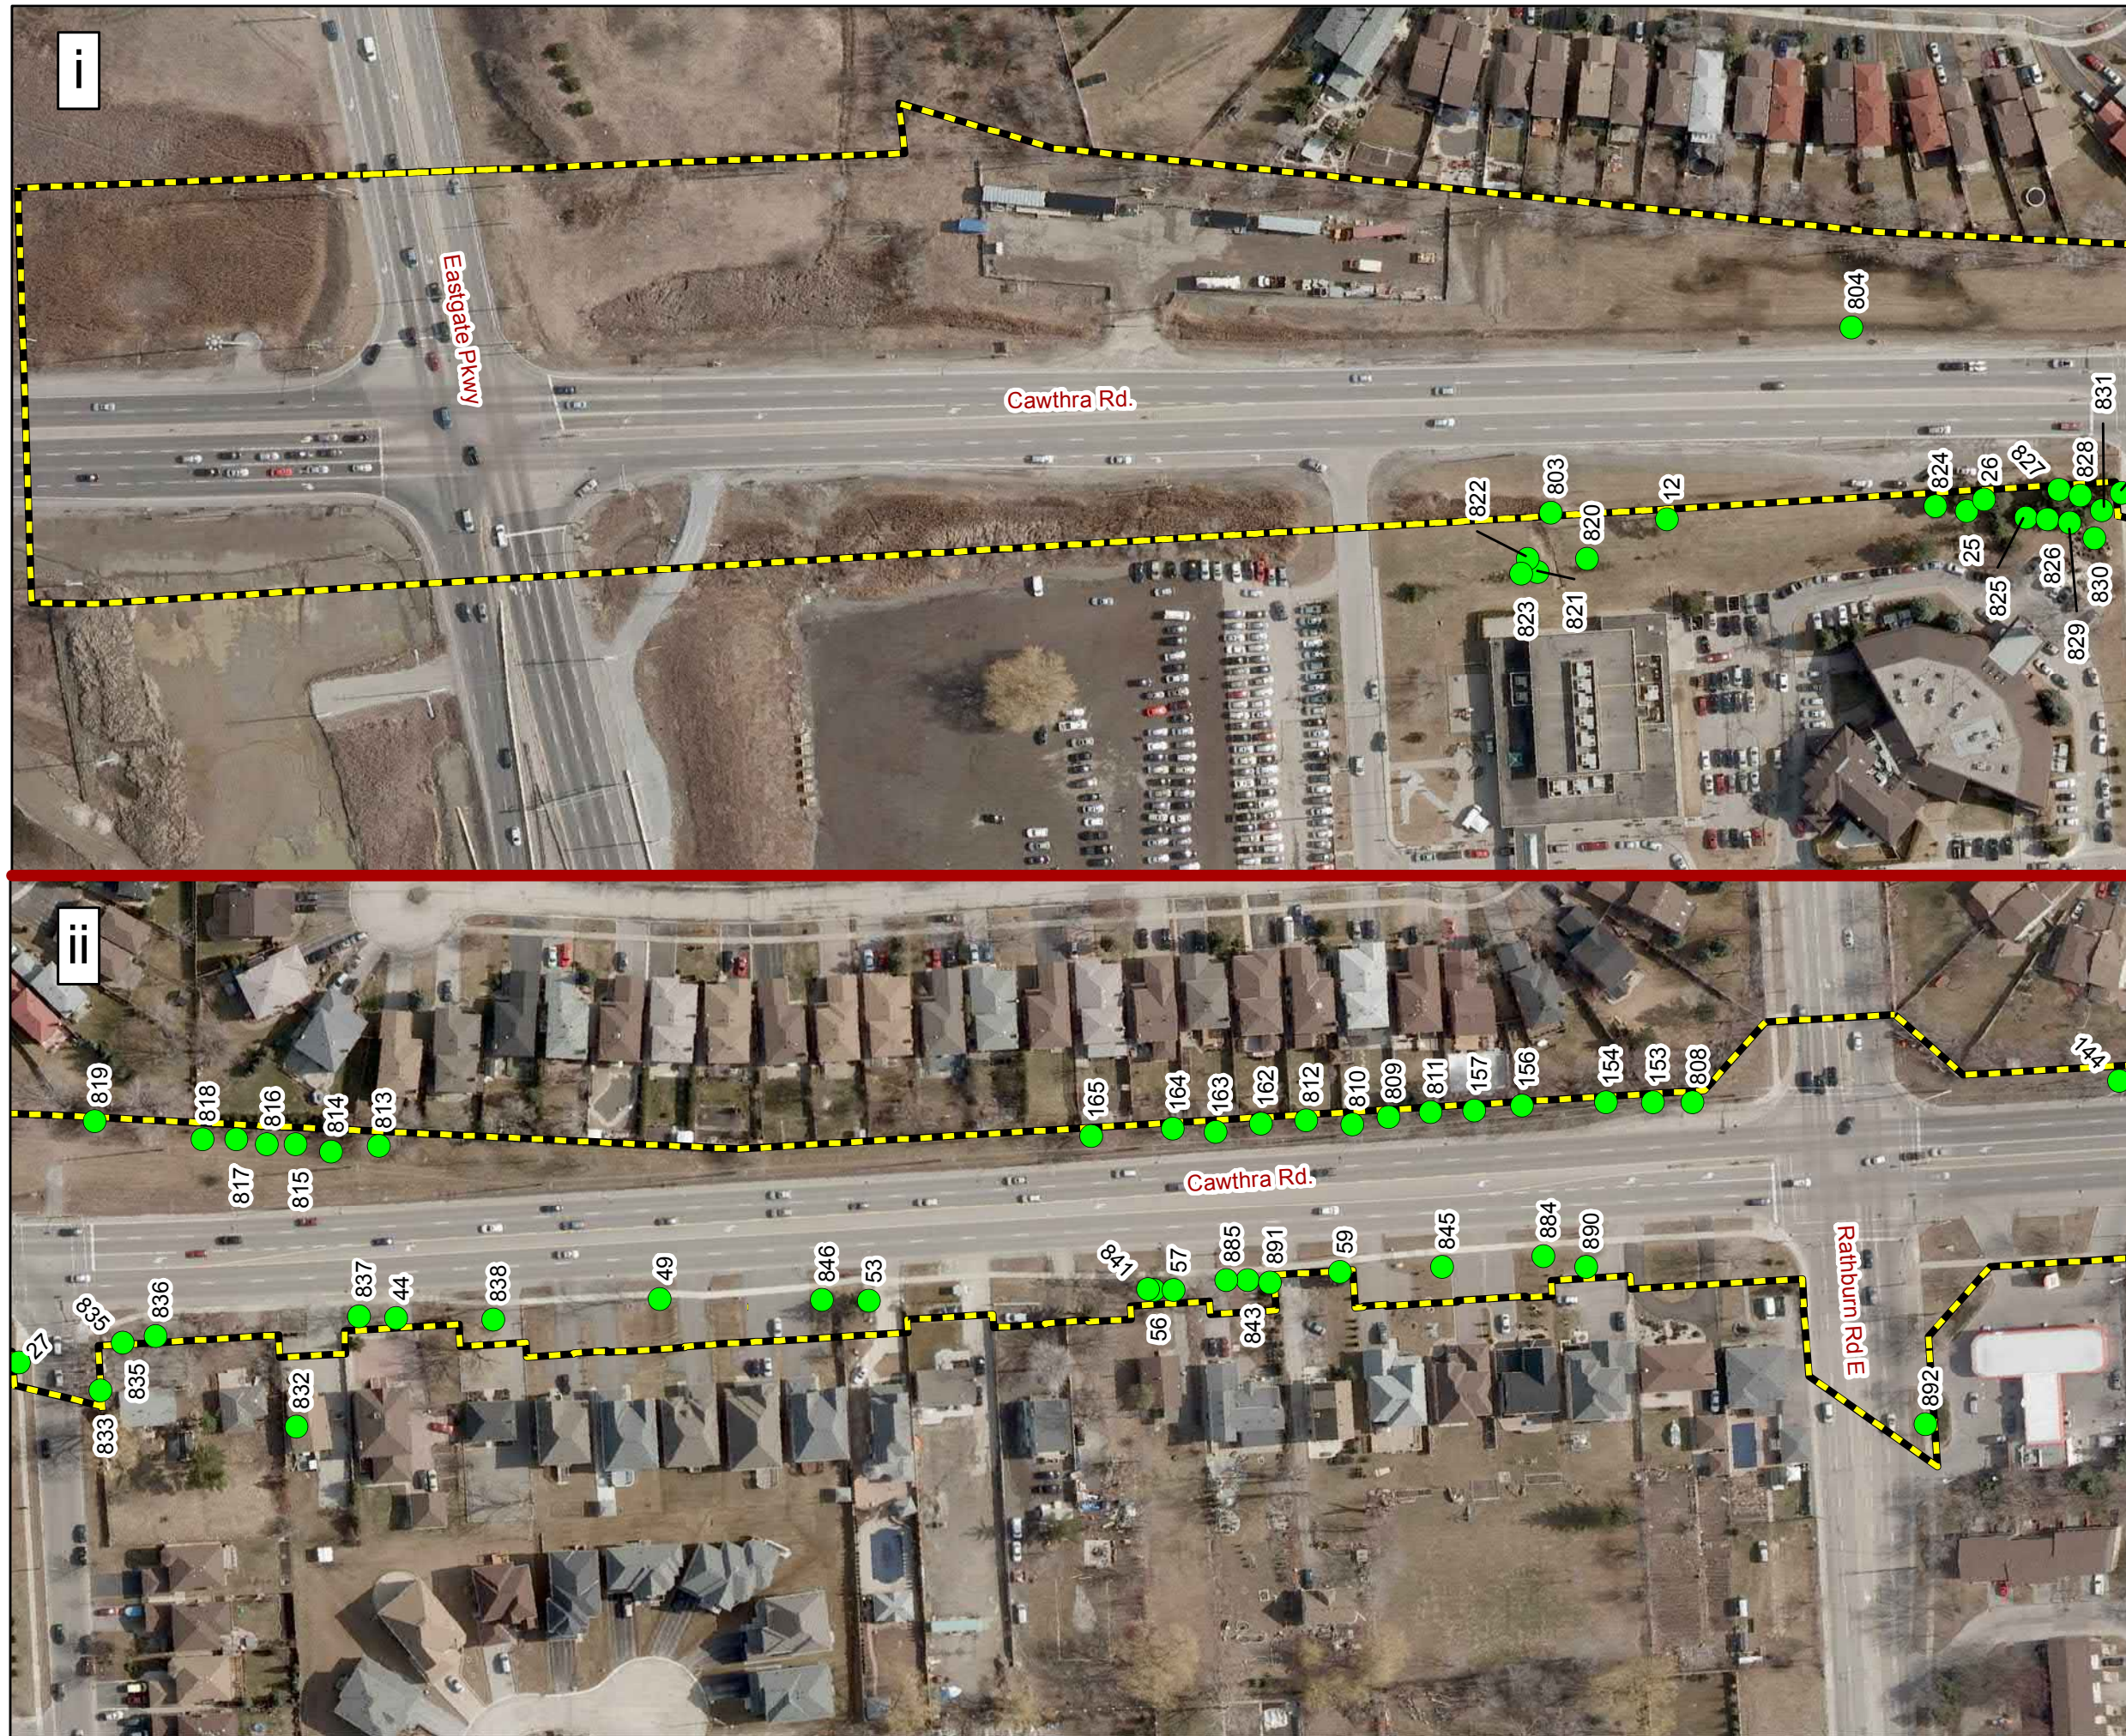
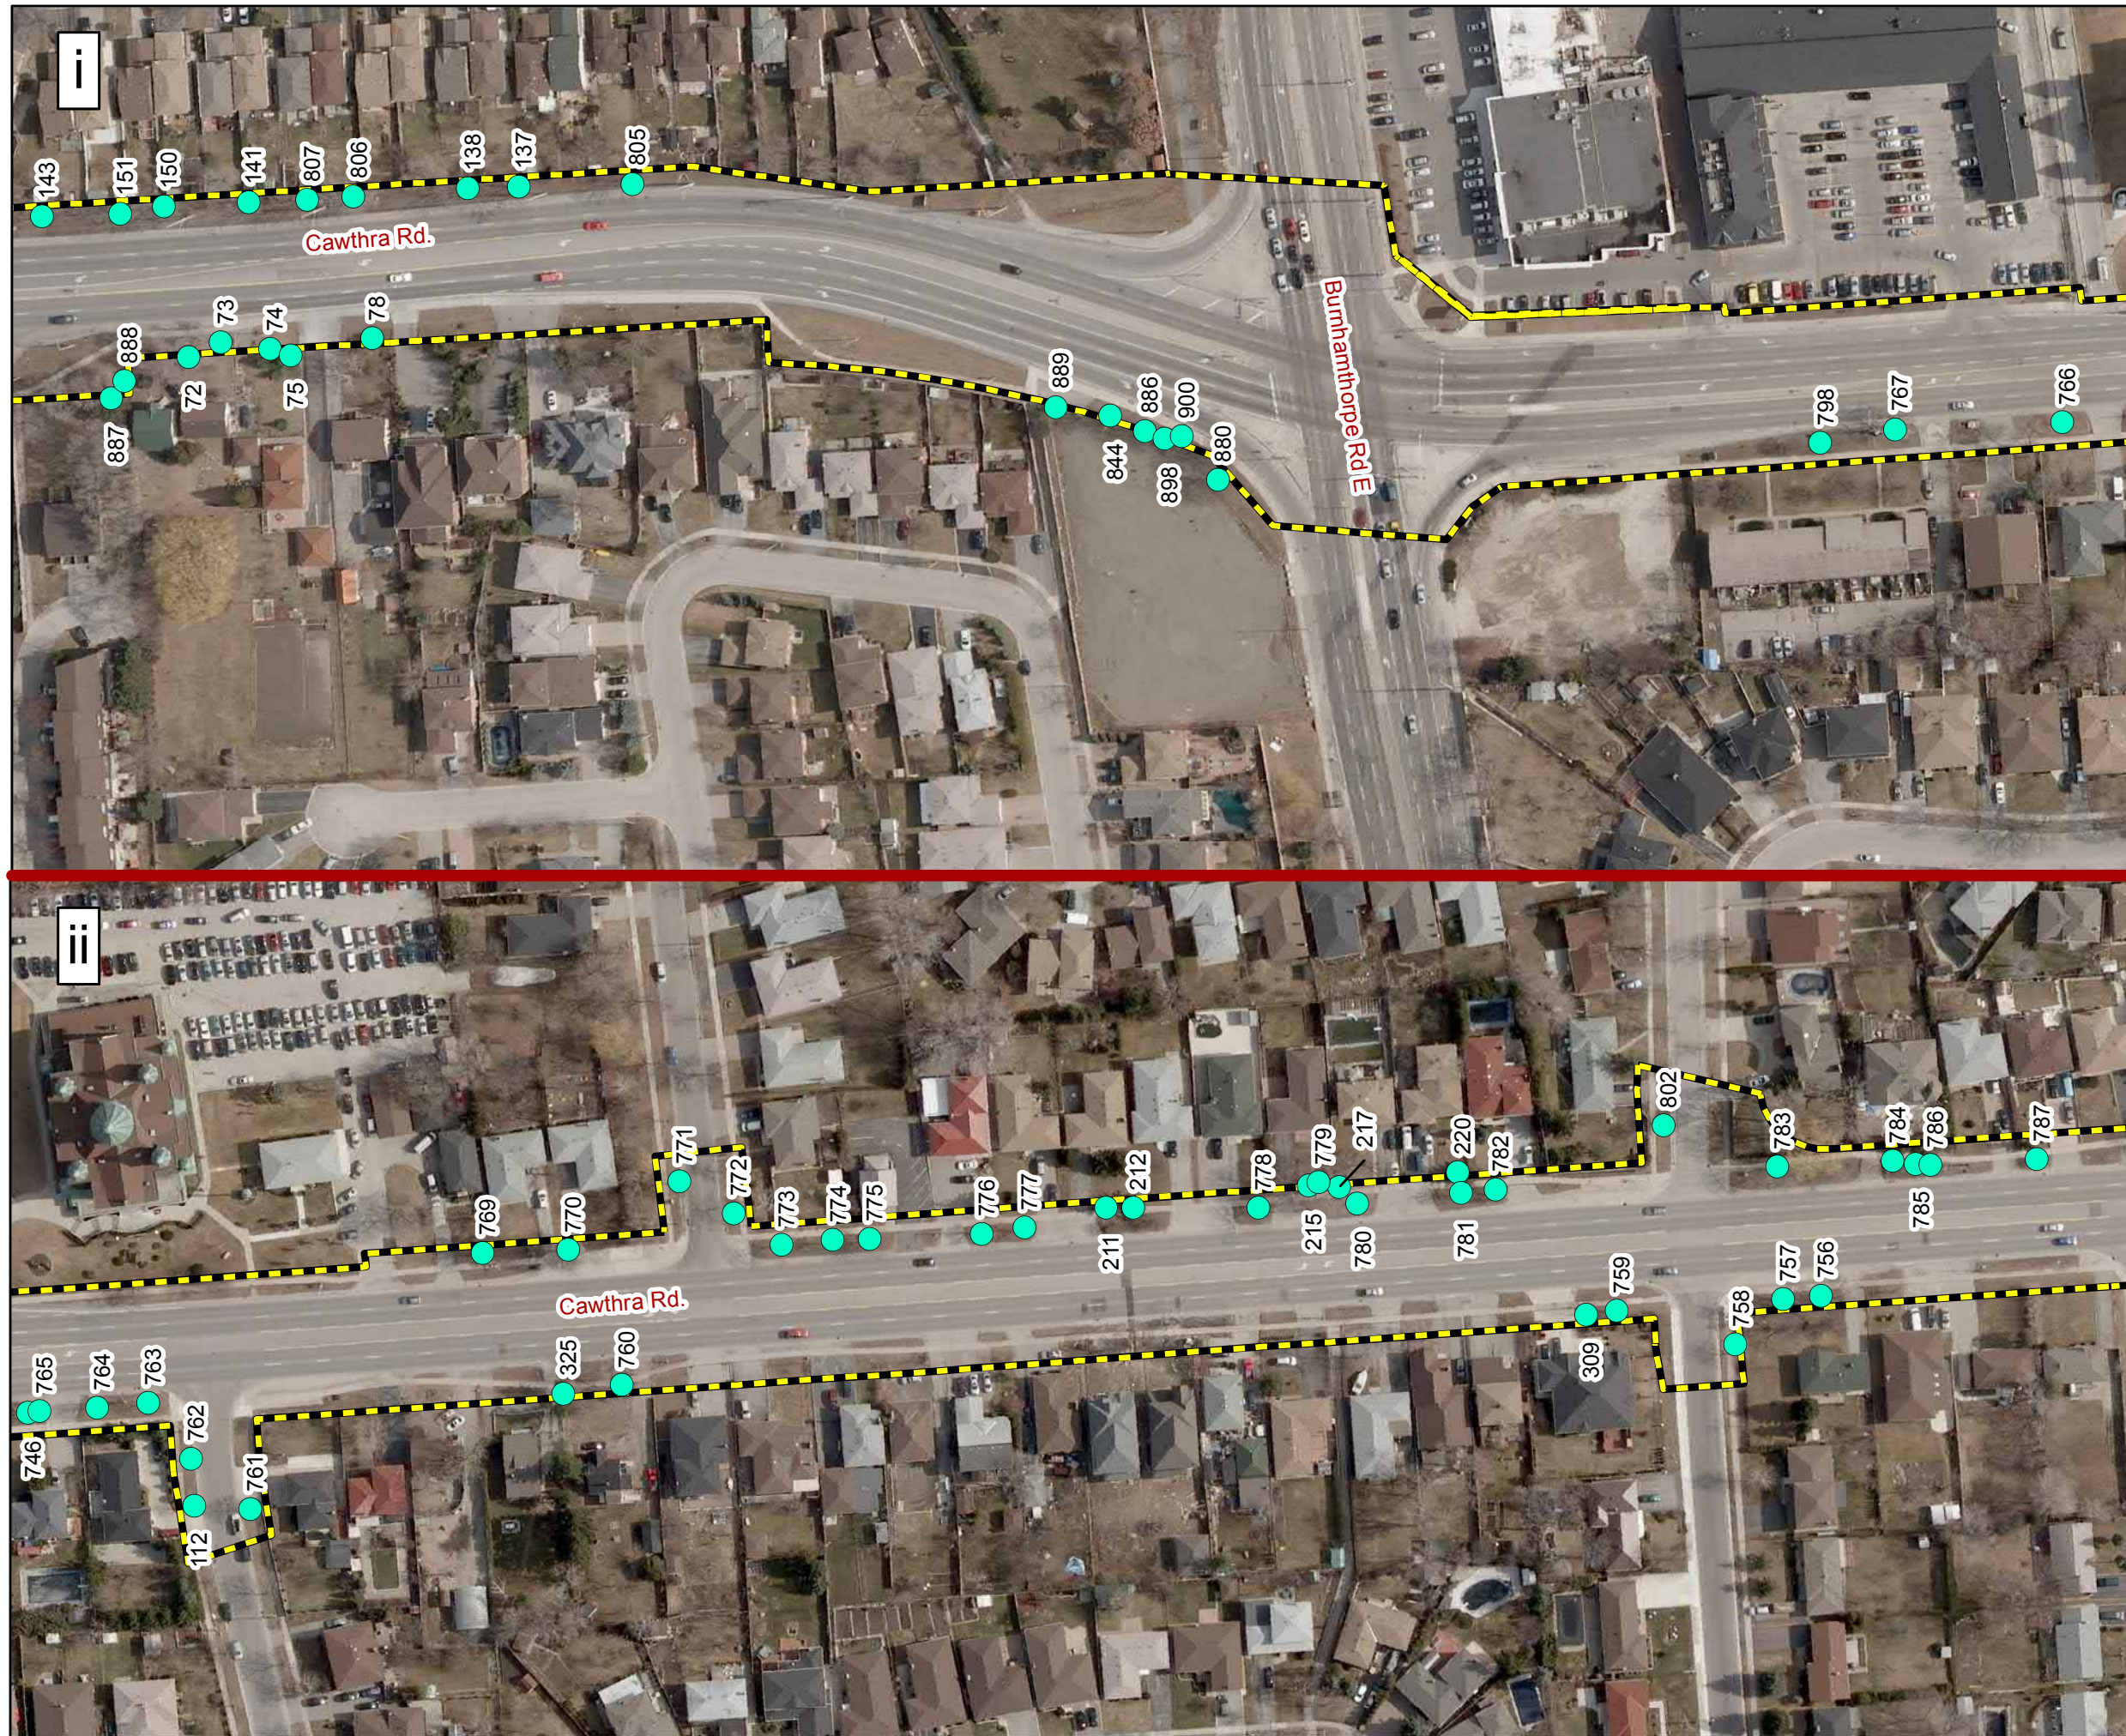
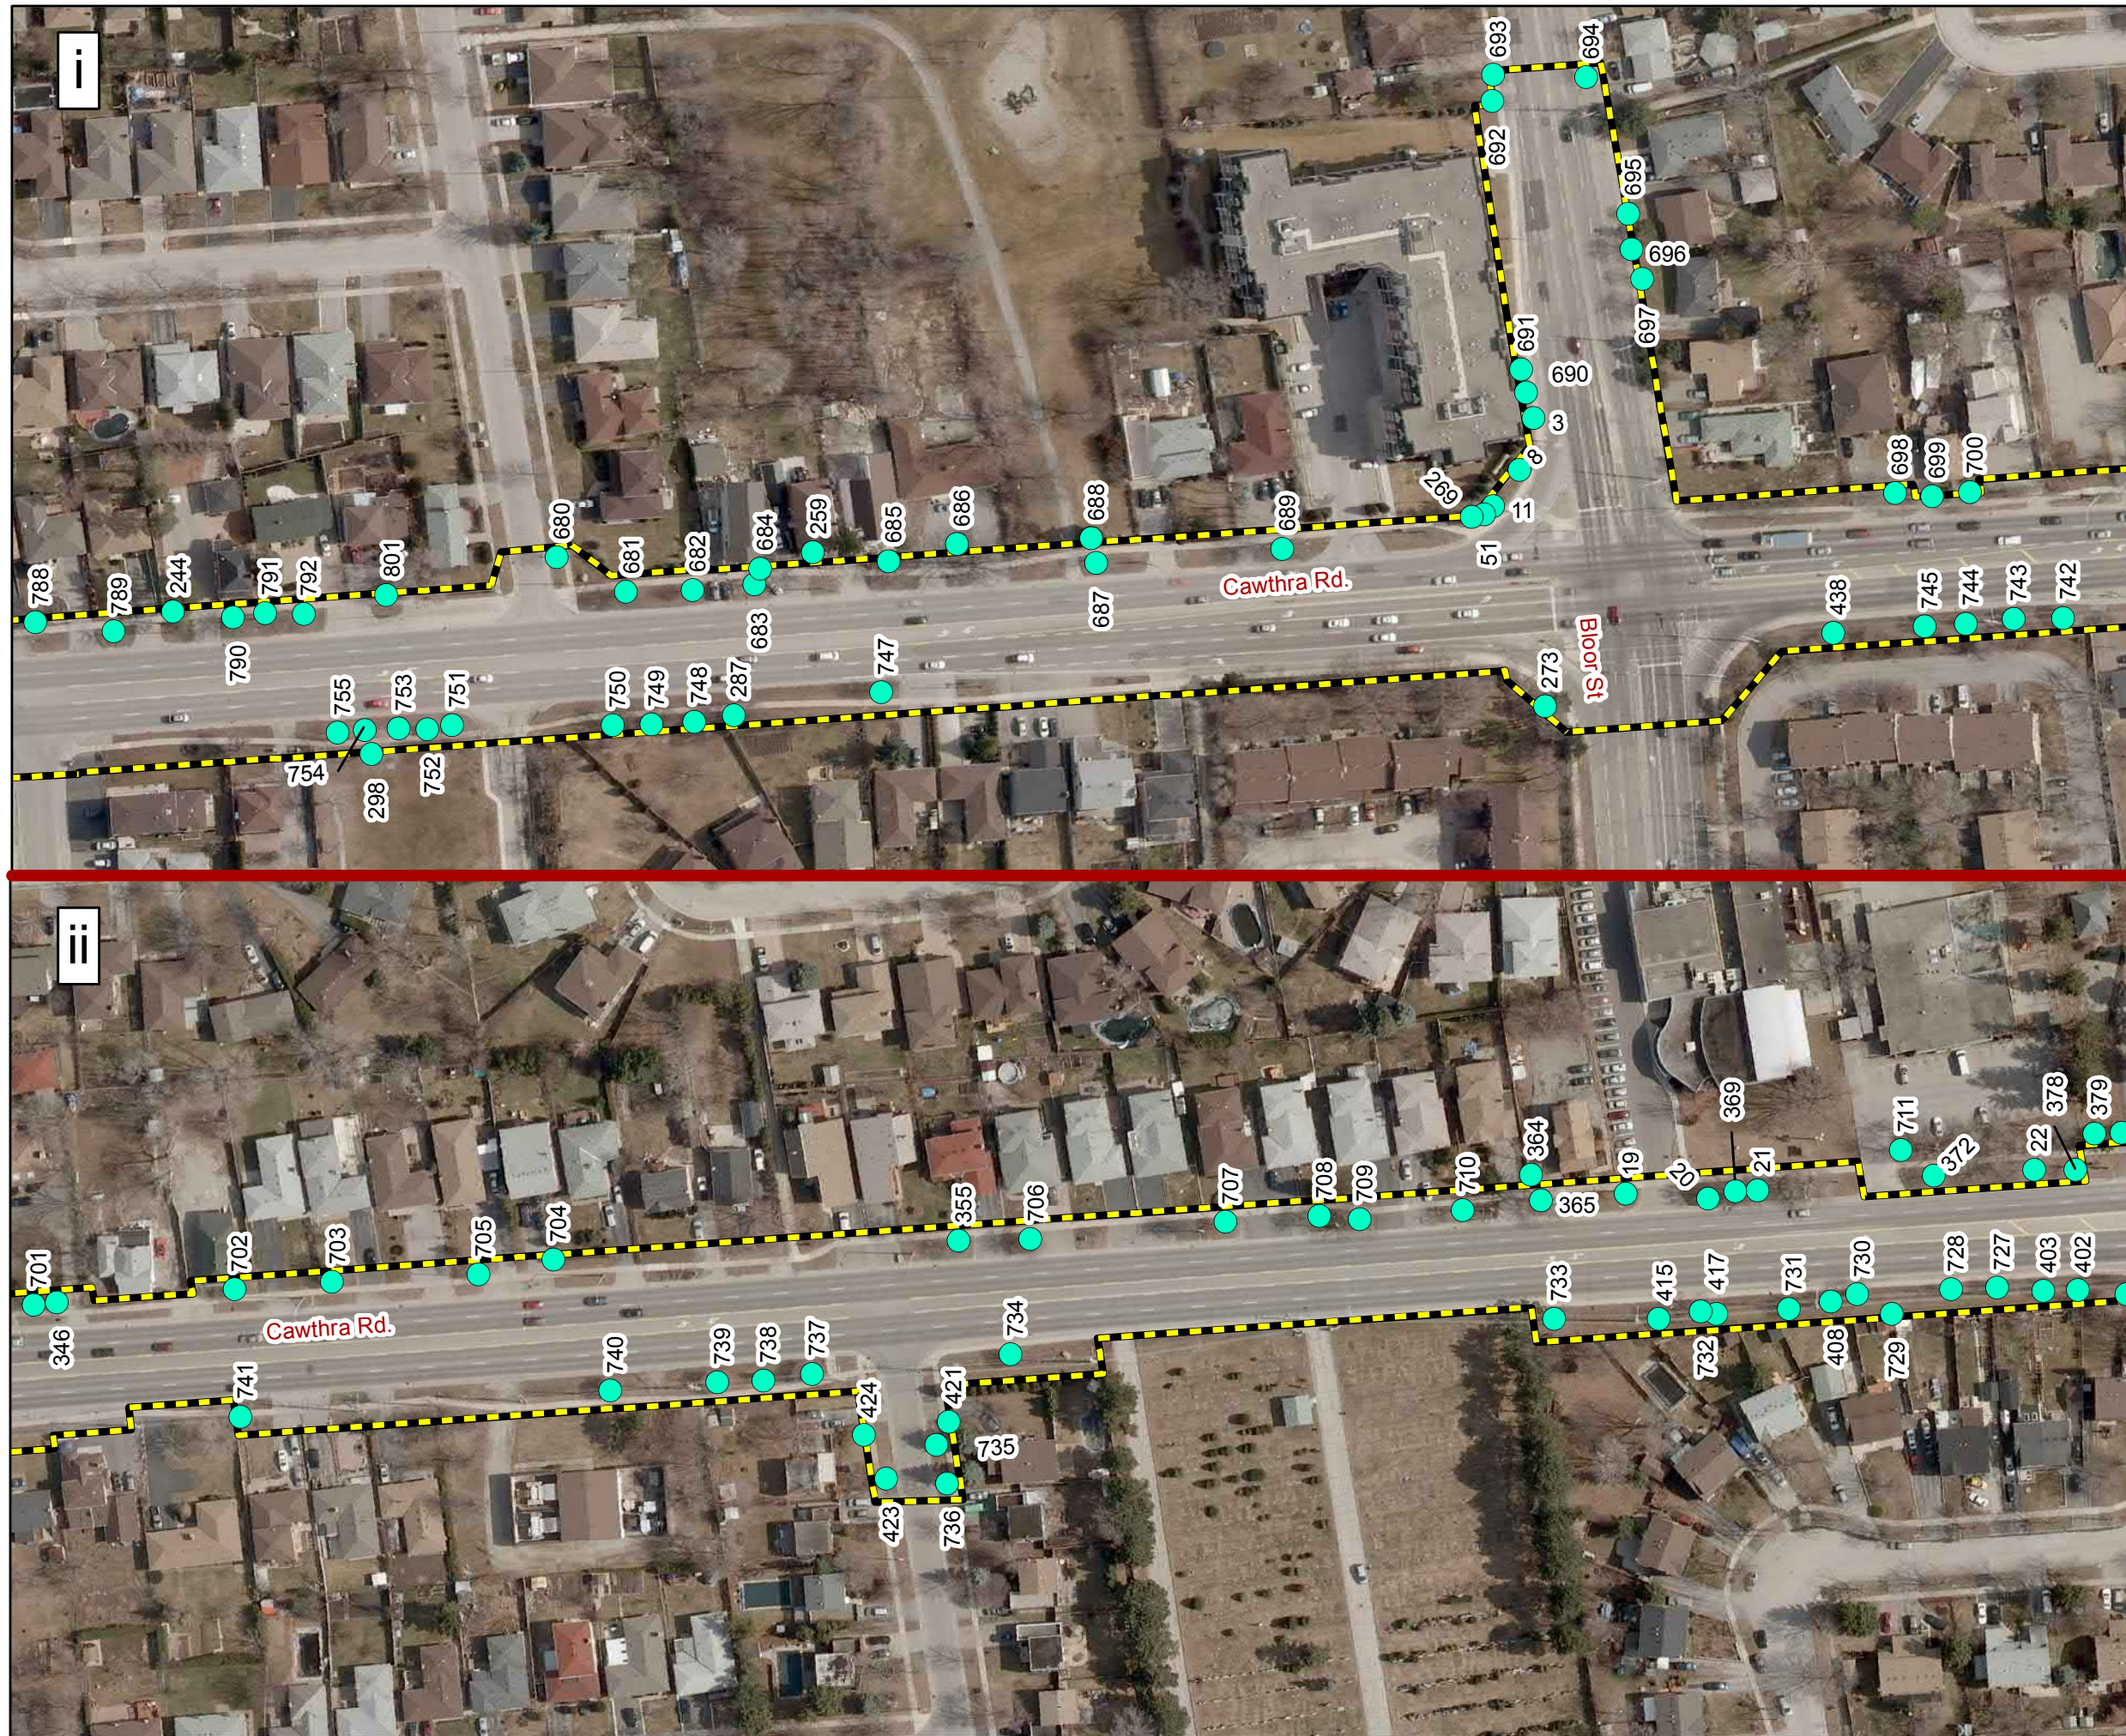
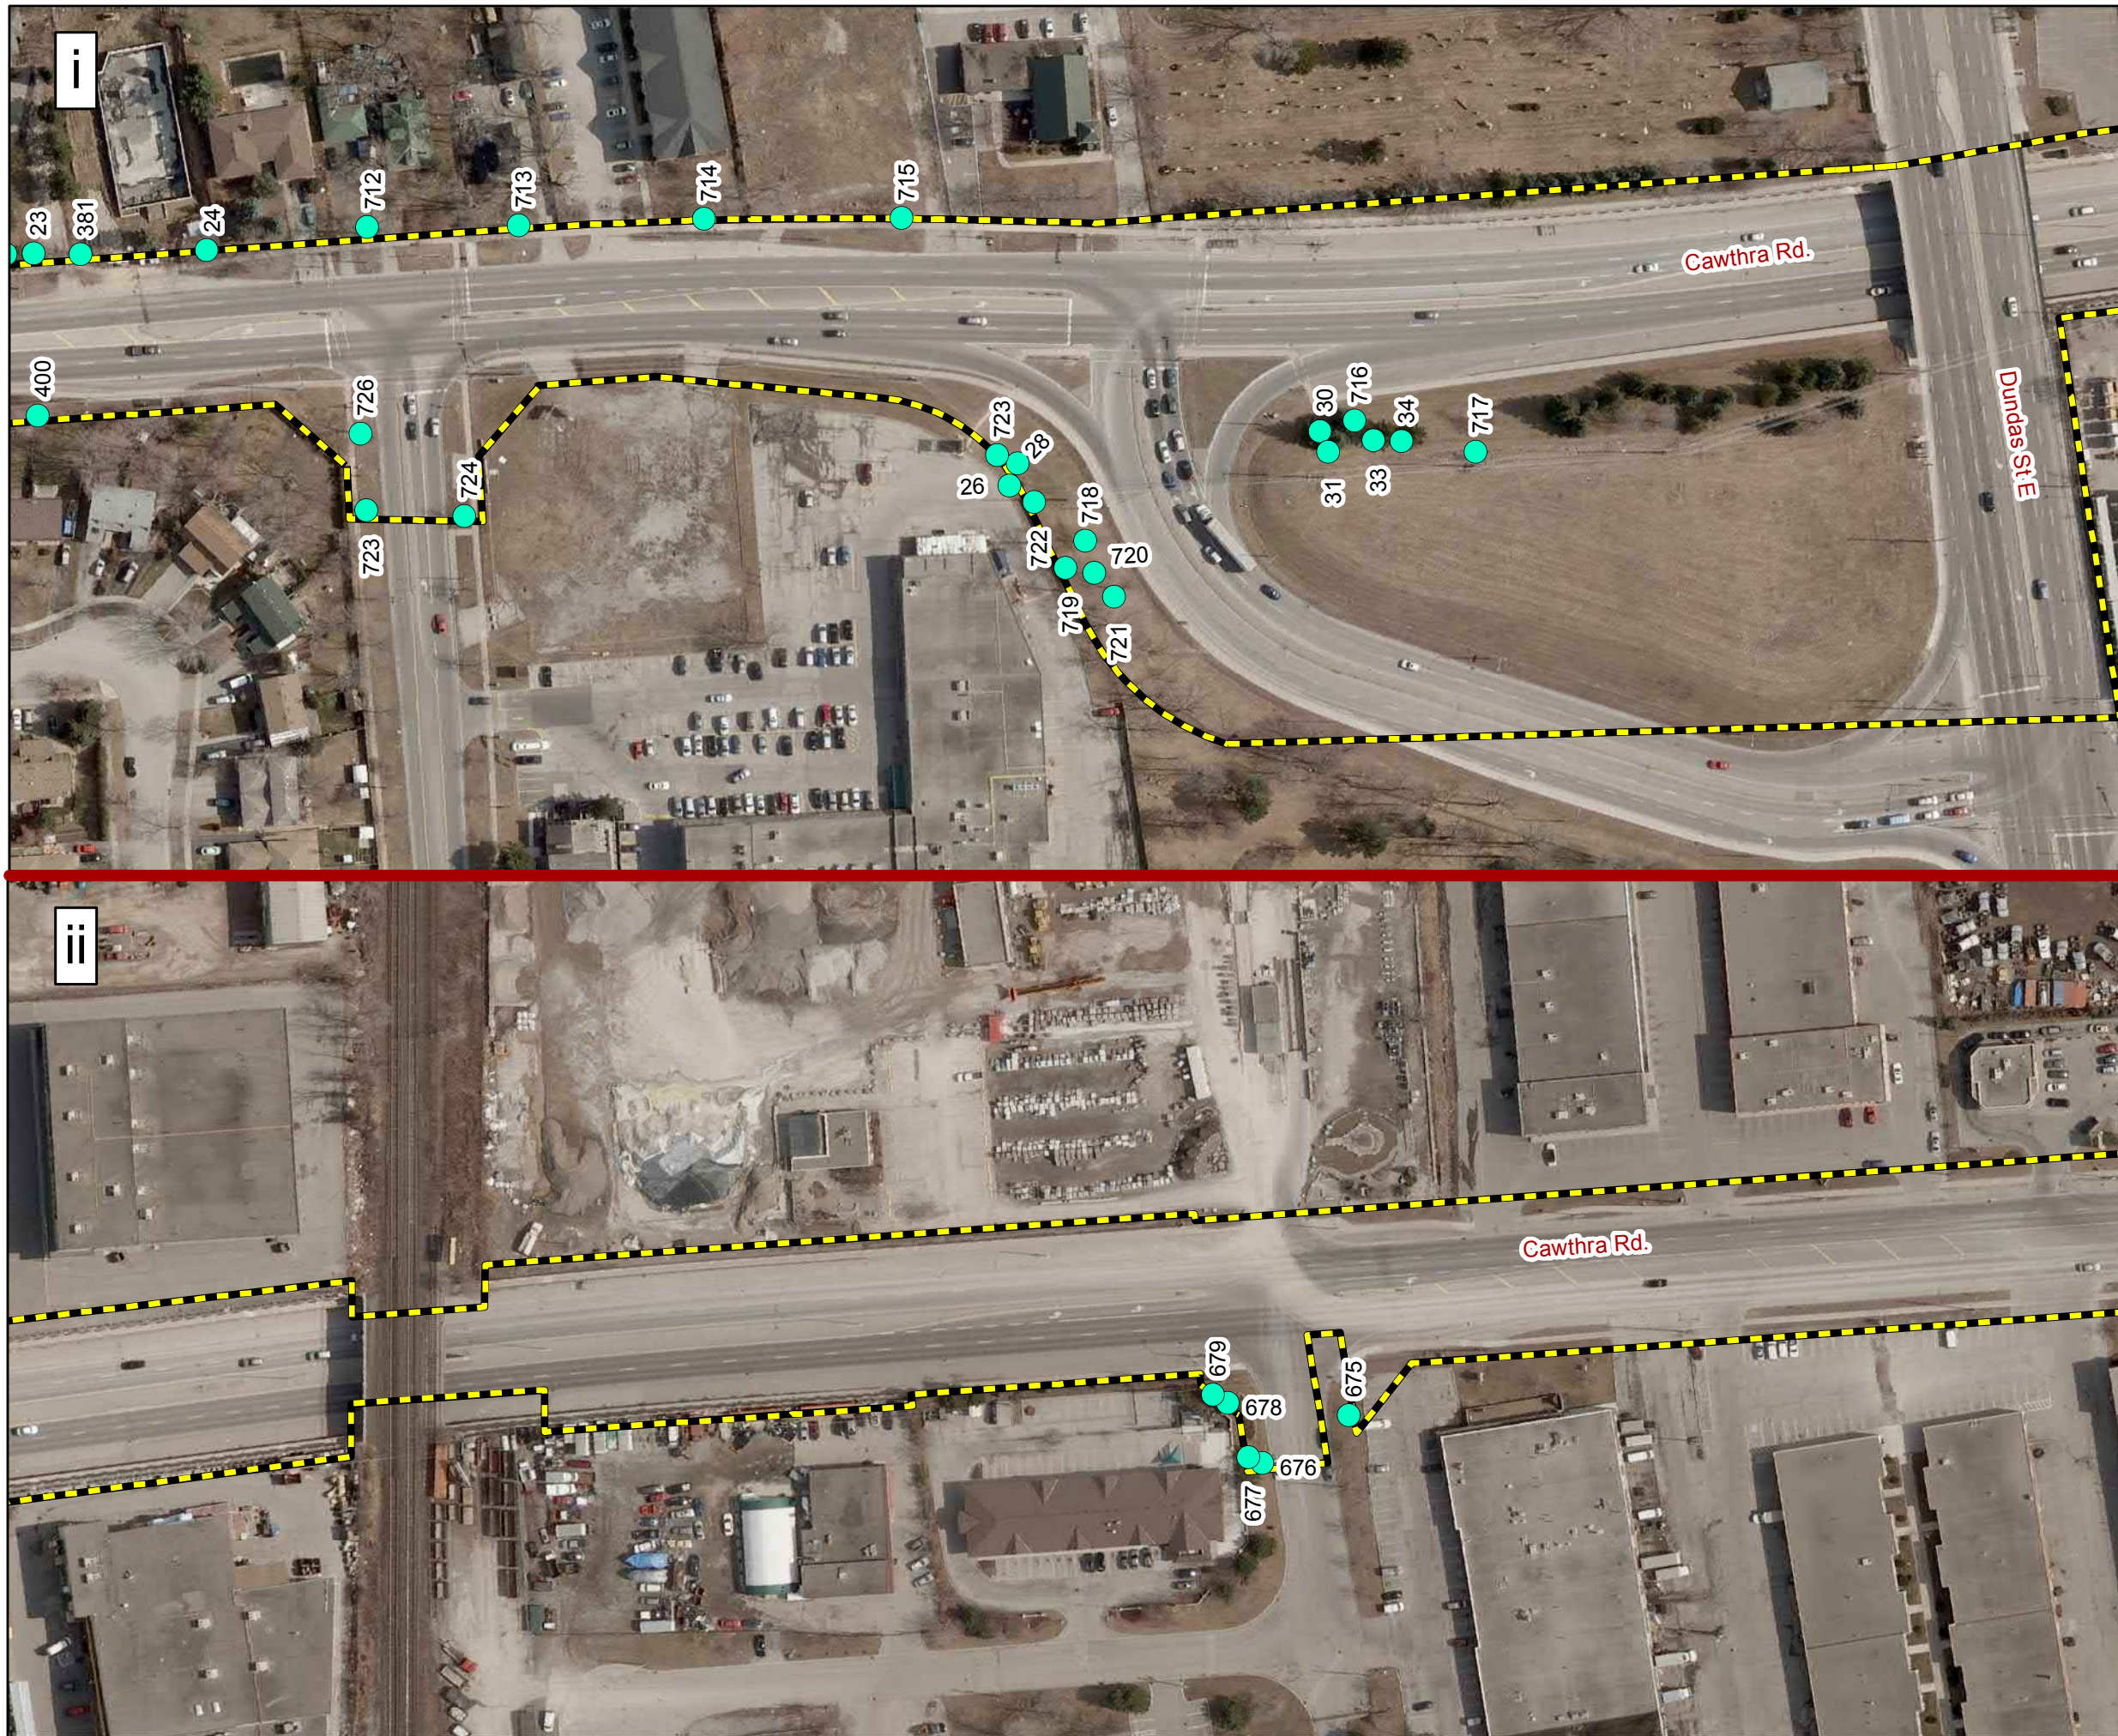
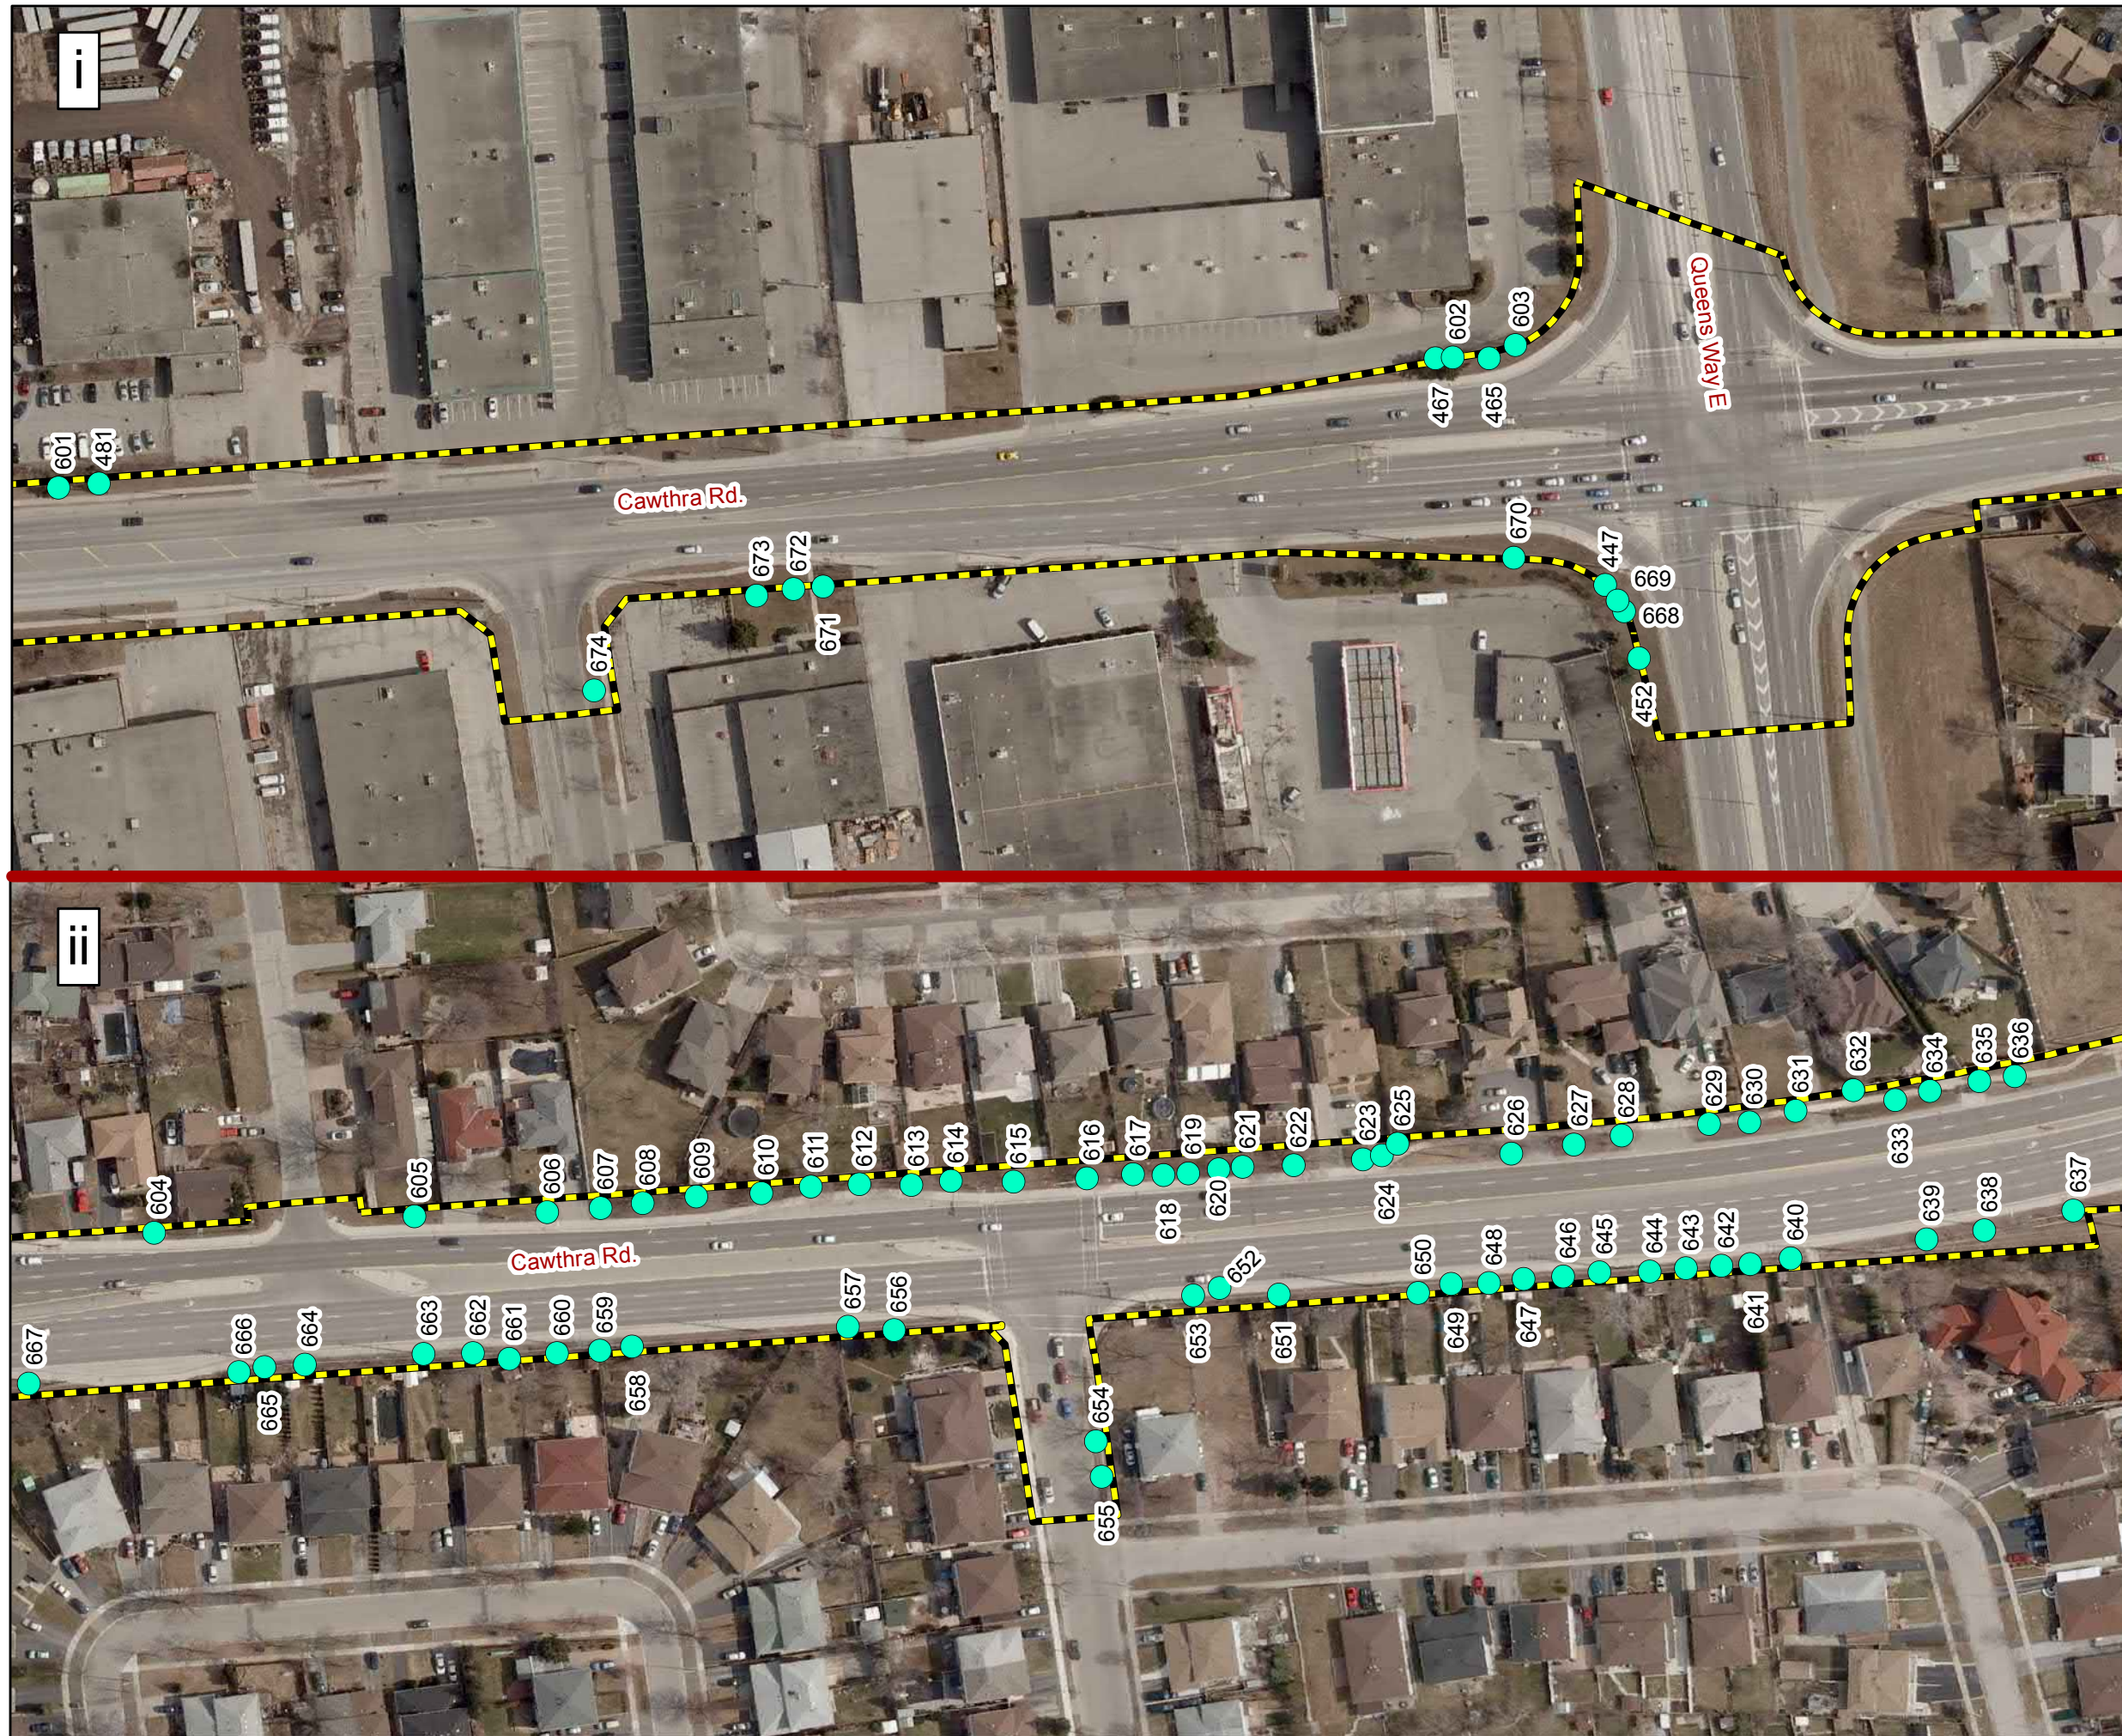
**Figure 2.** Tree Inventory.

The results of the tree inventory and health assessment are provided in **Appendix 1**. The locations of all tagged and assessed trees > 10 cm DBH are shown in **Figure 2A-F**.

Three hundred and thirty (330) trees were tagged and assessed. Tree composition and abundance within the study area is summarized below in **Table 1**. Of the thirty-one (31) tree species present along Cawthra Rd., Norway Maple (*Acer platanoides*) were the most abundant.
