# RIVERSTONE

March 4, 2020  
RS# 2016-008

**SUBJECT: Tree Inventory and Preservation Plan – Cawthra Rd. Improvements (Eastgate Parkway to South Service Road, Region of Peel).**

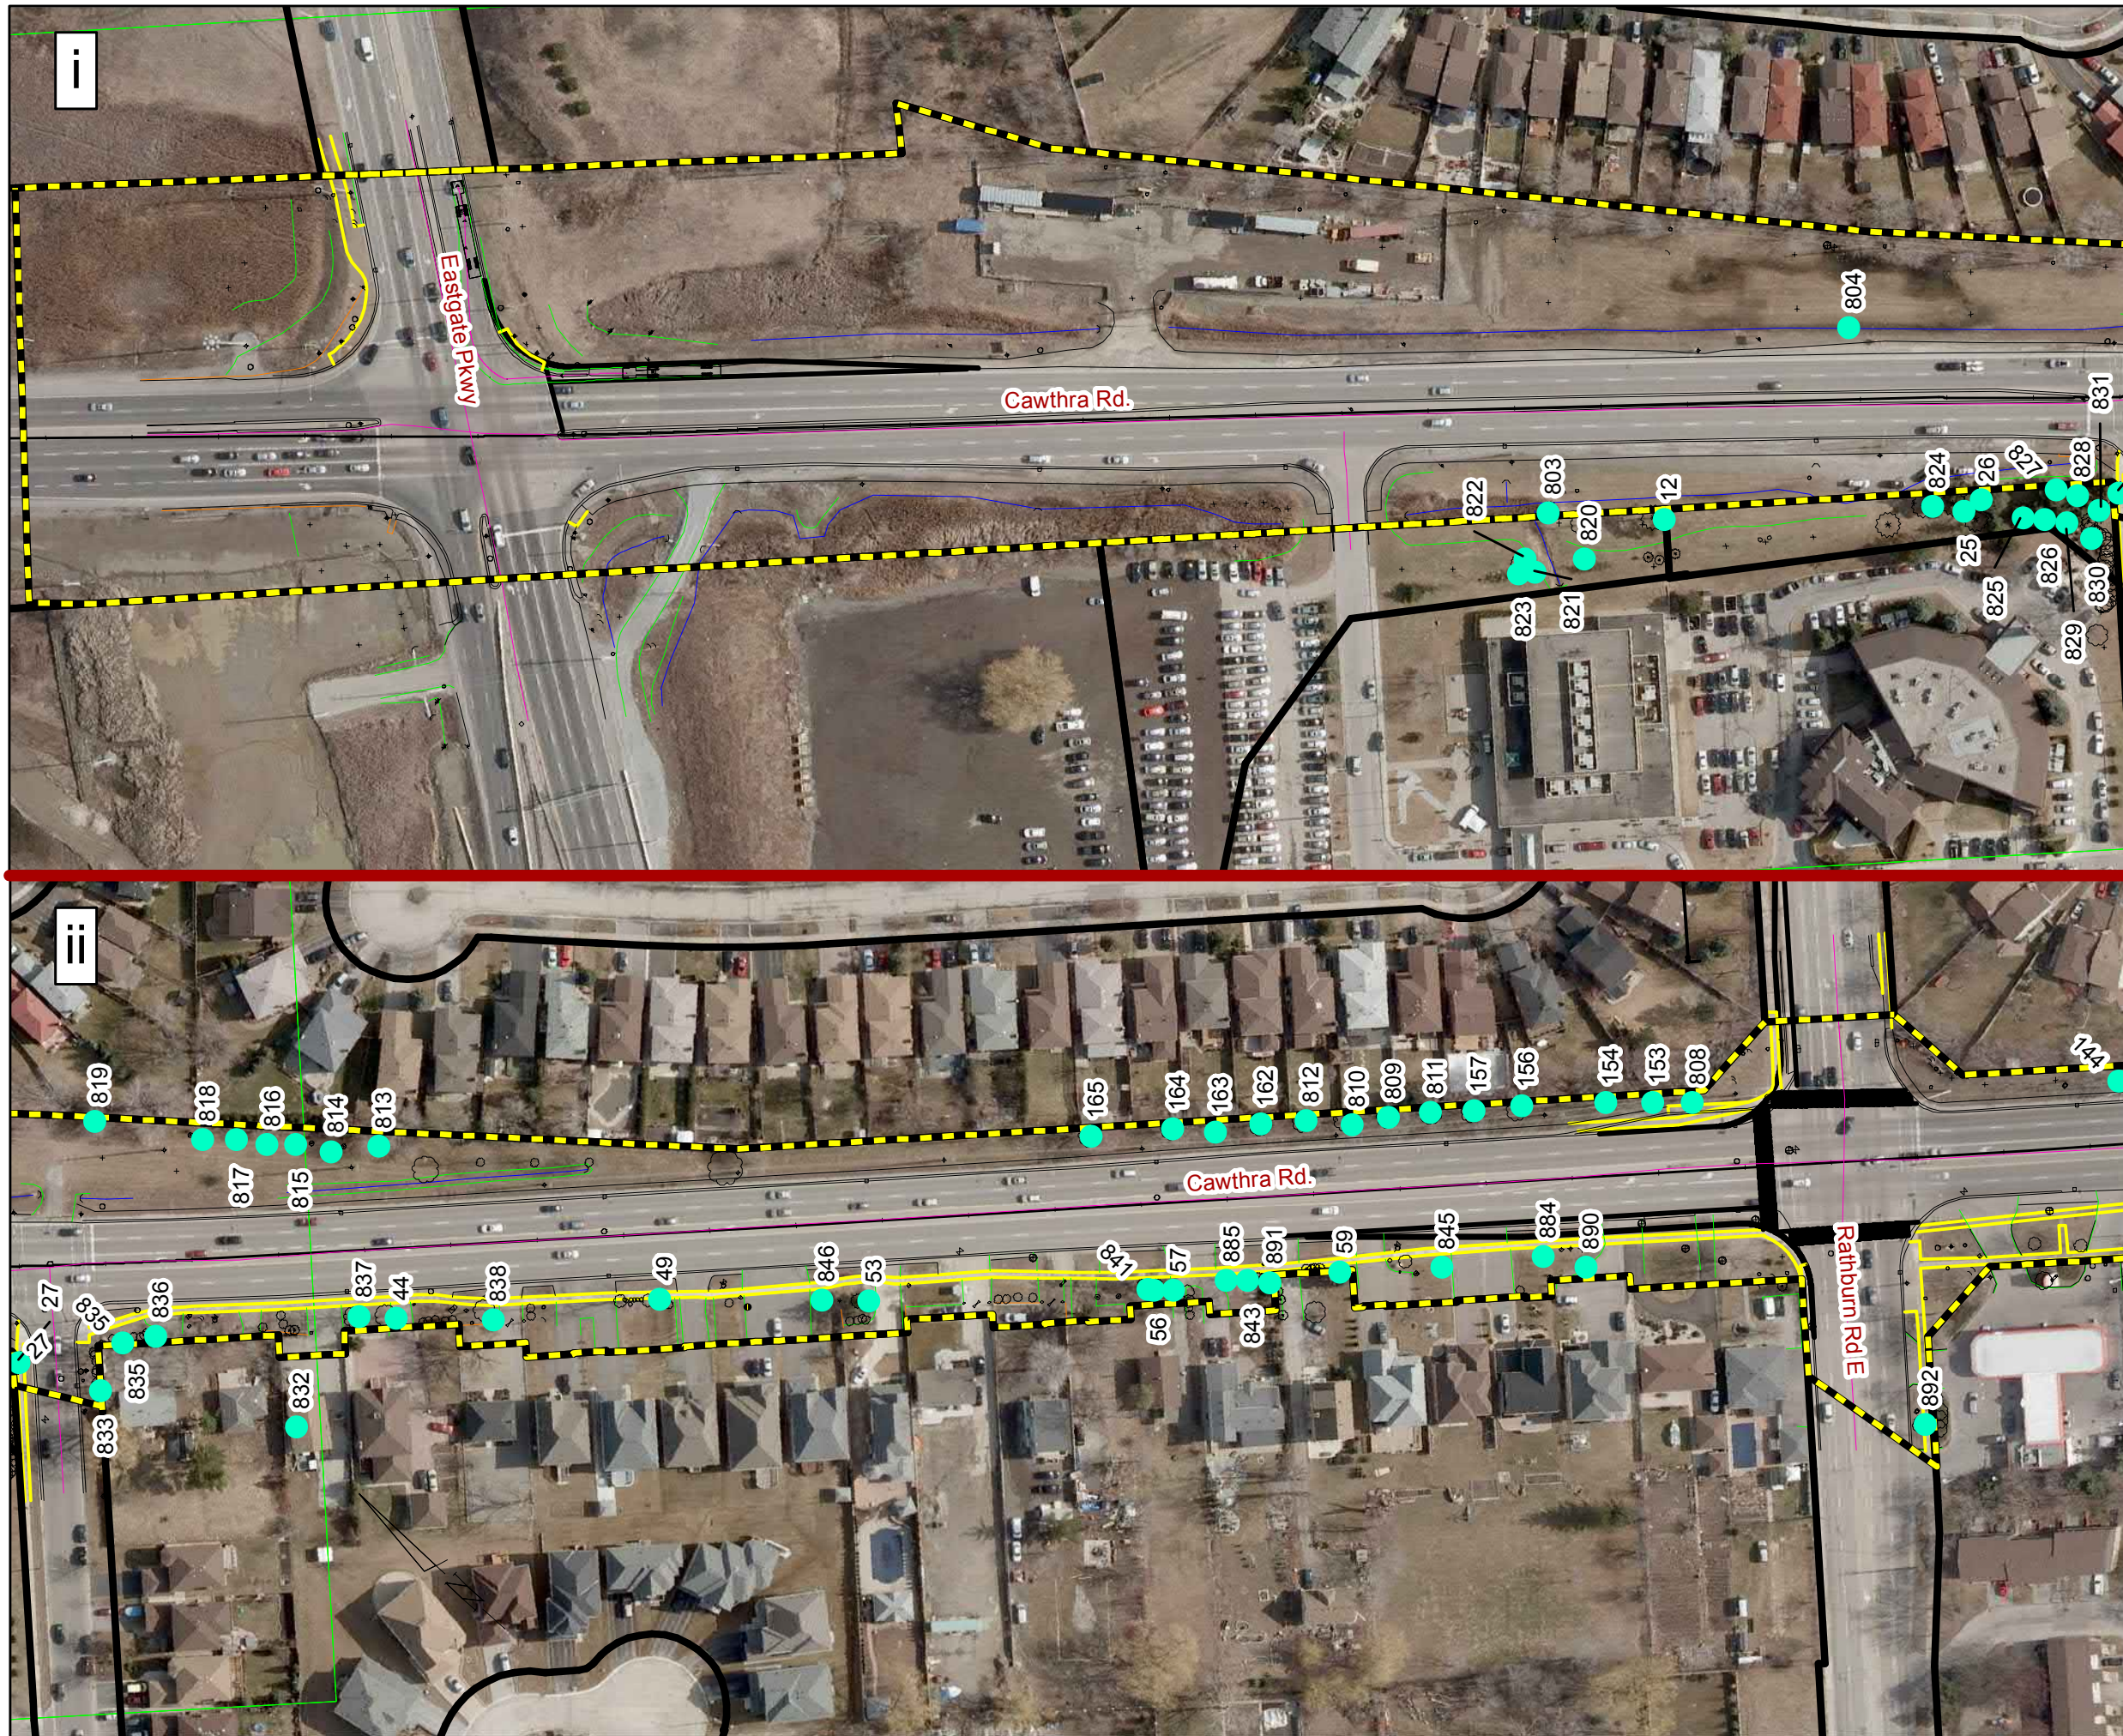
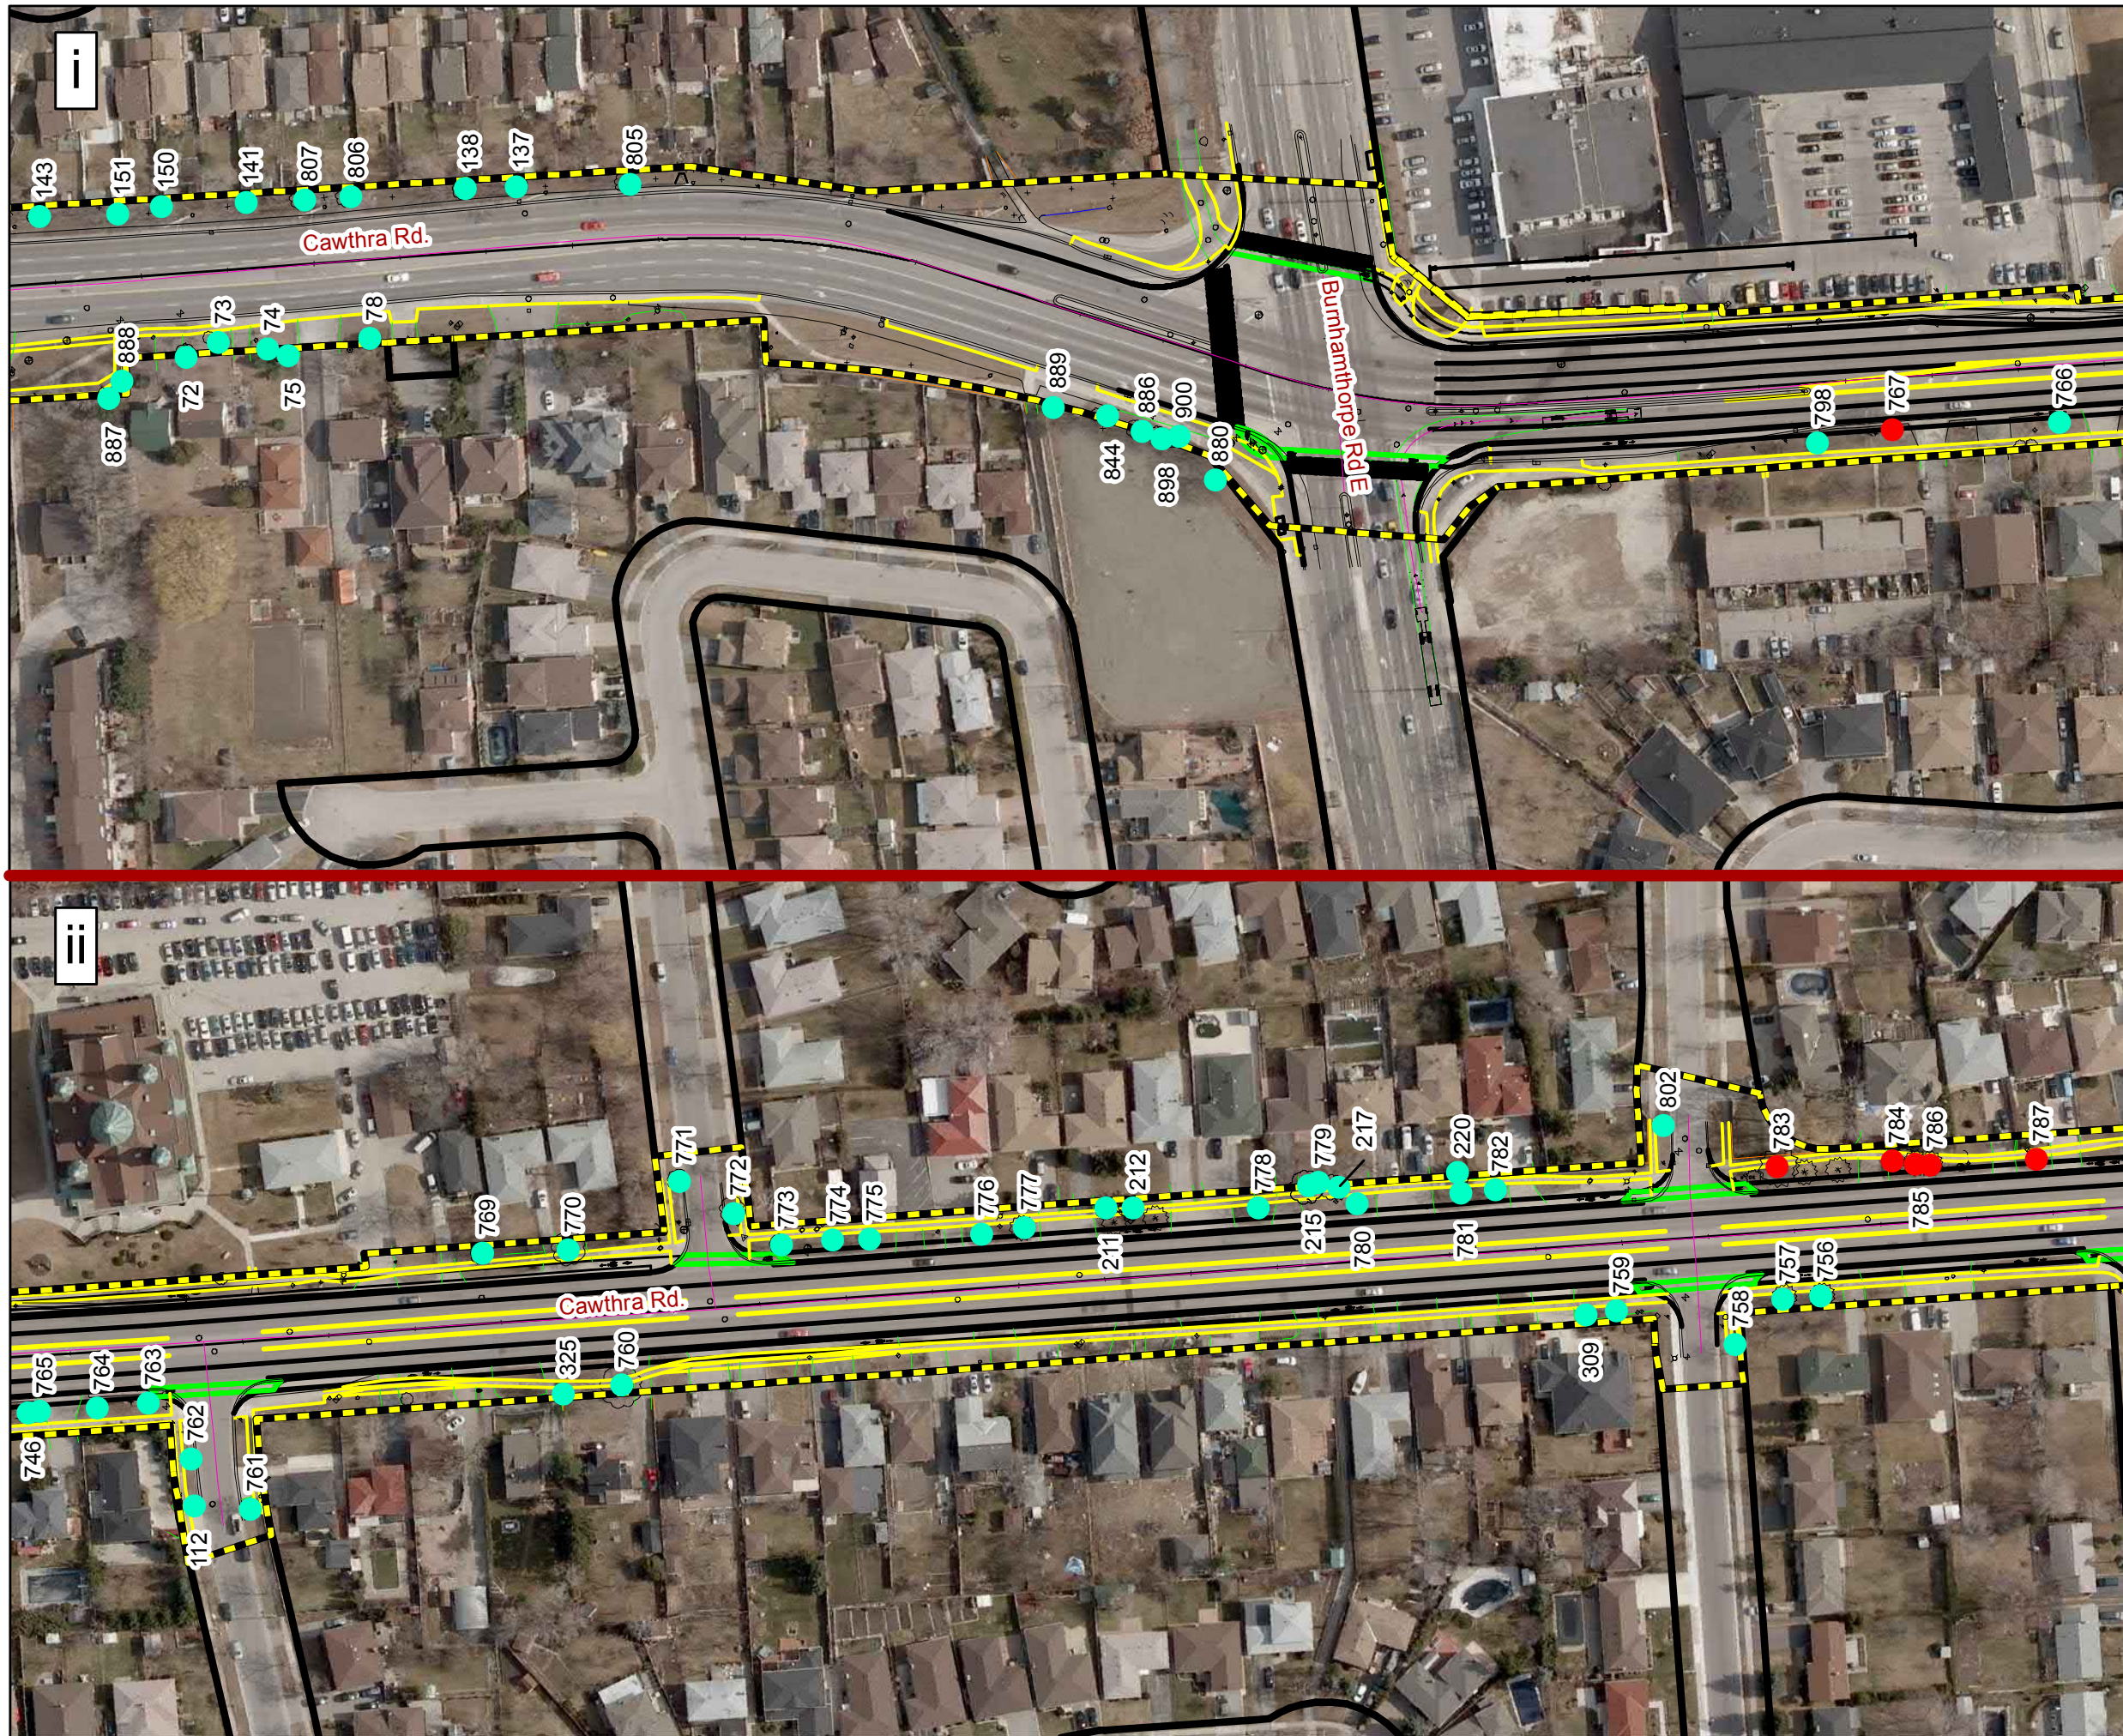
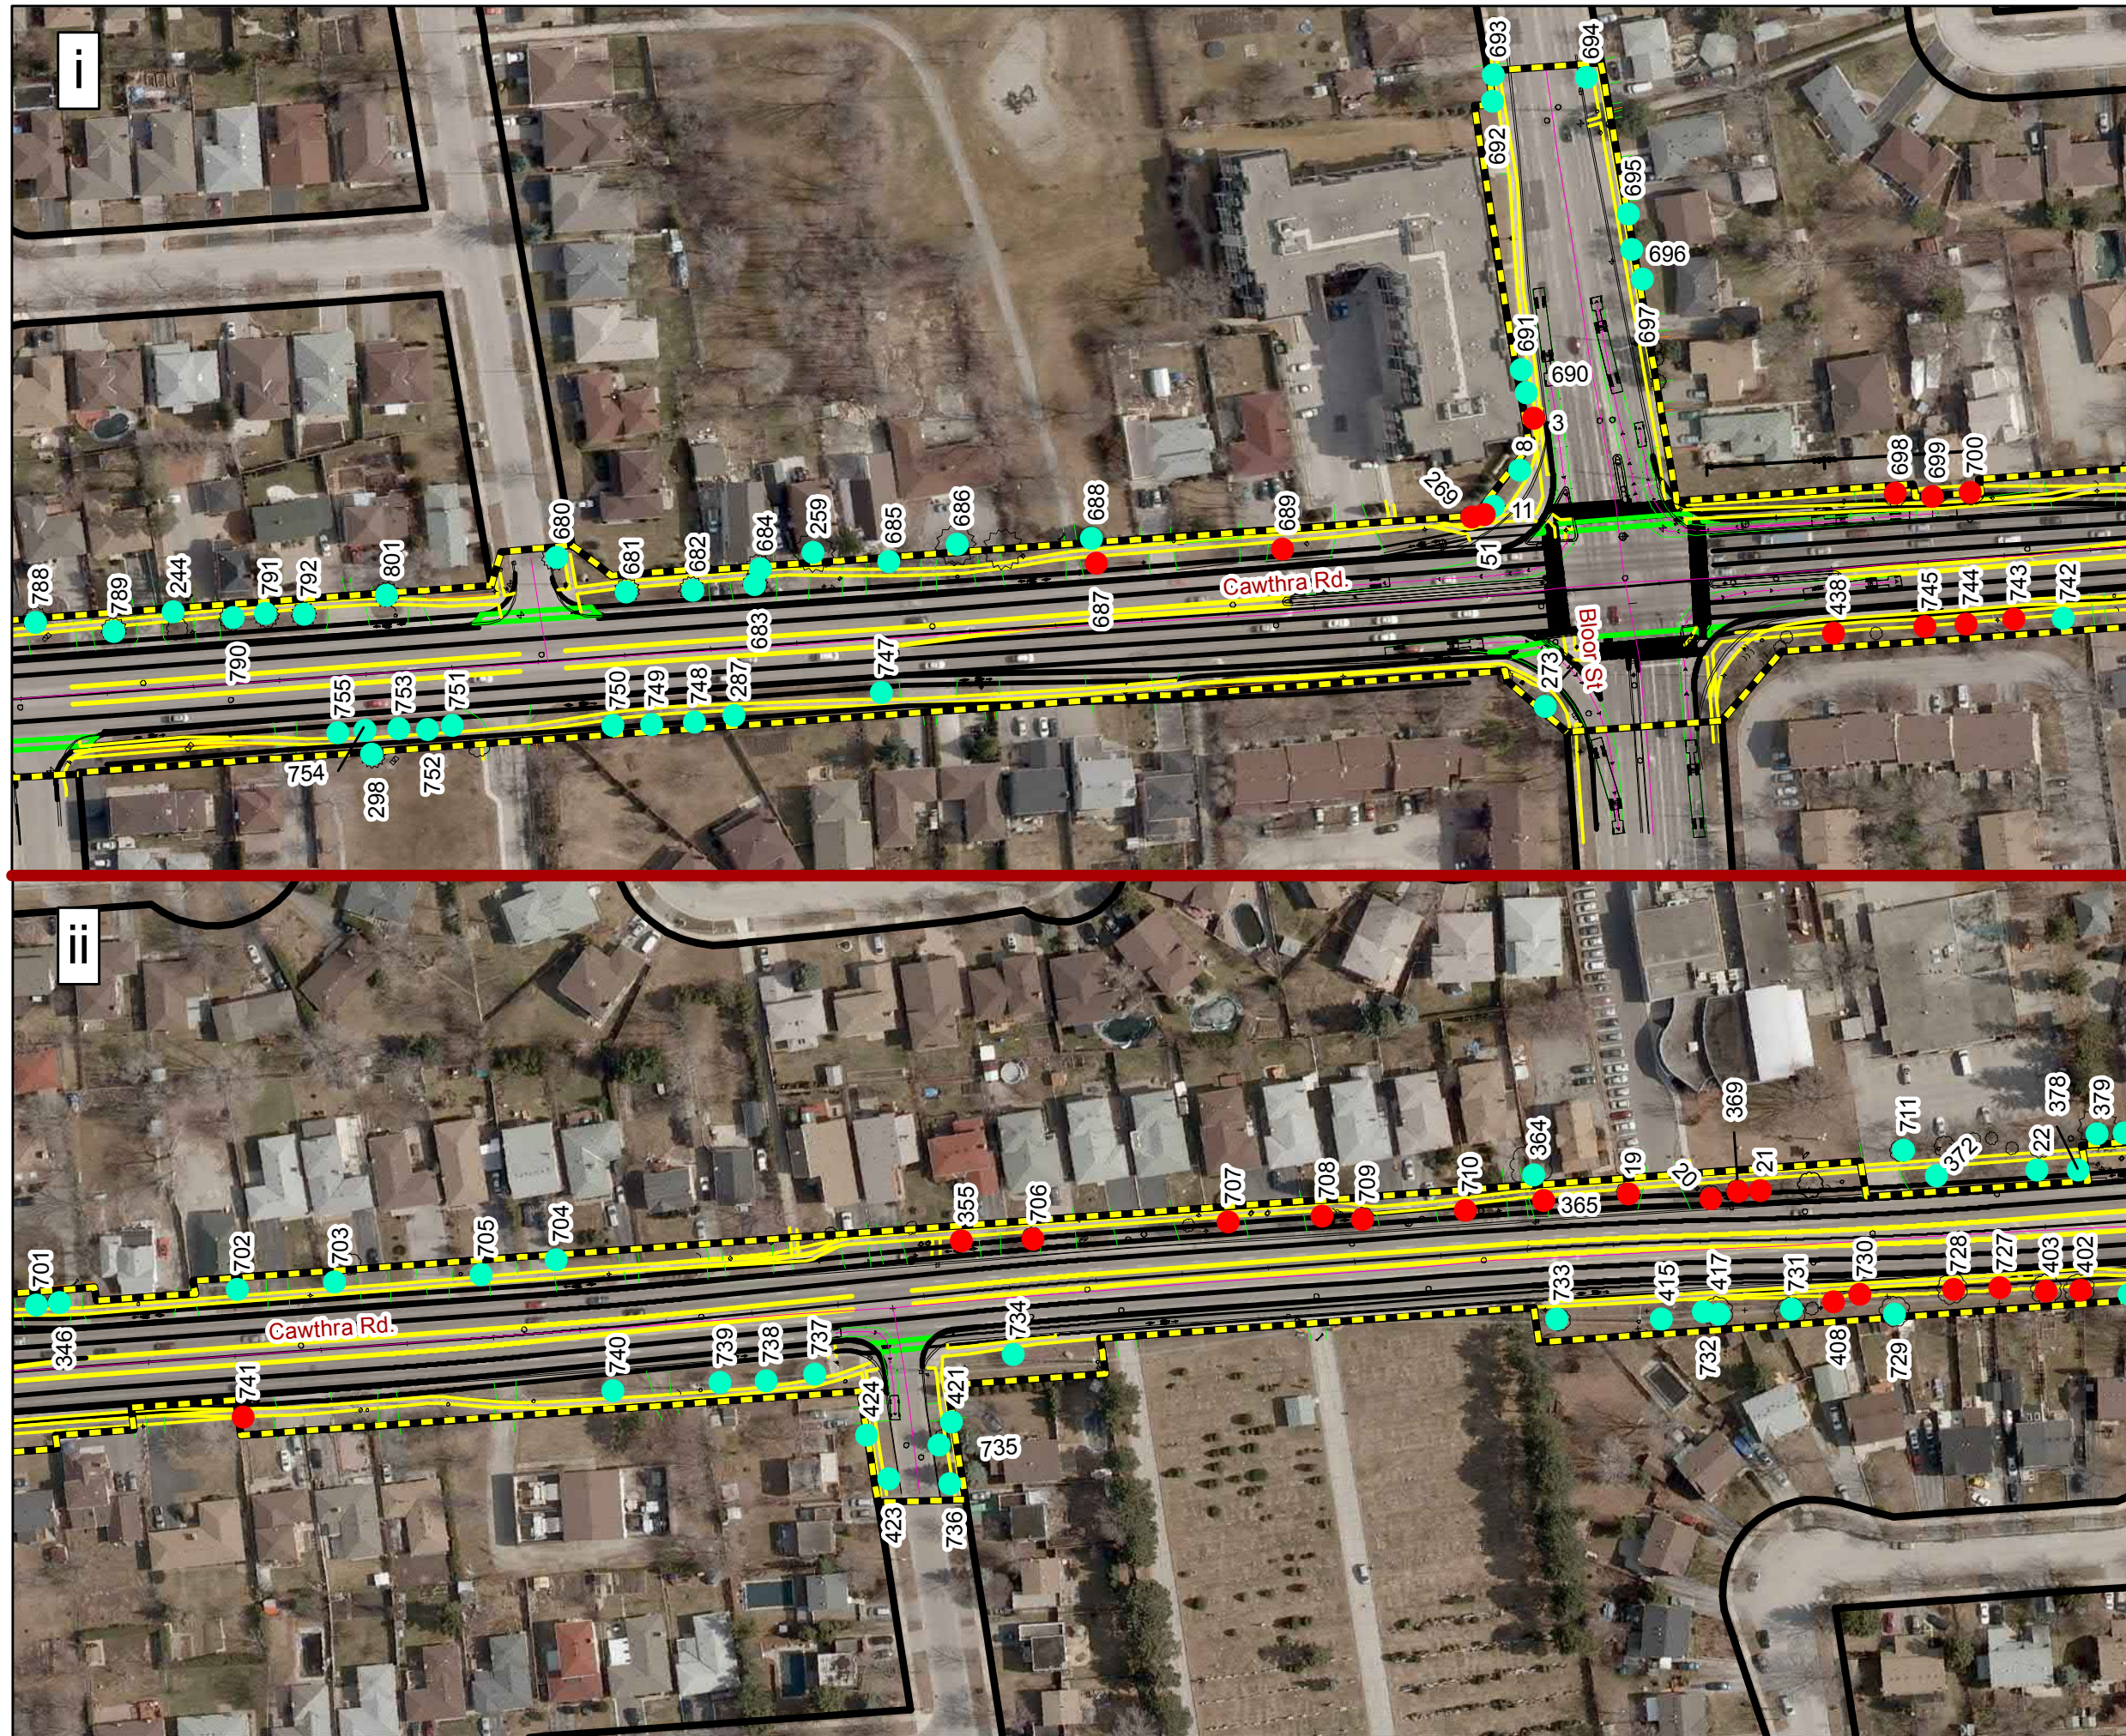
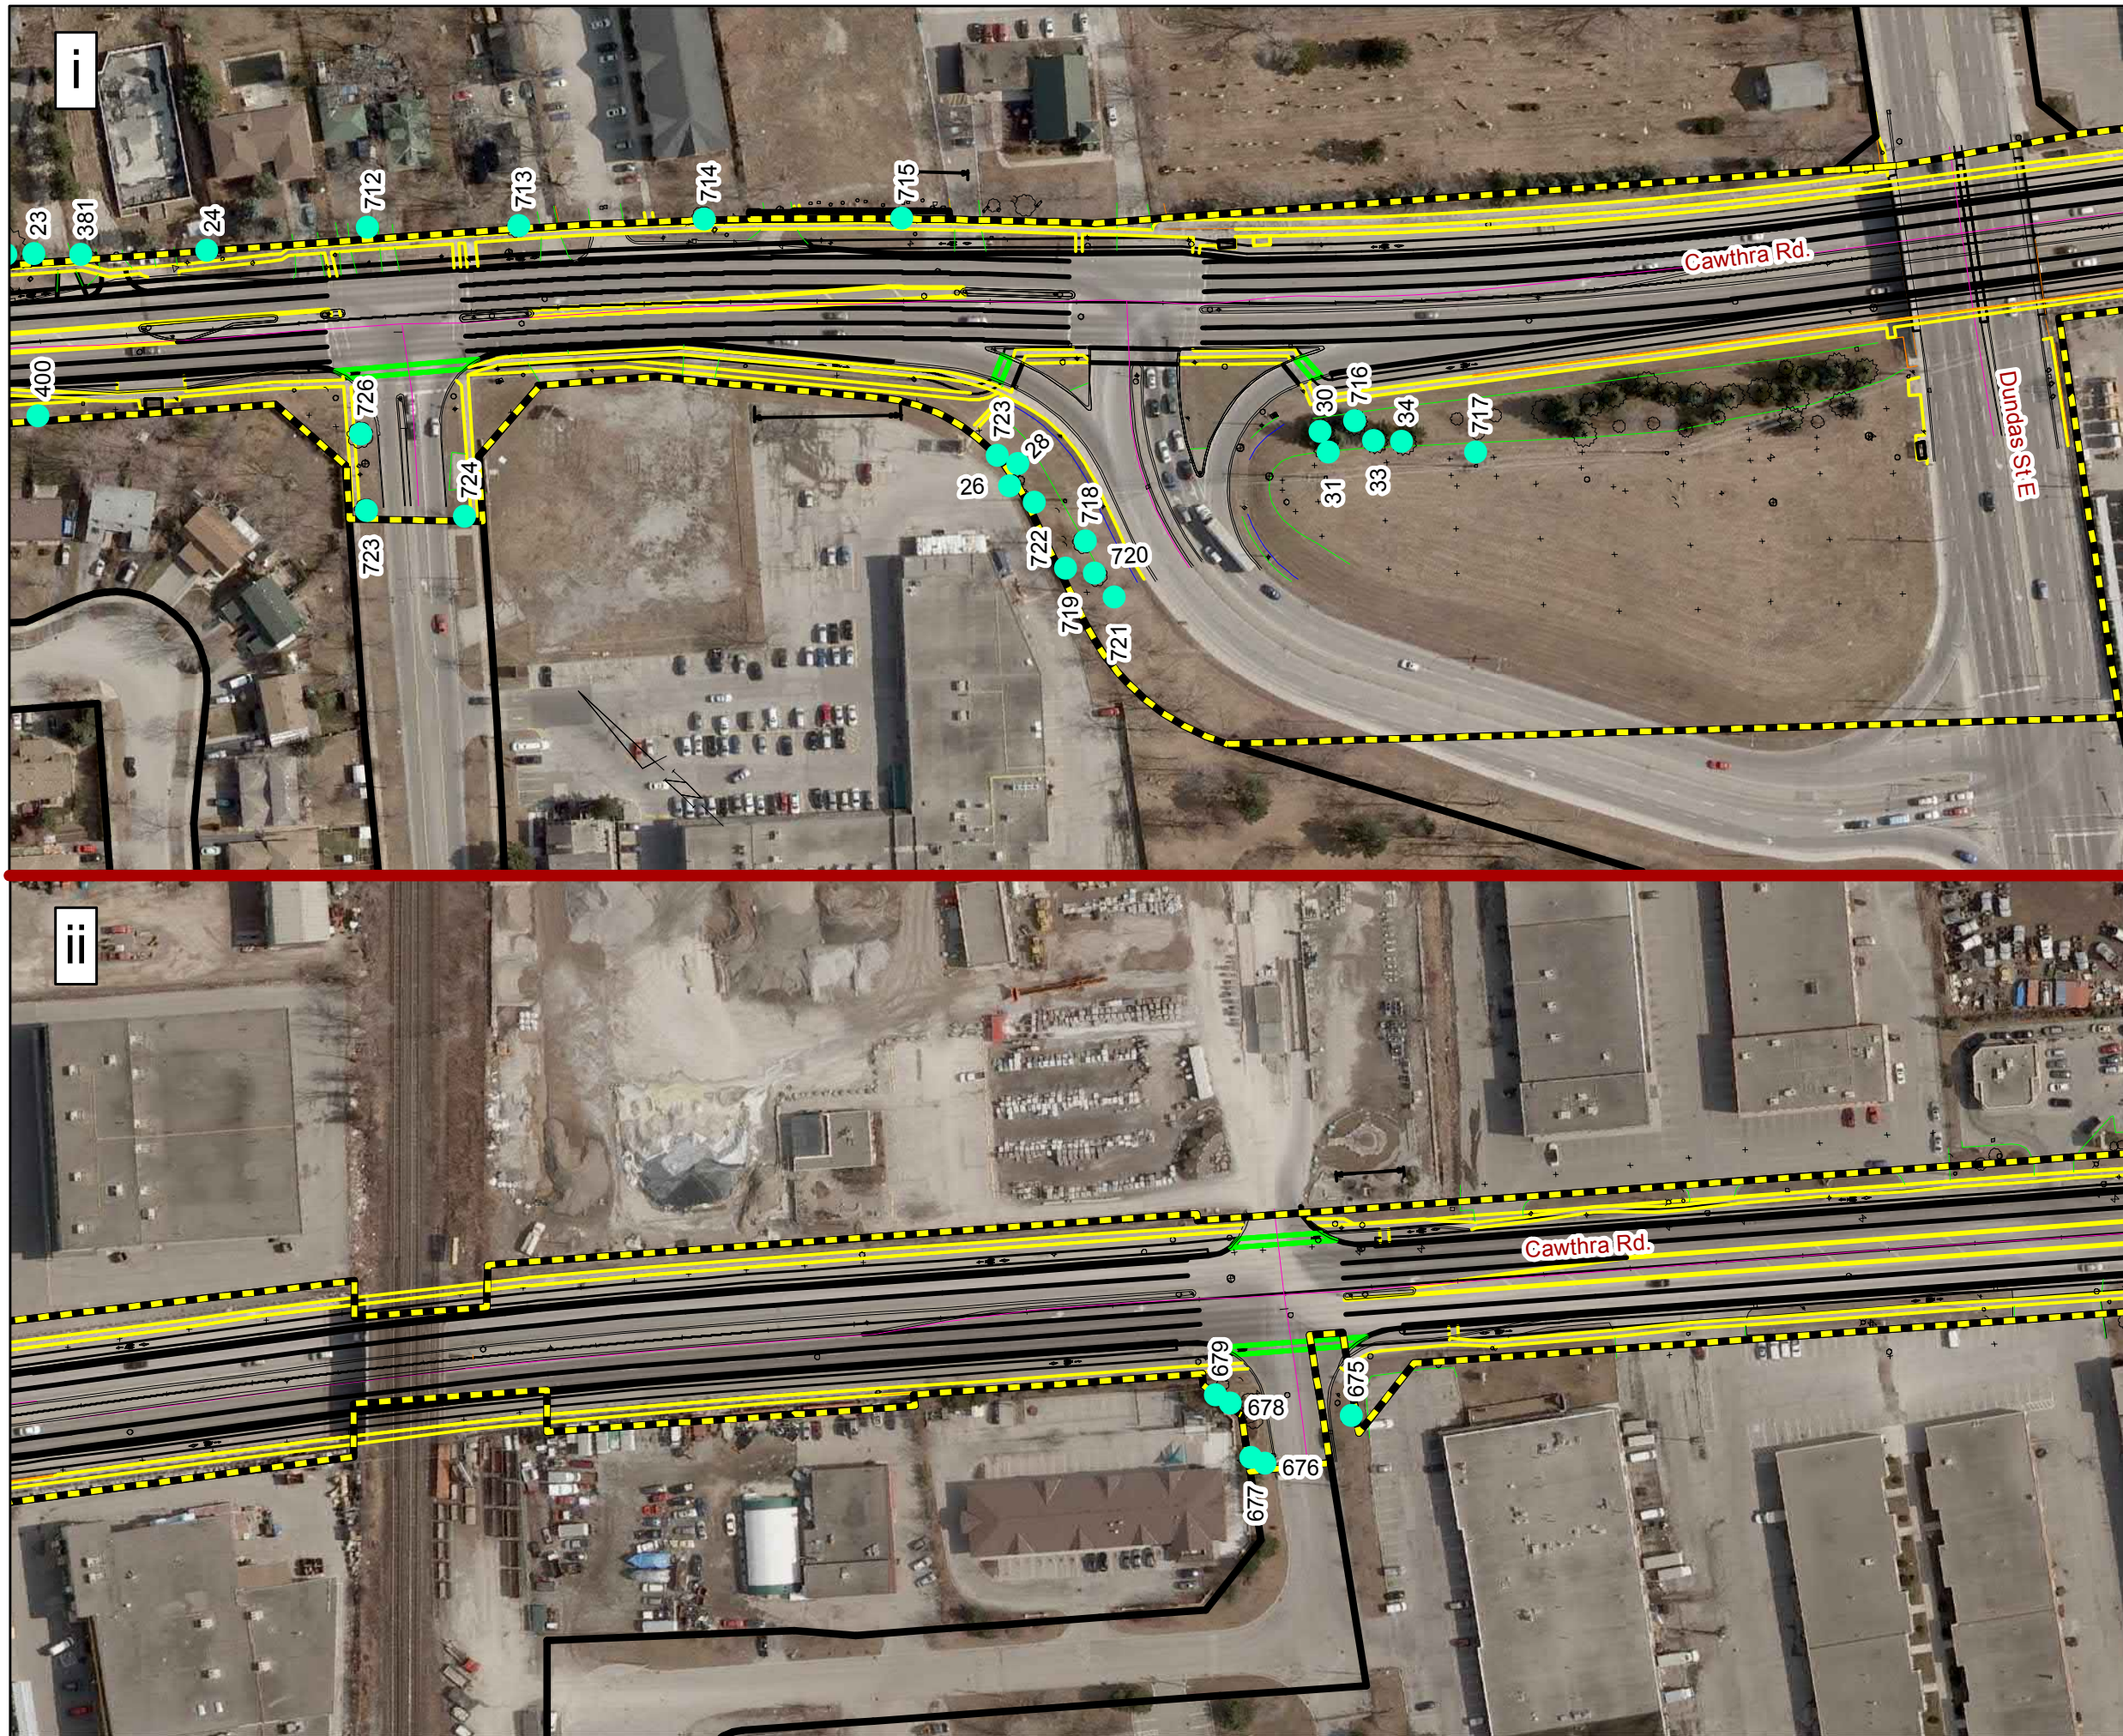
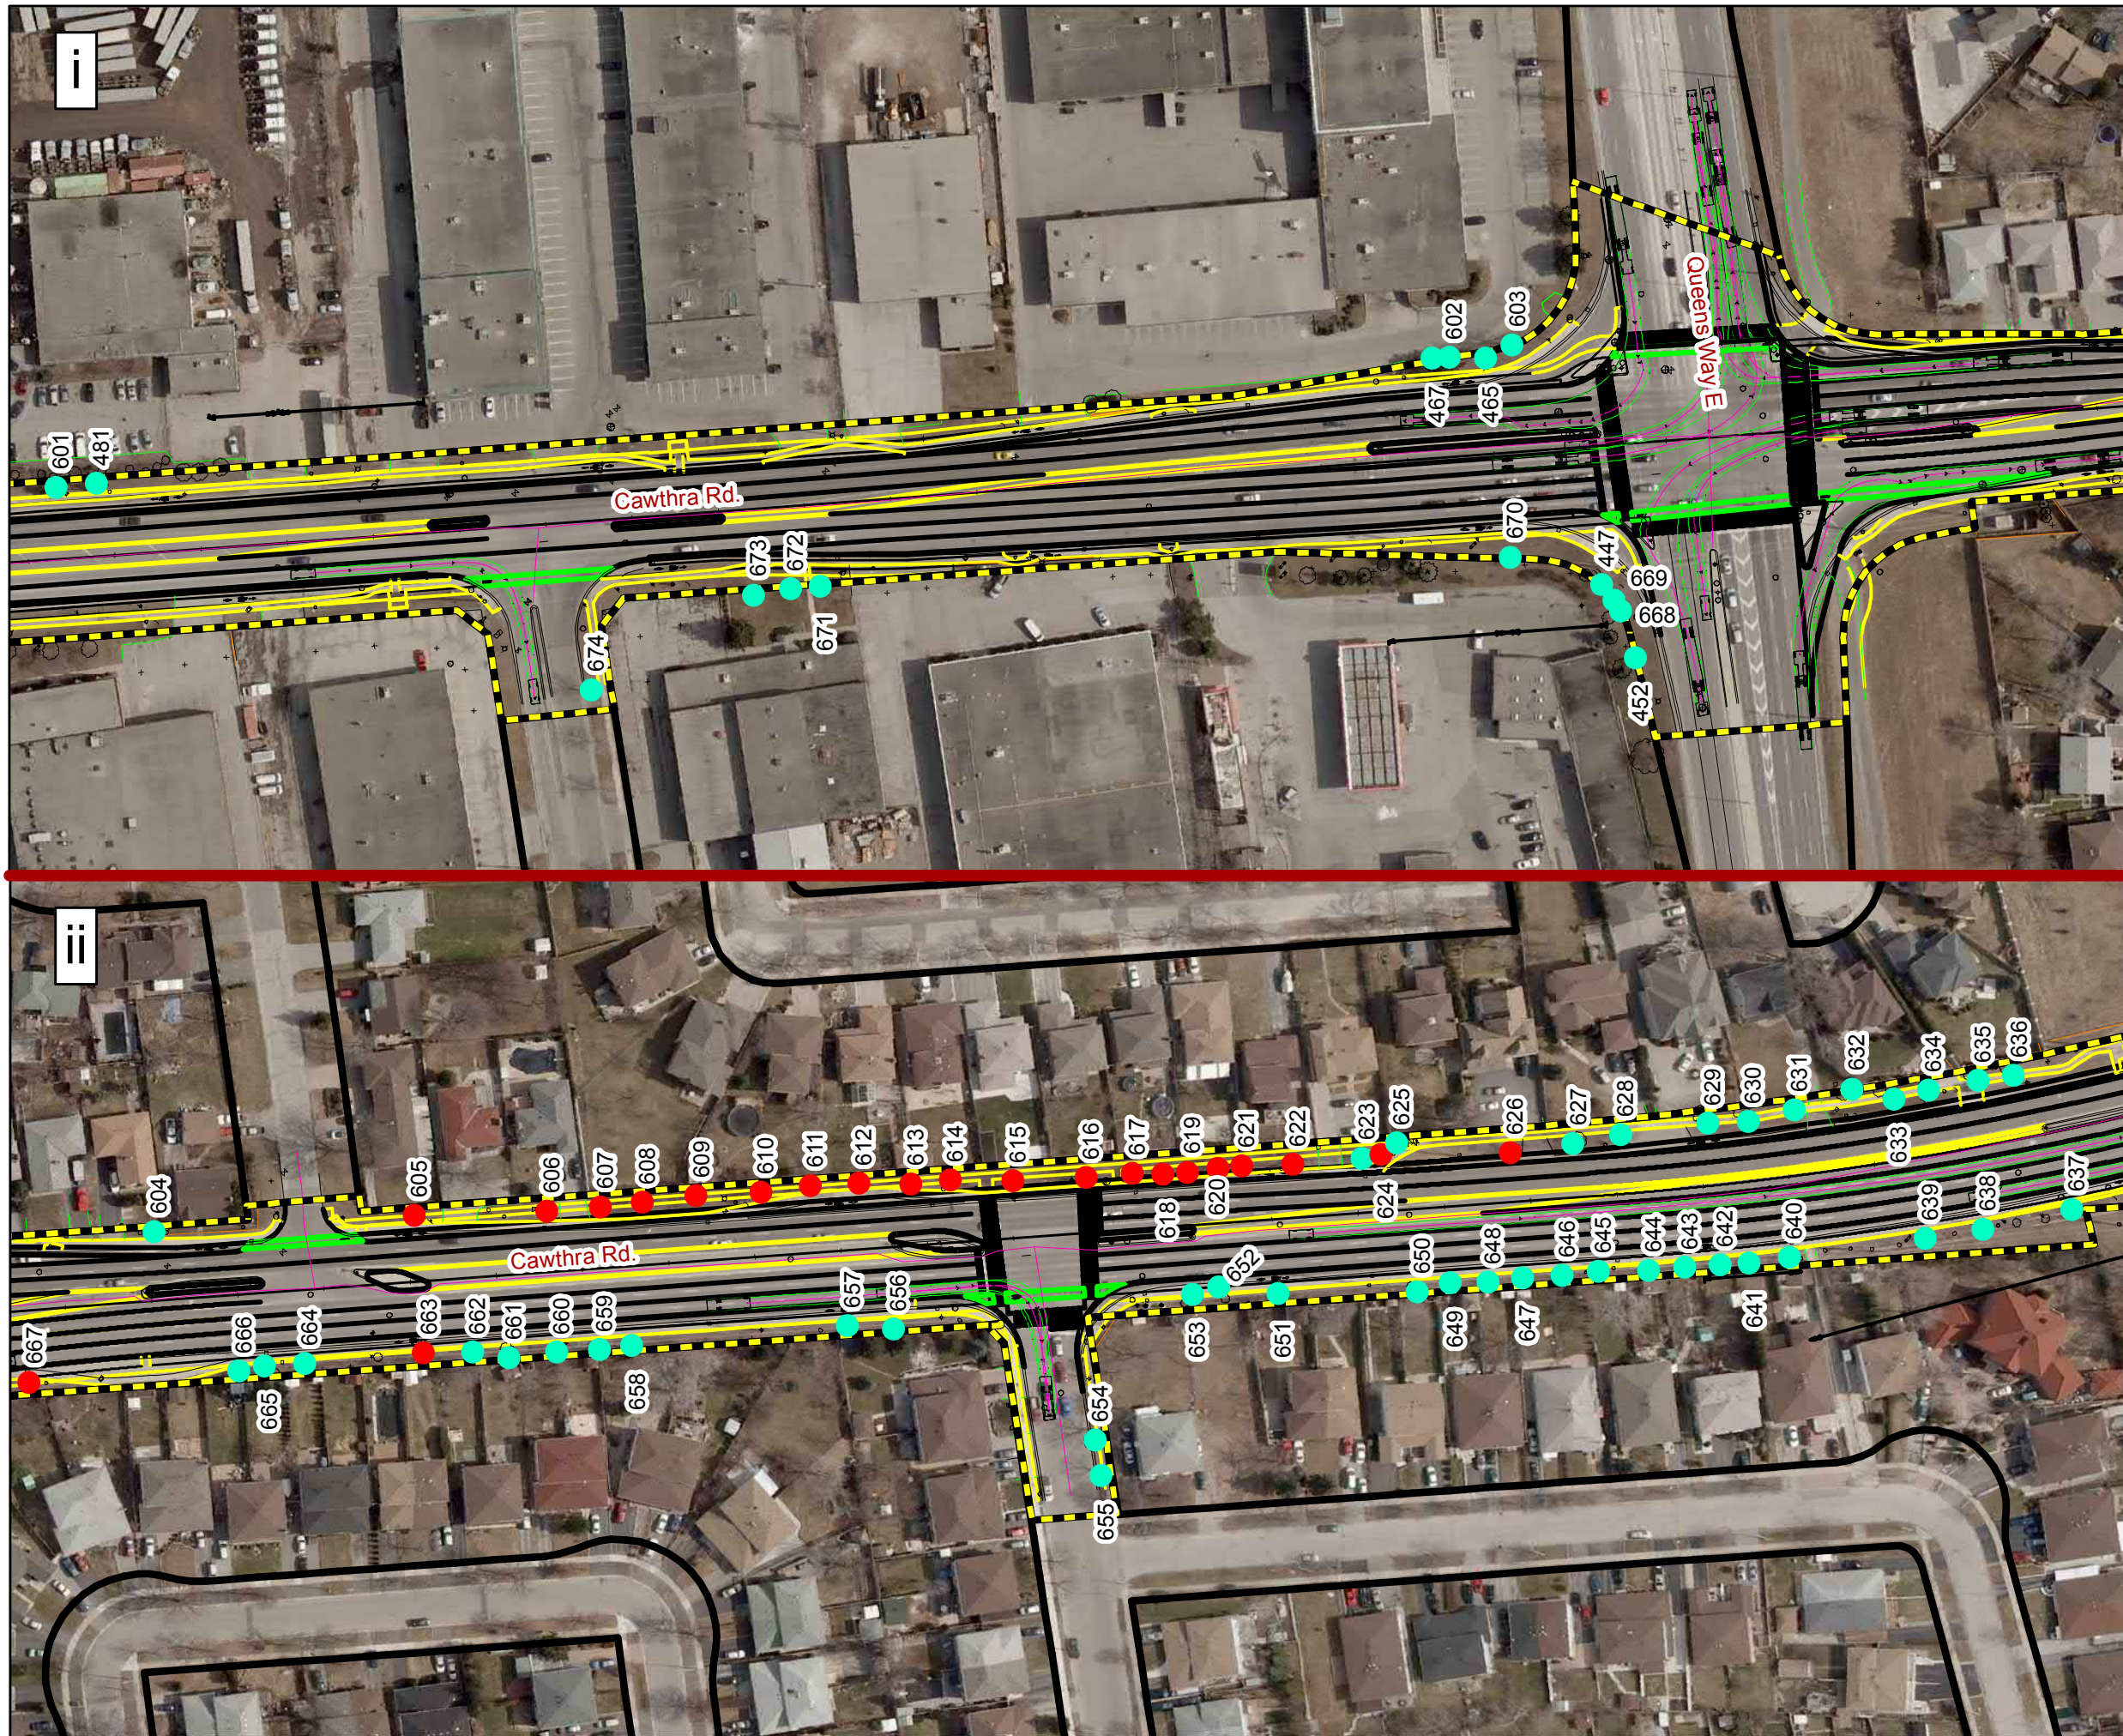
**Figure 3.** Tree Removal and Preservation Plan.

Based on a review of the proposed improvements to Cawthra Road (**Figure 3A-F**) a total of fifty-eight (58) trees require removal (**Appendix 1**). Minor impact/disturbance to the root system of trees recommended for retention that occur within proximity to the road improvements may also occur given their proximity to the area of disturbance.

As a means to protect the retained trees as indicated on **Figure 3A-F**, RiverStone recommends the following measures:

- **Tree protection fencing should be installed to protect the root systems at the dripline distance from each tree trunk adjacent to construction activities according to Driplines in Appendix 1. No site alteration activities (e.g., grading, etc.), machinery movement, or storage of any equipment or materials should occur within the tree protection fencing.**
- **In the event of mechanical injury to any trees recommended for retention and/or their branches, or if pruning is required to provide clearance for construction machinery, the following actions are recommended:**
  - **Prune damaged limbs cleanly and according to standard arboricultural practices.**
  - **Prune damaged roots that have been exposed cleanly and according to standard arboricultural practices.**
  - **Trim loose bark but avoid enlarging any open wounds.**
