**Region of Peel**

# Addendum to Environmental Study Report

Improvements to Bovaird Drive, from Lake Louise Drive/Worthington Avenue to 1.45 km west of Heritage Road in the City of Brampton

May 2015

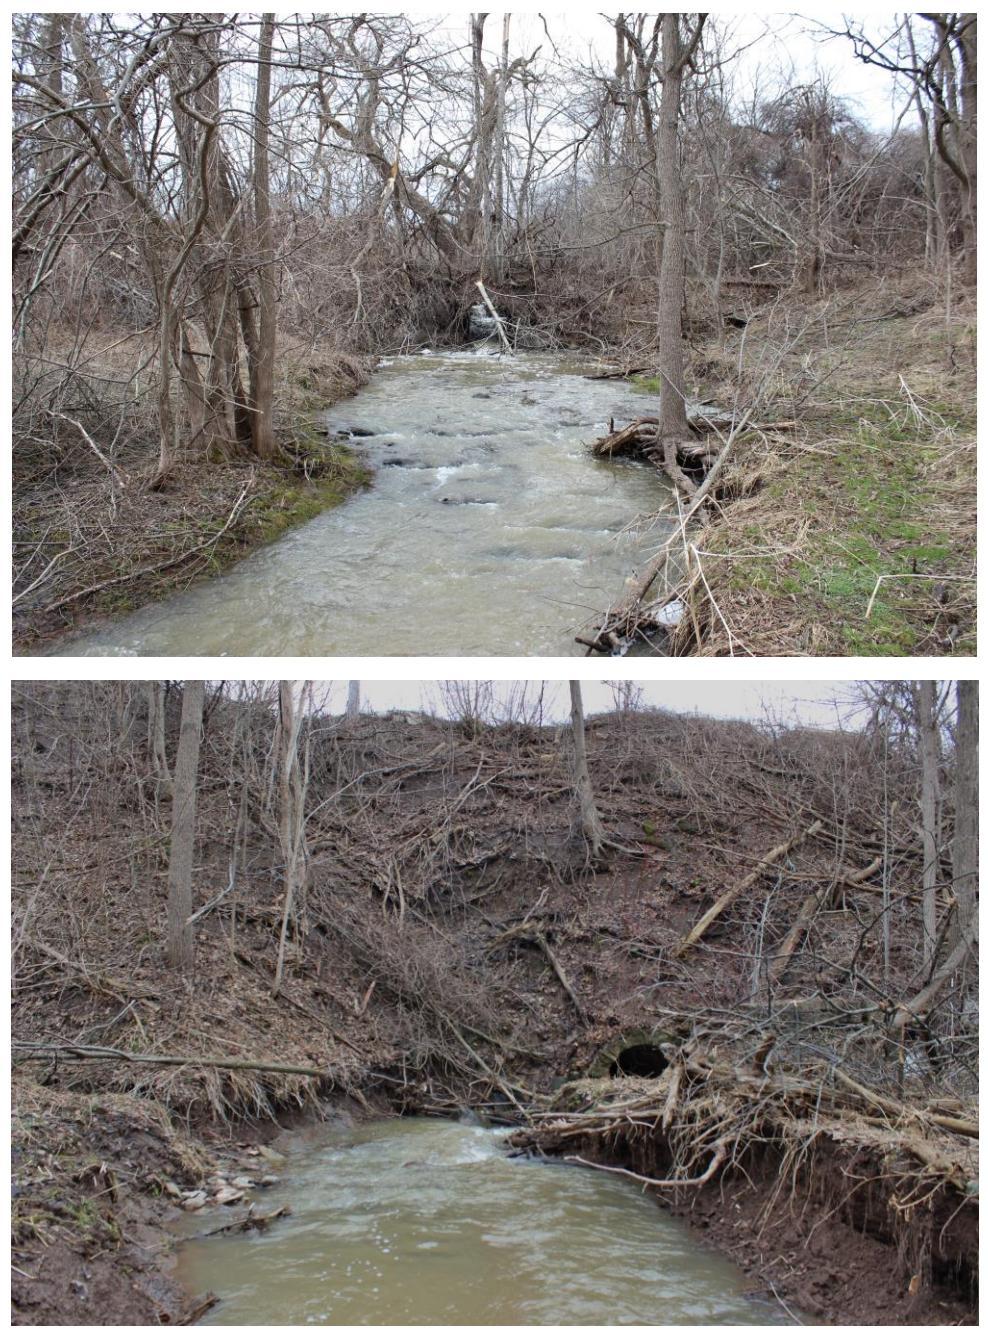
**Figure 4.3:** Photographs of existing culverts within Reach BV-A1, the small culvert approximately 250m US of Bovaird Drive (top) and the US (North) portion of the Bovaird Drive culvert (bottom).

Two culverts were identified within the reach and both were determined to be attributing to instability within the watercourse (**Figure 4.3**). The small culvert located near the upstream end of the reach (250m upstream of Bovaird Drive) is undersized and set at a steeper slope than the natural channel. This has led to the development of a deep scour pool immediately downstream of the outlet and backwatering at the upstream end resulting in aggradation. The second culvert, which conveys flows under Bovaird Drive, has also been identified as a major source of channel disturbance. Based on existing channel dimensions and flows, the culvert is considered to be undersized. The undersized culvert restricts effective conveyance of flows leading

to issues with flow constriction causing channel widening and degradation. Immediately upstream of the culvert, the channel consists of steeply eroding banks which increase in height towards the culvert, evidence of channel widening and degradation. The culvert drains into Reach BV-A2 located south of Bovaird Drive.

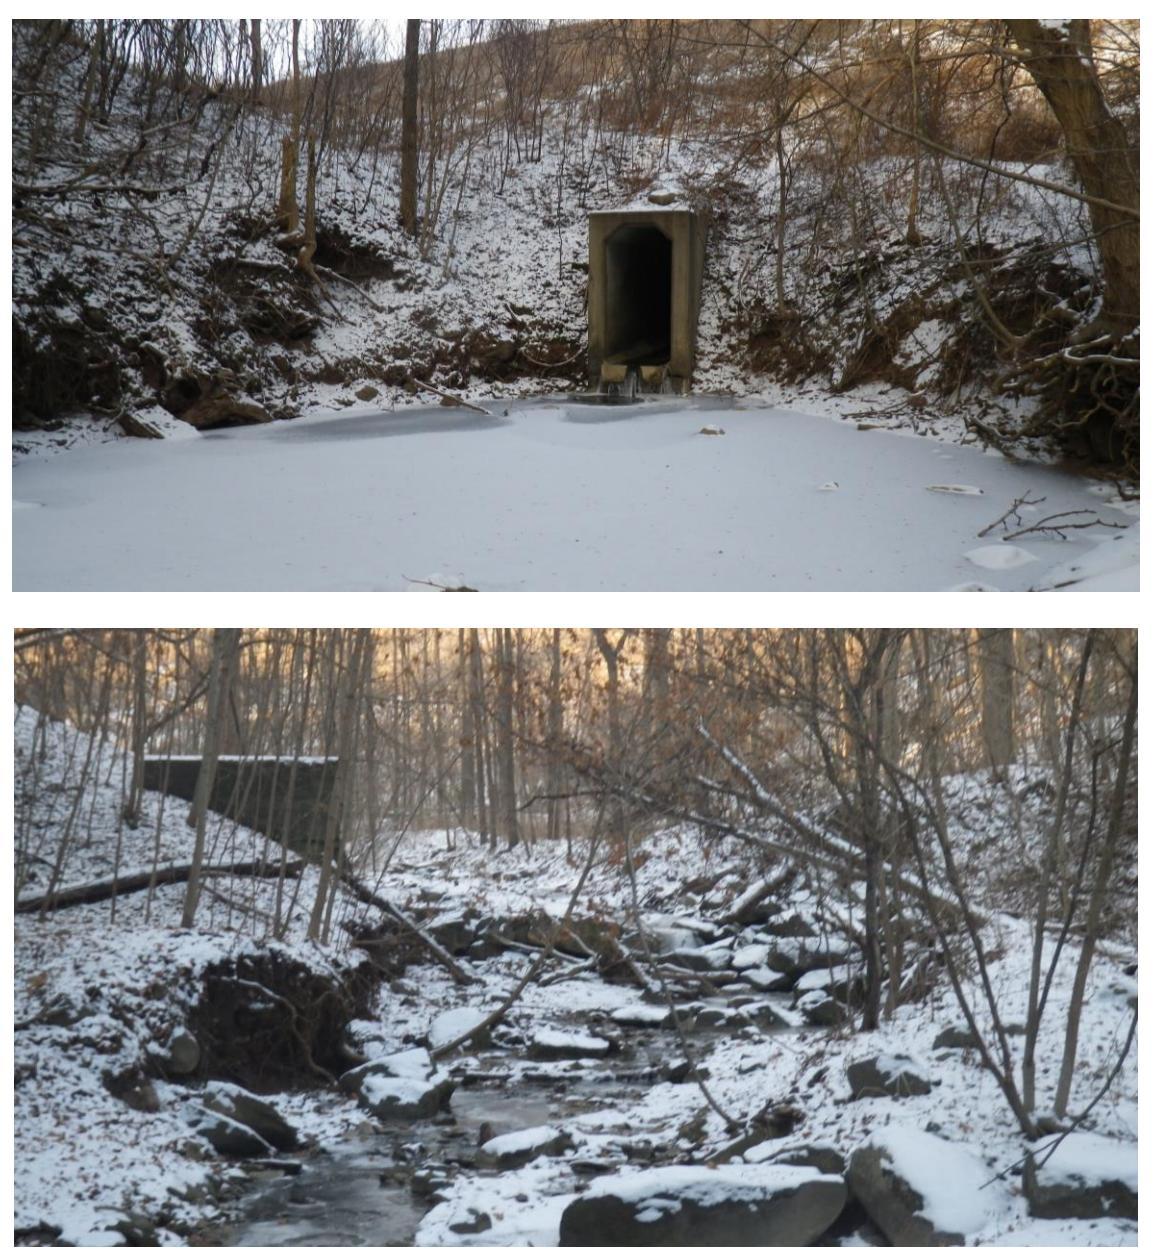
**Figure 4.4:** Photographs of existing fish barriers within Reach BV-A2, the perched culvert immediately DS of Bovaird Drive (top) and the relic weir approximately 60m DS of Bovaird Drive (bottom).

The most significant channel disturbance within the reach is the undersized culvert which conveys flows under Bovaird Drive (**Figure 4.4**). Immediately downstream of the Bovaird Drive culvert, a large scour pool has formed leaving the culvert invert perched creating a barrier for fish passage. Bed and bank scour, resulting from elevated flow velocities released from the culvert during high flows, have caused increases in channel width and depth immediately downstream of the culvert. Approximately 60m downstream of the Bovaird Drive culvert the remnants of a relic weir structure was observed (**Figure 4.4**). At this location, a sudden drop in elevation of approximately 1.2m was recorded with large pieces of concrete present creating a small cascadelike feature. This features impedes fish migration to upstream areas potentially reducing available habitat for fish species. Additional channel disturbances noted include, valley wall contacts which confine the channel and restrict lateral migration at various locations, and accumulations of large woody debris which were a common occurrence within the reach.

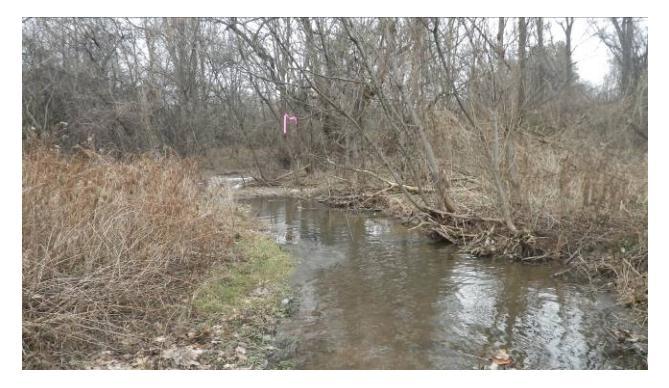
**XS 10:** View facing downstream. Note bank erosion along outside meander bend (left bank). Right bank has gradual slope.

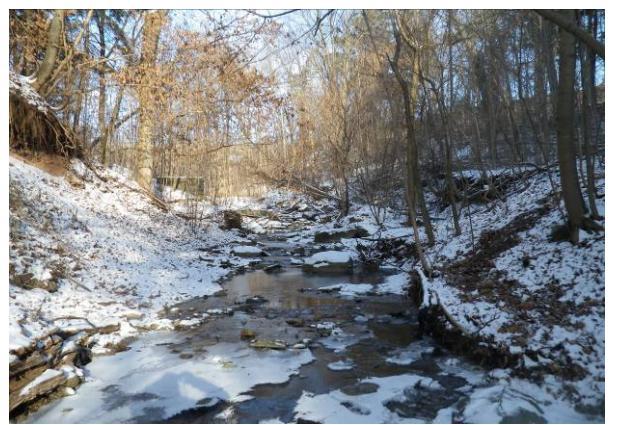
**XS 5:** View facing downstream. Channel slightly wider than downstream XS's. Scour along right bank resulting in leaning trees and exposure of roots.

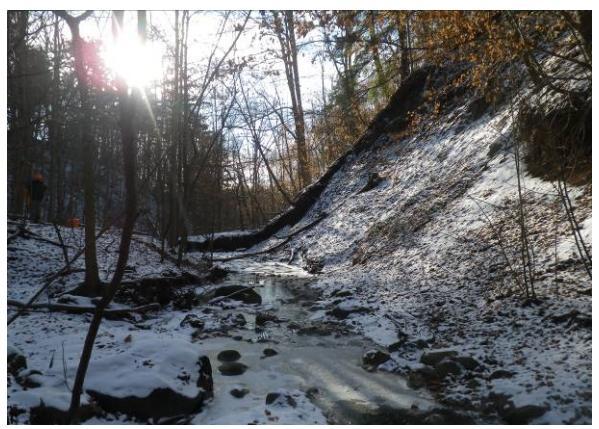
**XS 4:** View facing upstream. Exposed roots present along banks with overhanging vegetation observed on right bank (valley wall contact).

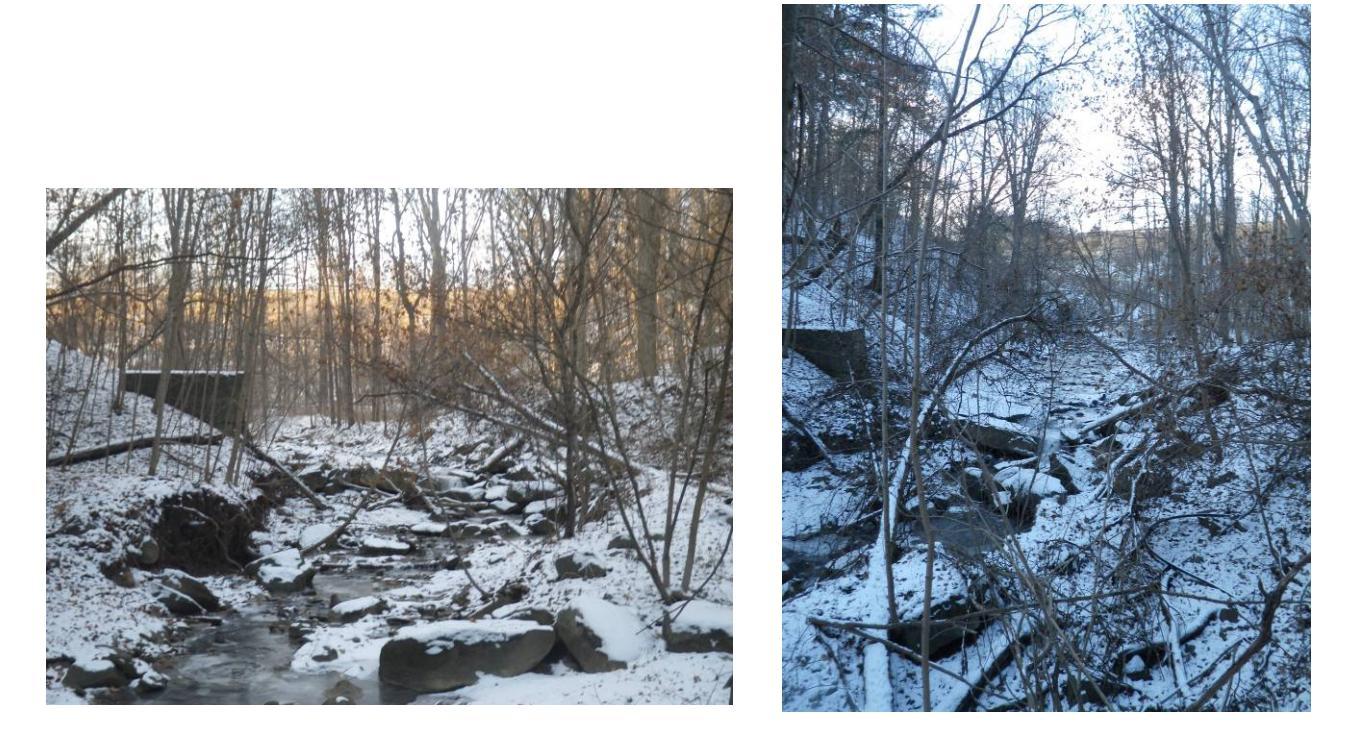
View facing upstream at the Bovaird Drive culvert outlet. It is evident that the culvert is undersized in relation to the existing watercourse. Scour along bed and banks of channel have resulted.
