**Geotechnical Investigation and Pavement
Assessment Report
For the Proposed Widening of Mayfield
Road Between Chinguacousy Road and**

December 2013

Prepared by:
GENIVAR Inc.
294 Rink Street, Suite 103
Peterborough, Ontario K9J 2K2

Project No. 101-17262-00

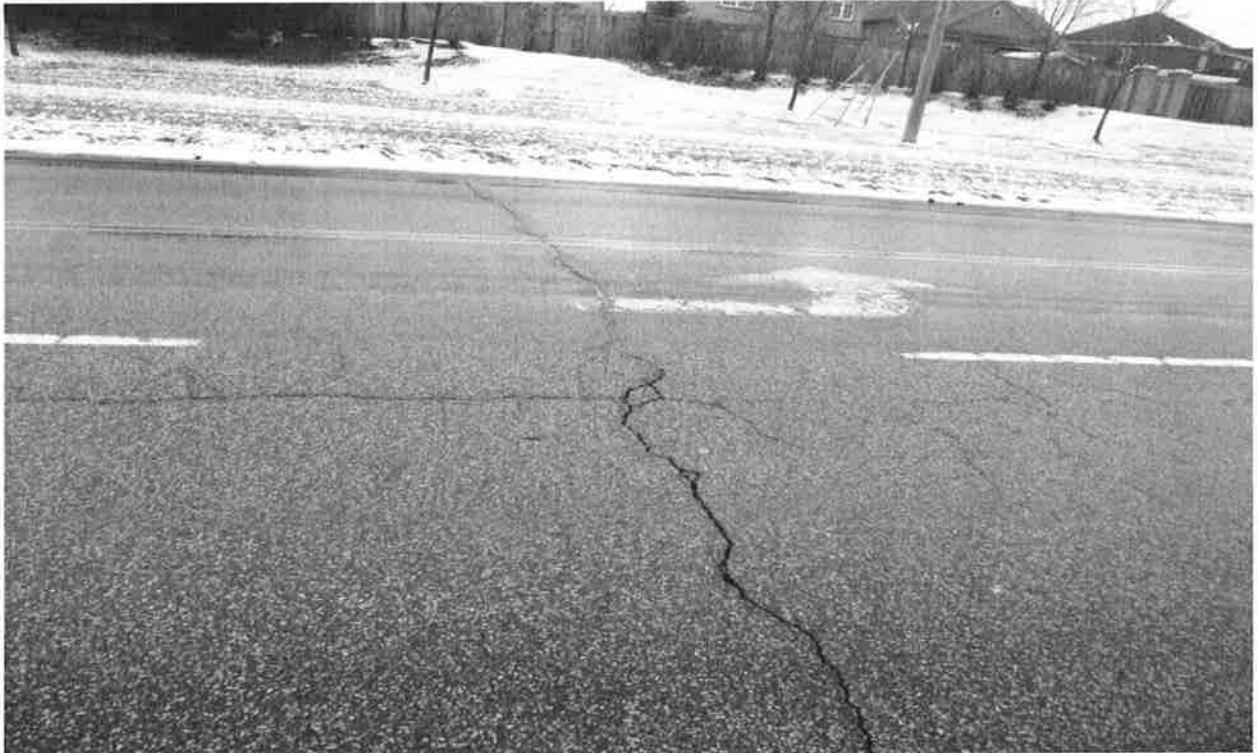
Mayfield Road\Section 2: Cracks on the Pavement

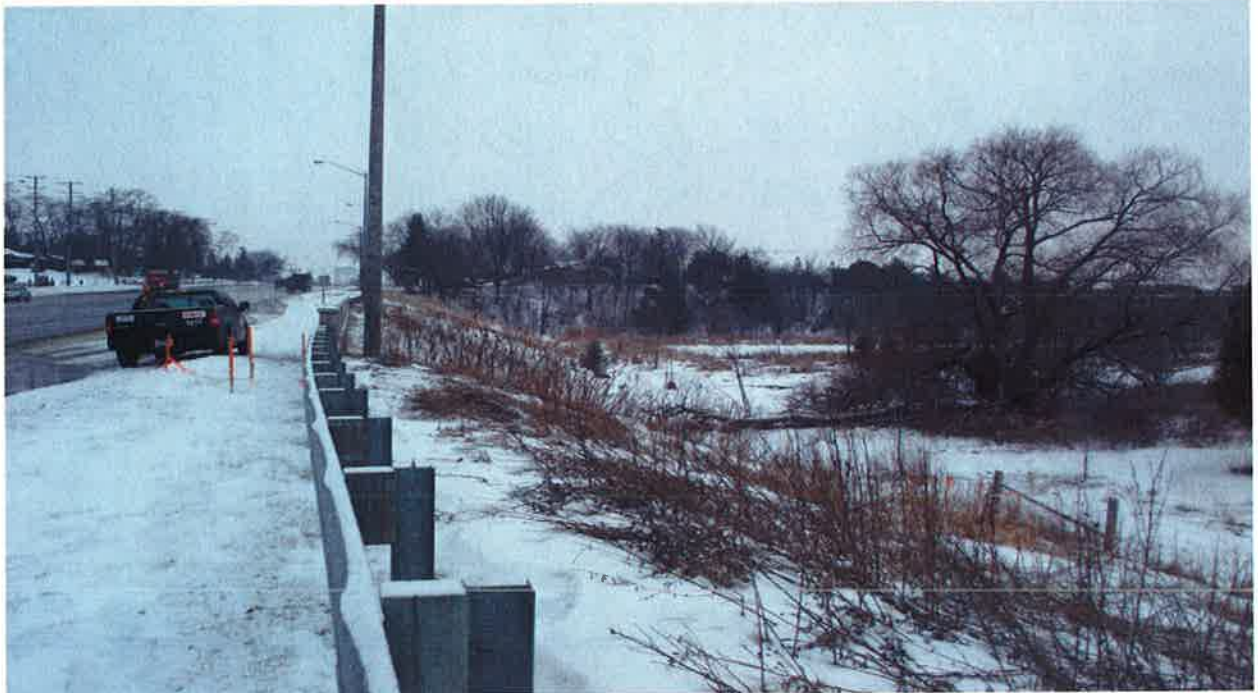
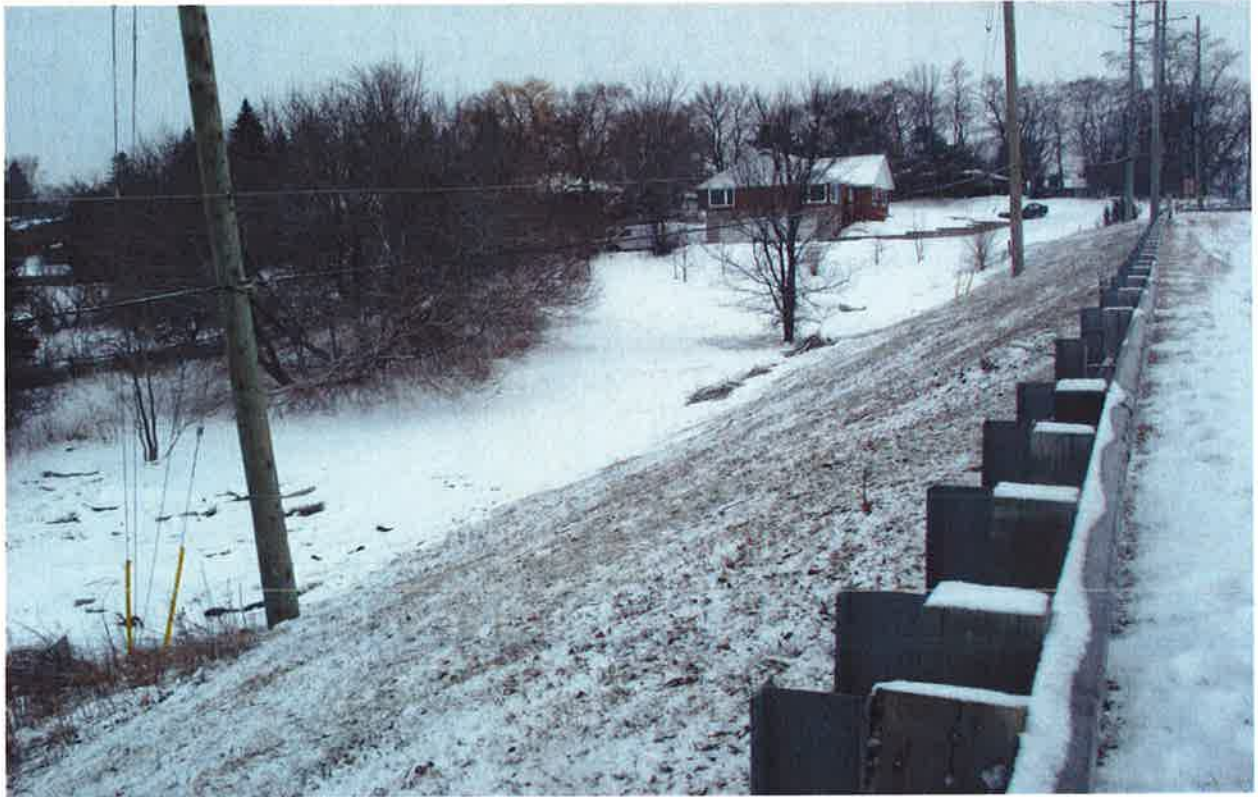
Mayfield Road\Section 3: 700 m West of Kennedy Road Looking towards West\Embankment Fill for Structural Bridge crossing Tributary

Mayfield Road\ Section 3: Looking towards West\Embankment Fill west of the Structural Bridge \ South side of Mayfield, West of the Bridge

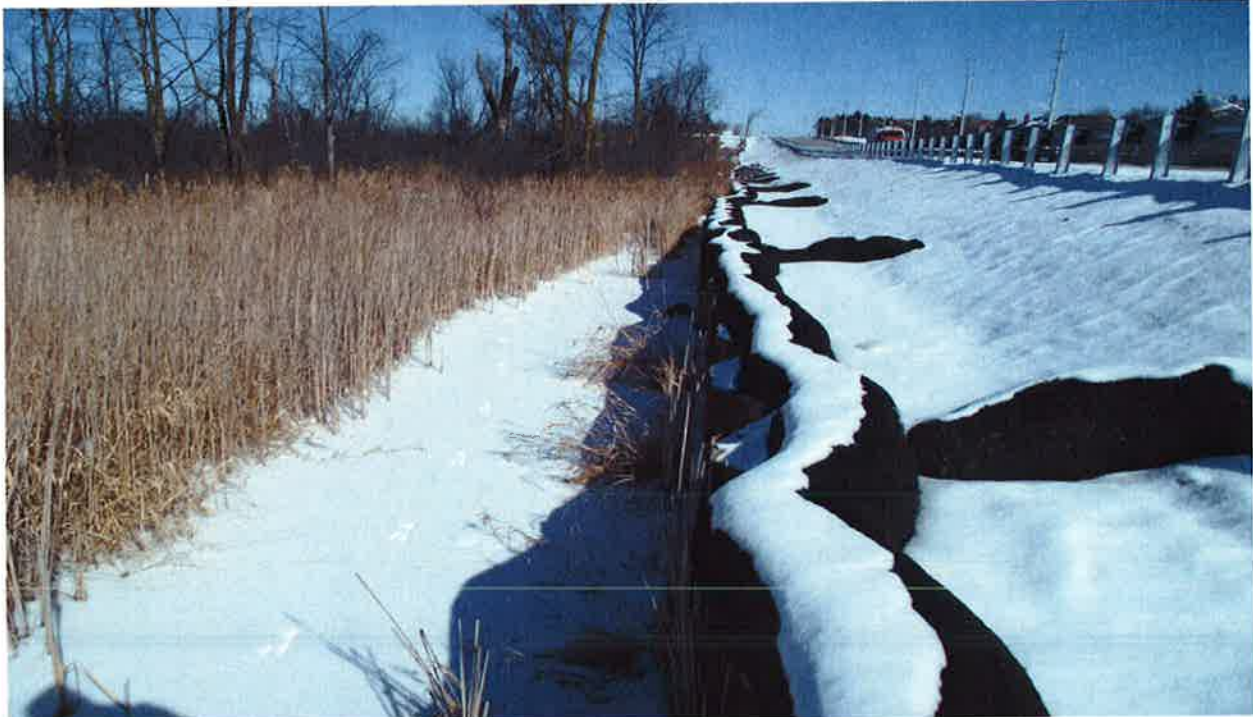
Mayfield Road\Section4: Looking towards East\Steel Sheet Piles at the North Side of Mayfield Rd. as Retaining walls for the road Embankment (Approx. 400 m long)

The loose and compressible peat soils were encountered to significant depth in this area and, therefore, the Mayfield Road crossing of the wetland area was constructed by replacing the peat with 0.4 MPa concrete filler caissons 2.5 m to 12.5 m deep. The north side of the road embankment was shored using sheet piles, steel piles and anchor tiebacks.

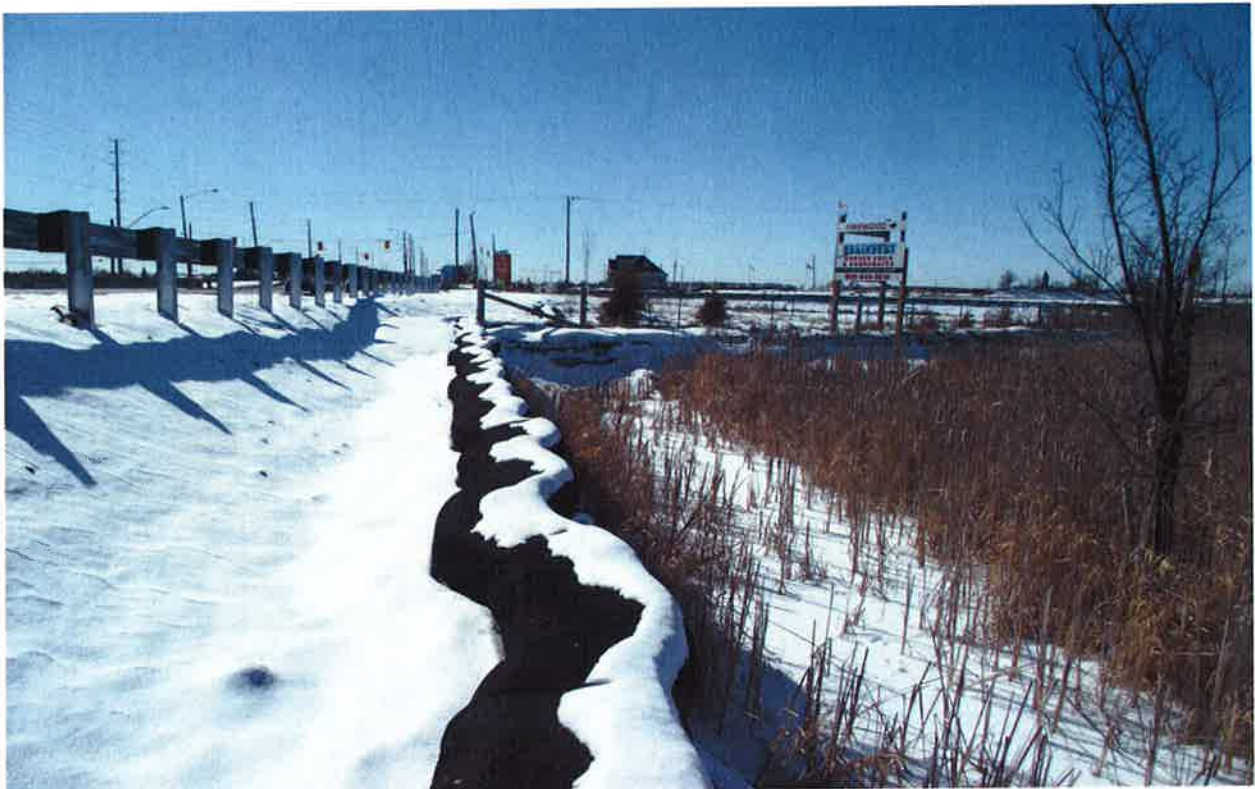
Mayfield Road\Section4: Looking towards West\Steel Sheet Piles at the North Side of Mayfield Rd and Wetland Area to the North OF Mayfield Rd and East of Kennedy Rd.

The widening of Mayfield Road crossing wetland area 1 located north side of Mayfield Road and just east of Kennedy Road where peat deposits, loose and compressible soils were encountered to significant depth in this area. At the preliminary design stage, several options could be considered for the road crossing wetland area 1 as follows:

- Replace the peat deposit and the underlying loose and compressible soils with 0.4 MPa filler caissons to various depths depending on the thickness of the peat and compressible soil layer within the footprint of the road widening. In addition, shoring should be provided along the north edge of the new embankment using sheet piles and supported by H- piles and anchor tiebacks. It is our opinion that this option is the most recommended option since the existing road was constructed over concrete caissons and therefore will form an integrated foundation for the road that should reduce differential settlement potential.

- Excavate only the peat deposit and replace it with newly constructed embankment using rock fill. The embankment should be placed (prior to the placement of the pavement structure) for a minimum six months to one year (depending on the soil compressibility of the clayey silt to silt some clay layer that lies beneath the peat layer) to accelerate consolidation of compressible soils beneath the widening. Several consolidation tests should be performed during the detailed investigation to determine the compressibility behaviour of the soils.

- Excavate the peat deposit and the underlying loose and compressible soil to the full depth using shoring techniques consisting of sheet piles supported by H- piles and anchor tiebacks. The new sheet piles should be installed at the northerly edge of the proposed new road embankment, and then excavation and removal of the peat and any compressible soils should be conducted between the new sheet piles, from the north and the existing sheet piles to the south. The newly constructed sheet pile wall will be permanent to support the newly constructed embankment.

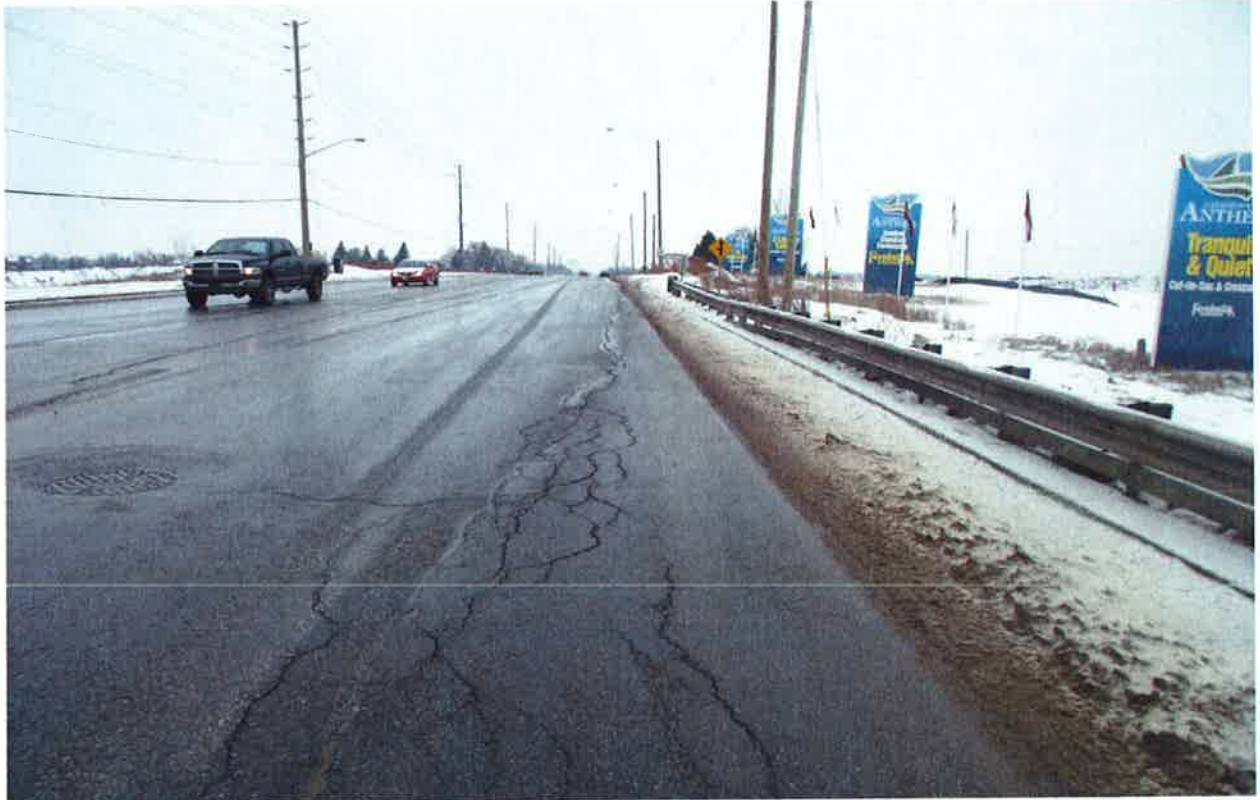
Mayfield Road\Section4: Looking towards West \ from Kennedy Road to 150 m Westerly\see cracks and distortion area\ new Subdivision will be constructed at the Northside of Mayfield Rd., West of Kennedy Rd.

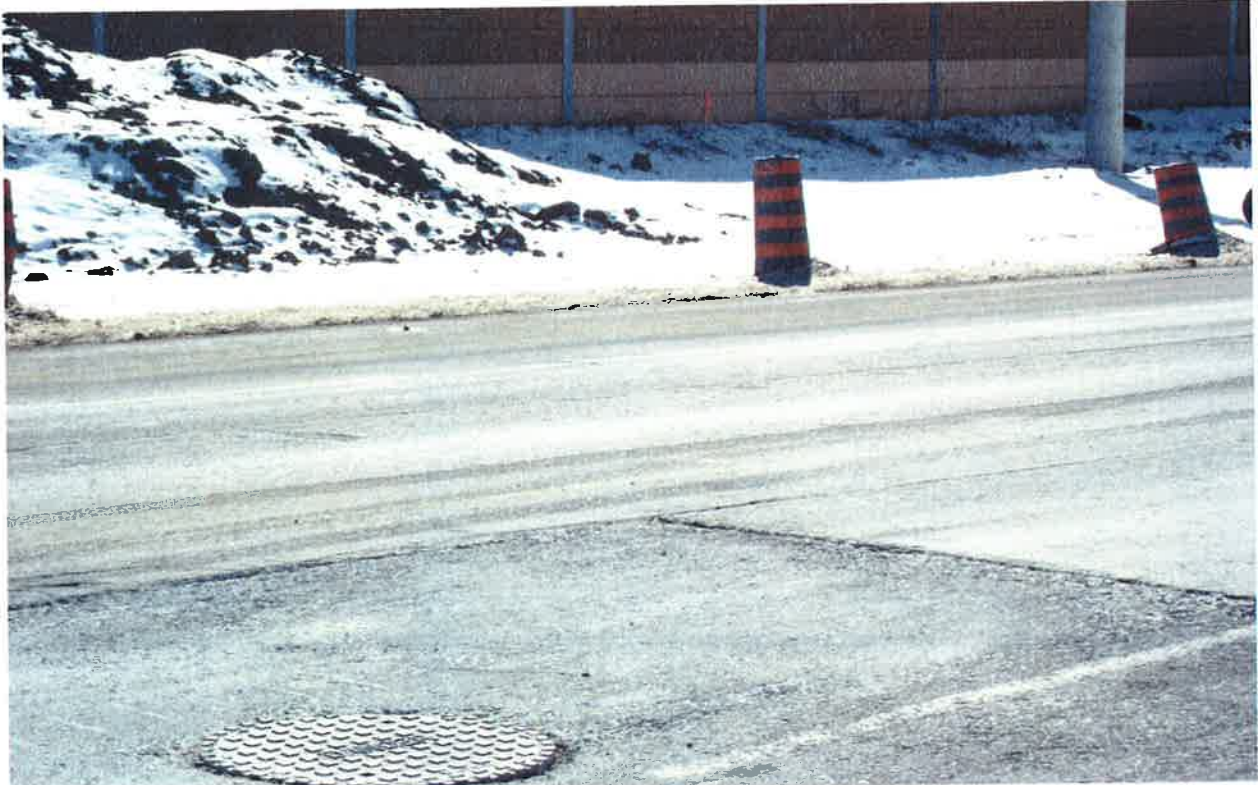
Mayfield Road\Section4\ Maintenance Treatment

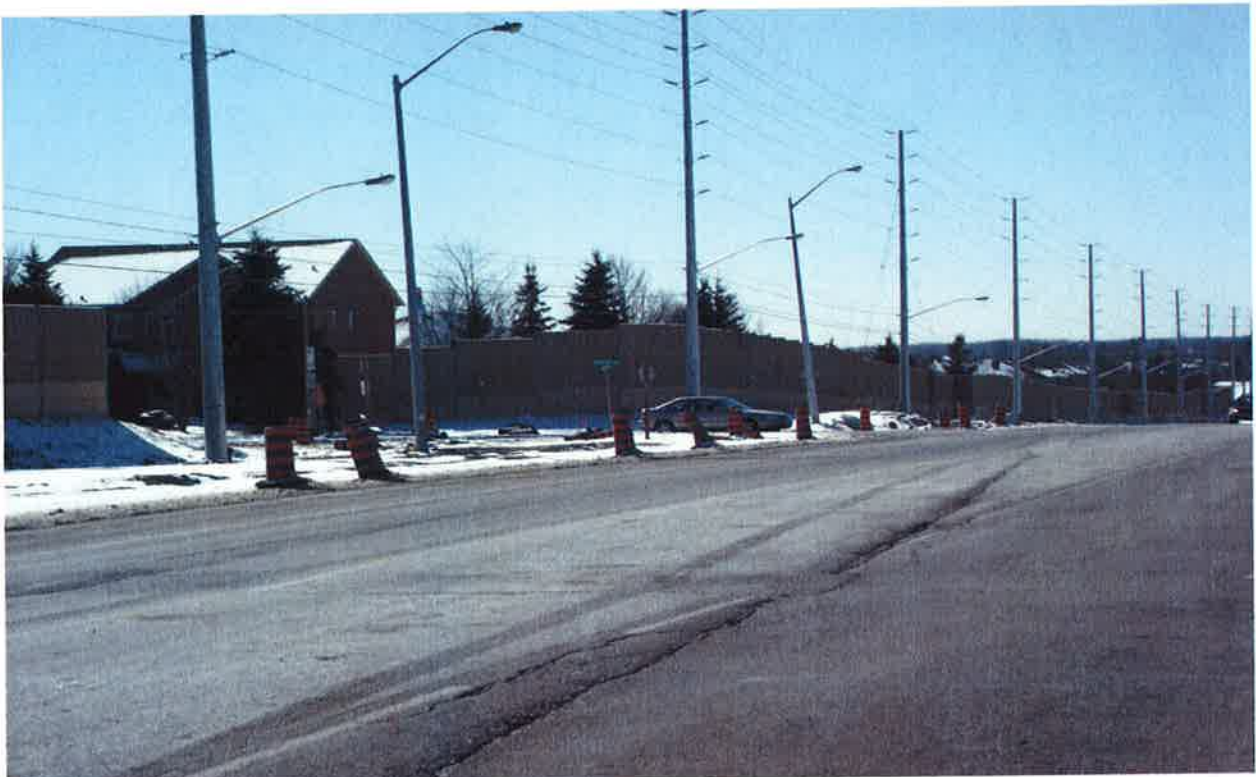
Mayfield Road\Section4: Looking towards West\cracks and Distortion Area \See Noise Wall along the South Side of Mayfield Road

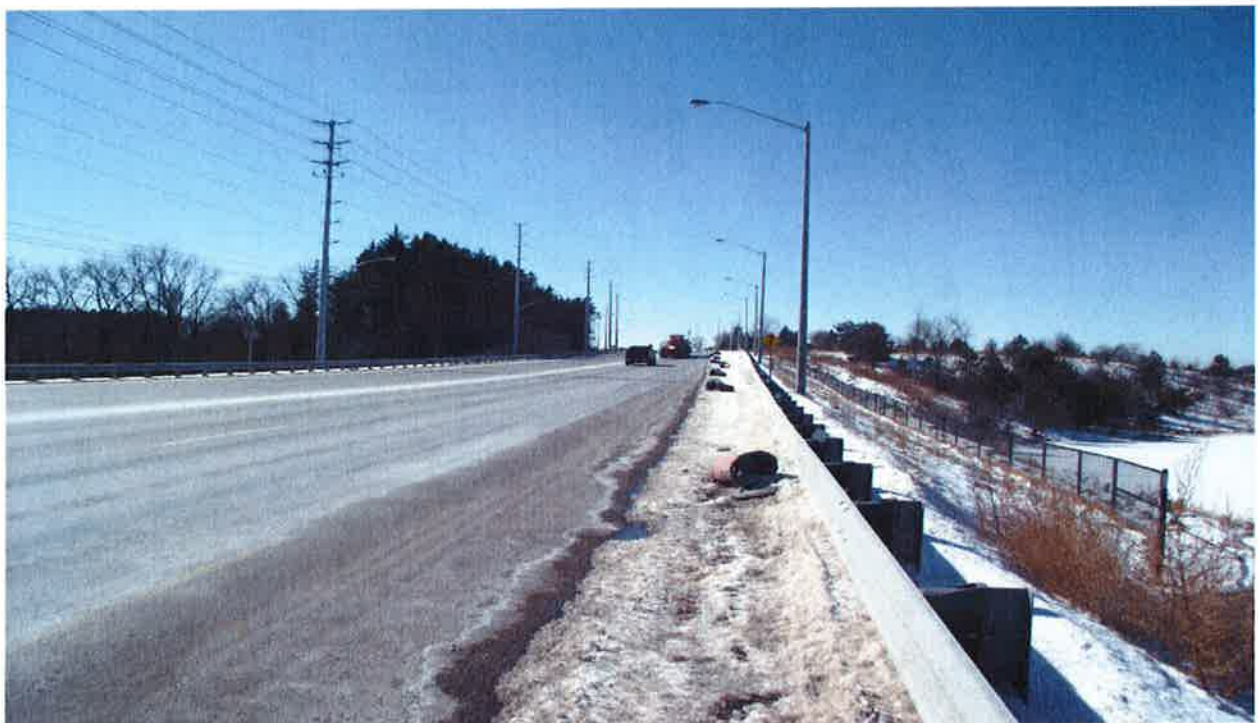
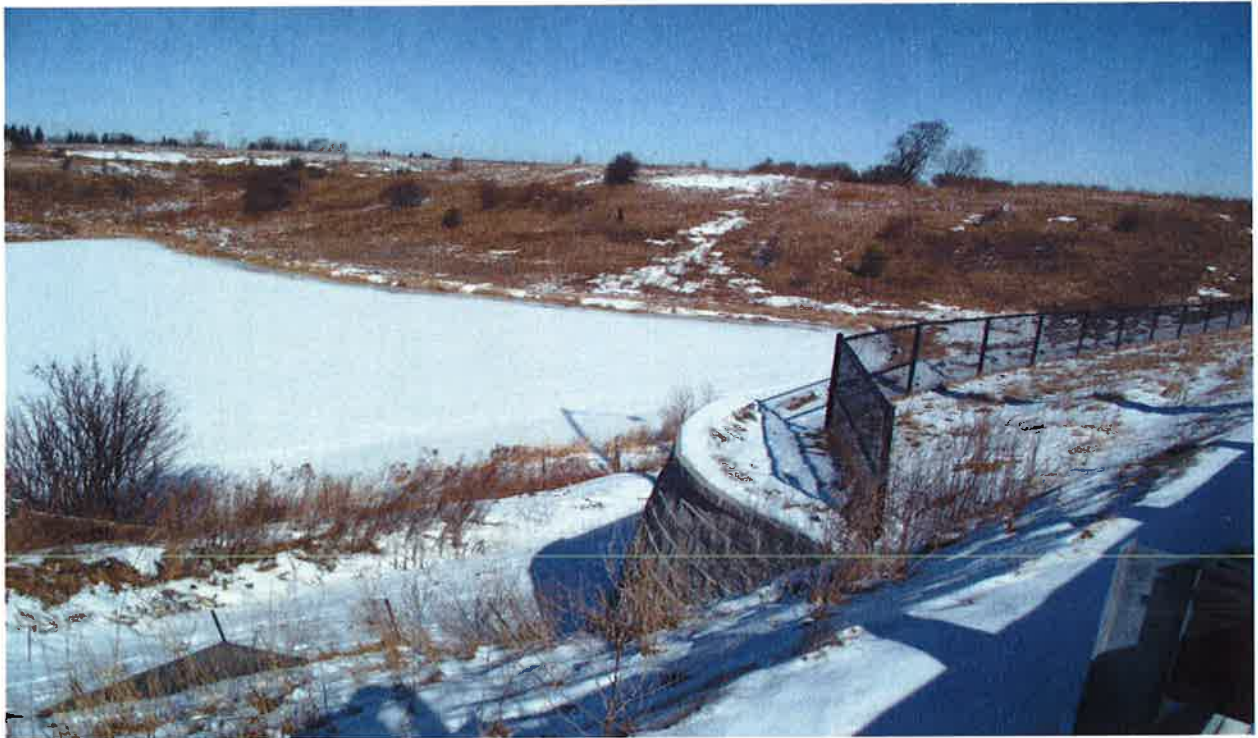
Mayfield Road\Section 5: Looking Towards West\Wetland Area at the North side of Mayfield Rd. , about 400 m West of Heart Lake Rd.

Mayfield Road\Section 5: Wetland Area at the North side of Mayfield Rd.

It should be noted that a high fill road embankment, about 400 m west of Heart Lake Road, will need further borehole investigation both on the north and south side of Mayfield Road, to assess the geotechnical capabilities and settlement characterization of the soil beneath the proposed high embankment.

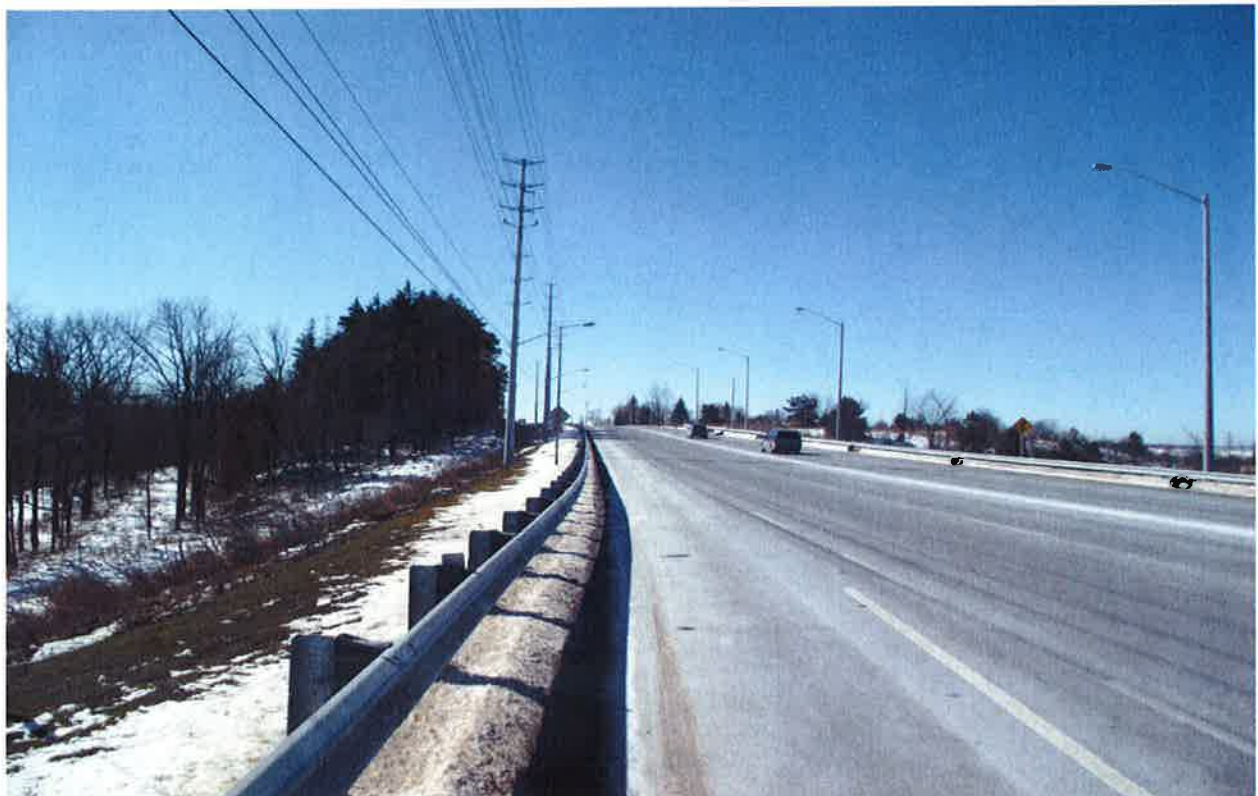
Mayfield Road\Section 5: Looking towards West\South side of Mayfield Rd., High Fill Embankment
