## Mississauga Road, Old Main Street, Bush Street, Olde Base Line Road, and Winston Churchill Boulevard Class EA

### Community Working Group Meeting

Wednesday, October 16, 2013

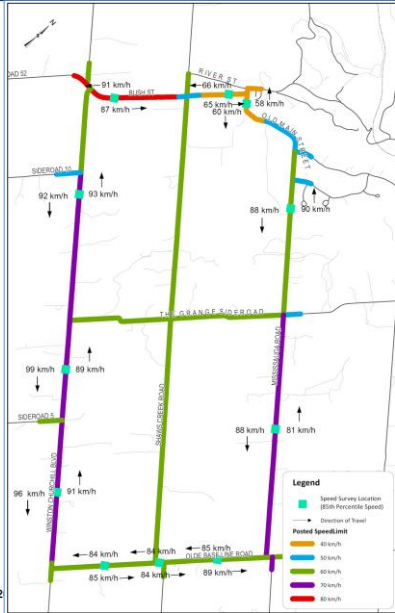
# 6 Traffic Speeds

Speed surveys indicate that traffic generally travels at higher speeds than the posted speed limits.

Road segments where the 85<sup>th</sup> percentile speeds are more than 20 km/h over the posted speed limits include:

- Olde Base Line Road
- Mississauga Road between The Grange Sideroad and Woodlands Court
- Winston Churchill Boulevard
- Bush Street in the Village of Belfountain

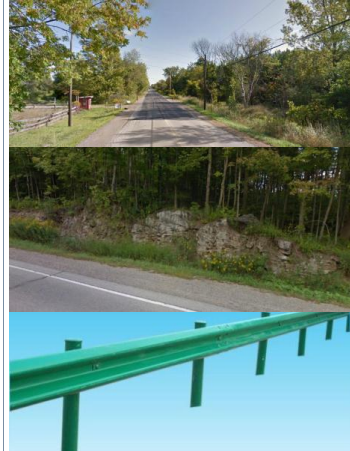
# 8 Roadside Hazards

Roadside hazards include hydro poles, steep slopes, and rock cuts. The Study will consider options to improve safety at roadside hazard locations.

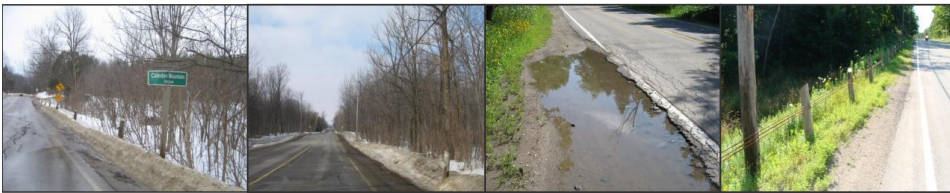
## 12 Pavement and Drainage Conditions

- The preliminary findings from the geotechnical investigations completed to date reveal that structural capacity and strength of all roads are in poor condition and are expected to continuously deteriorate.
- The main cause to pavement distress is attributed to variable granular thickness along roadways with a non-uniform base and sub-base materials.
- Shoulder granular is also thinner than the sub-base below the roadway which affects the drainage of the base leading to frost heave and rutting.
- Some of the pavement deficiencies identified throughout the study area include:
  - Wheel tracking and rutting
  - Transverse and longitudinal meander and mid-lane cracking
  - Alligator pavement edge cracking

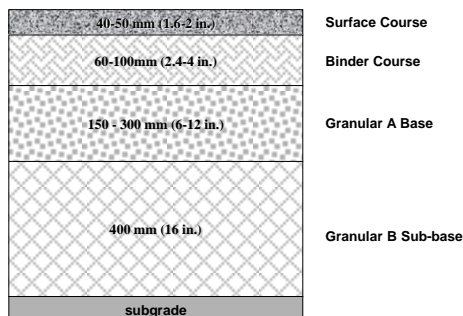
# 15 Recommended Pavement Structures

Geotechnical Investigations completed to date have recommended the following typical pavement structure to address the deficient pavement conditions:

\* Note: The pavement recommendations will be confirmed in the subsequent phases of this study.  
 Pavement structure granular materials must conform to OPSS (Ontario Provincial Standard Specification) specifications.

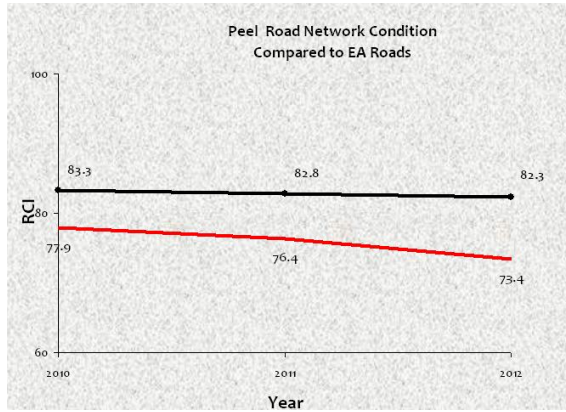
## Ride Condition Index (RCI)

- The Ride Condition Index (RCI) is a quantitative number that represents the overall condition and quality of a Regional road network.
- The RCI aggregates the rating of many types of road defects including cracking, rutting, potholes and surface quality into one measurable number.
- Study area roads are below the network average and are deteriorating faster than the network average and will likely be below the level of service (72) for roads in the next 3- 5 years.

- Black line represents projected network RCI for all Regional Roads.
- Red line represents projected RCI for the roads in the study area.

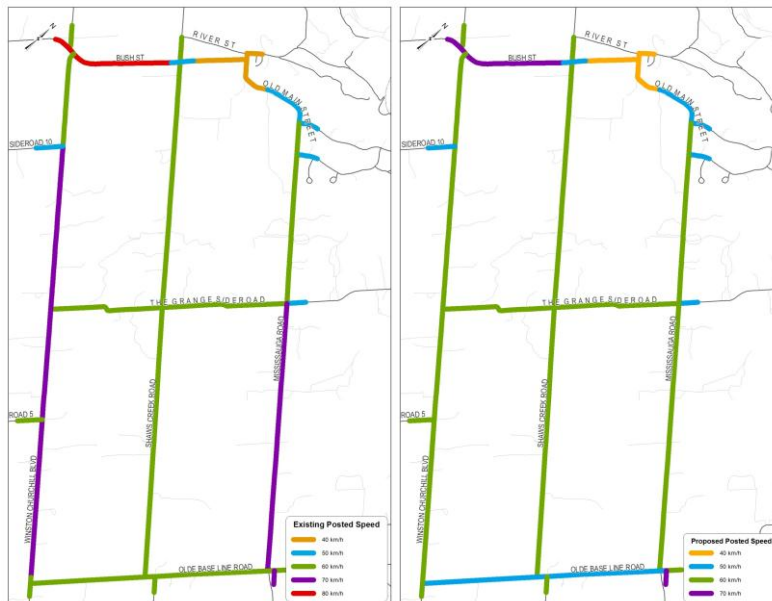
## Existing and Proposed Posted Speeds

In general, a reduction in posted speeds throughout the study area is proposed.

This will address deficient stopping sight distance and driveway sightlines, while minimizing changes to the existing profiles
