**Phase I
Environmental Site Assessment
Part Lot 27, Concession 1 E.H.S. (Chinguacousy)
Property Number 0021 on Block 14297
Caledon, Ontario**

Prepared for:

Region of Peel
10 Peel Centre Drive, Suite A and B
Brampton, Ontario
L6T 4B9

BRGE00306669B
December 18, 2009

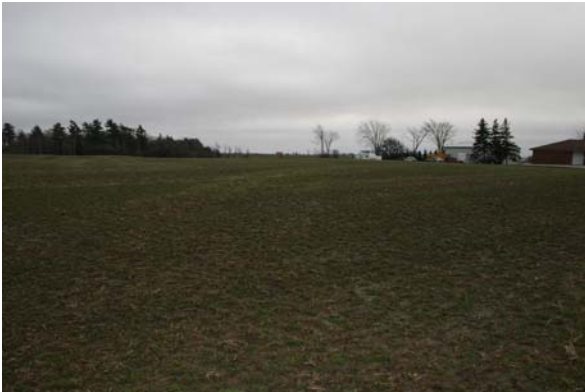
Photograph No. 1
View of northwest portion of Site.

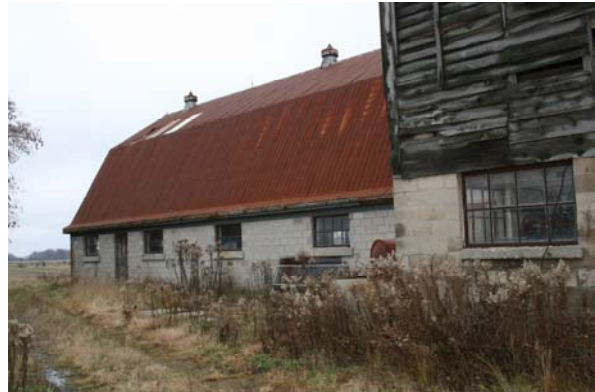
A two-storey wooden barn structure (Building B) was located adjacent to Building A. The ground level of Building B was primarily used for storage of various farming accessories (i.e. wooden crates, tools). The second level was observed to be primarily empty with the exception of hay and some tools. A greenhouse area was located on the north side of the barn structure. Through cursory observations, Building B was likely used for the penning of farm animals. Concrete troughs were observed traversing Building B and were likely previously

Photograph No. 2
View of Building B on Site.

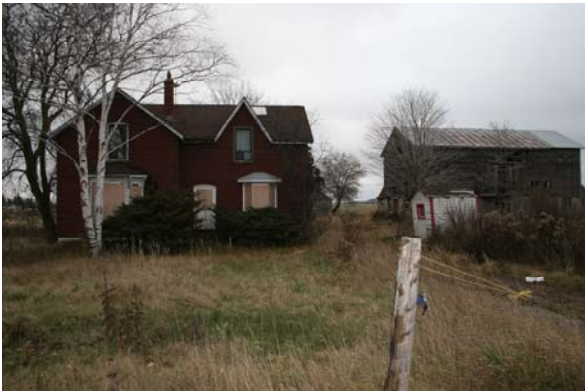
A vacant residential dwelling (3427 King Street) was observed on the south side of King Street and was constructed prior to 1960 (Building A). The dwelling is a two storey, wood-framed structure with one (1) partial basement level and a sloping shingled roof. A crawl space was observed in the areas adjacent to the basement level. The basement was primarily used for storage and the oil-fired furnace and aboveground storage tank for fuel oil.

Photograph No. 3
Building A and B on Site.

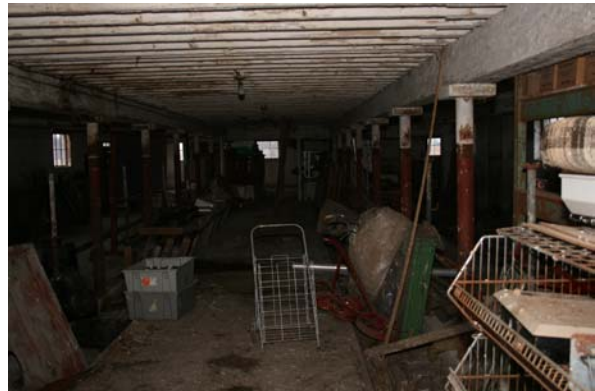
used for wash troughs for animal feces. No significant staining was observed in this section of the building.

Photograph No. 4
Main level in Building B.

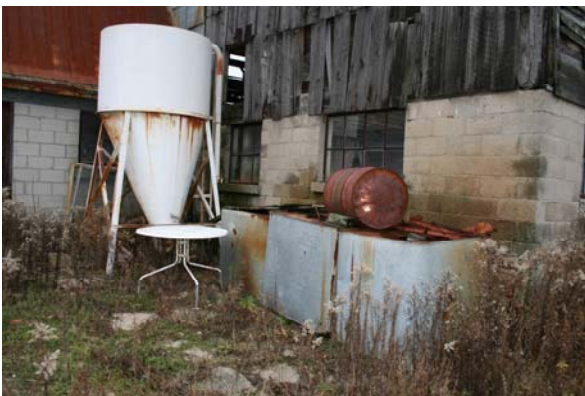
Three (3) empty metal containers were located on the east side of Building B. No signs of spills or leaks (i.e. staining or stressed vegetation) around the containers were observed during the site visit.

Photograph No. 5
Empty containers on east side of Building B.

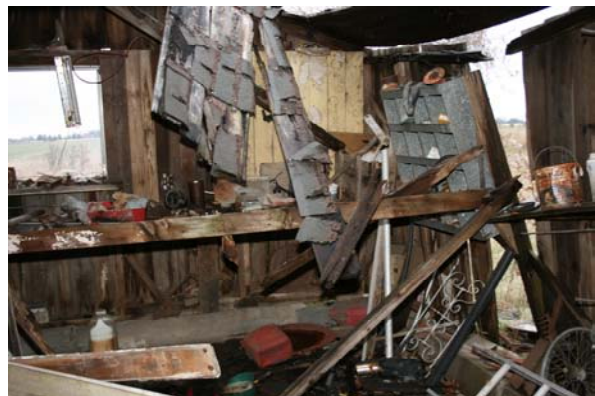
Photograph No. 6
View of damaged Building C. Building used for general storage.

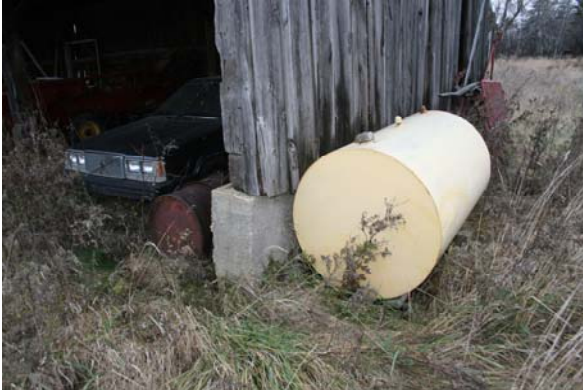
Another AST was observed adjacent to Building D on the south side of the structure. No signs of spills or leaks (i.e. staining or stressed vegetation) around the AST were observed during the site visit. Drums storing waste oil were observed within Building D. Oil staining on the ground surface in the immediate vicinity of the oil drums was observed.

Photograph No. 7
AST on southeast side of Building D.

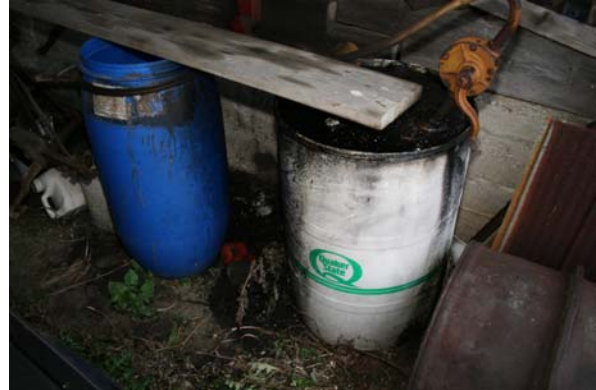
Building D is a wooden garage-style structure. At the time of the site visit, the structure was being used for general storage (car, oil drums, etc.). Minor ground staining was observed in the vicinity of the waste oil drums on the south side of the structure. The ground surface of Building D was a concrete slab on the southern half and bare earth on the northern half.

Surficial staining (oil) was observed on the ground surface in the southeast portion of Building D in the vicinity of waste oil storage (drums).

Photograph No. 8
Waste oil storage in Building D. Minor ground staining around drums.

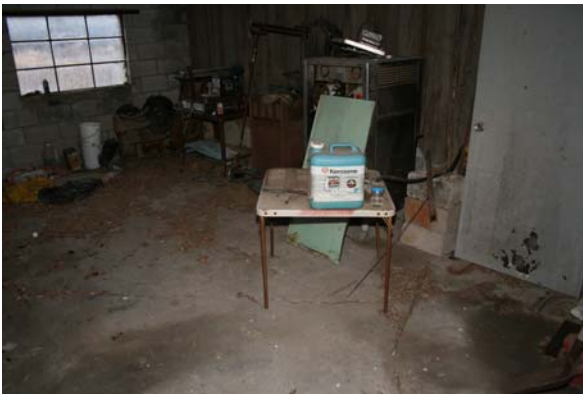
Photograph No. 9
Inside northwest portion of Building D.

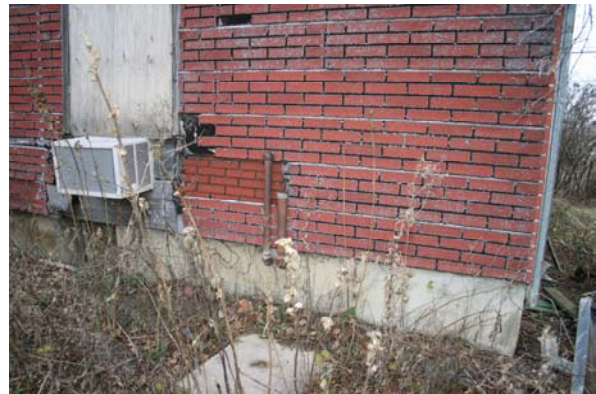
Building A is cooled by an individual air-conditioning unit that may contain R-22 as a refrigerant. A household refrigerator was also present in the residential dwelling.

The residential dwelling (Building A) was previously heated by a fuel oil-fired furnace. However, at the time of the site visit, the furnace was not in operation. An individual air-conditioning unit was located on the southeast corner of the house.

Photograph No. 10
Air-conditioning unit and fill and vent pipes on southeast side of Building A.

Under the management of a licensed contractor, the subject systems do not represent a significant threat to human health or the environment. However, any ODS will require replacement by 2010 and as such consideration should be given to future phase out programs.

Maintenance of refrigerant containing equipment, if any, should continue to be completed by a licensed refrigeration contractor. The equipment should only be repaired, removed, or serviced by an appropriately licensed contractor.

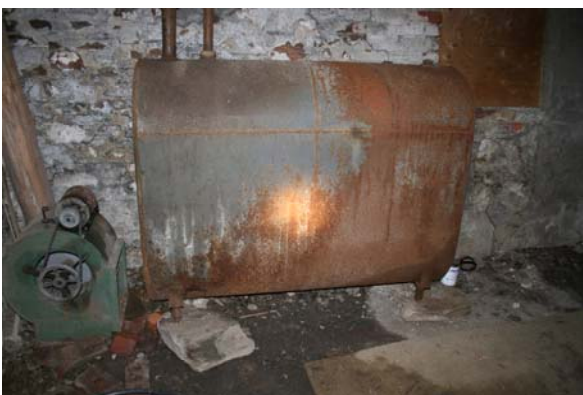
An aboveground storage tank (AST) was located in the basement of Building A on Site. The AST was previously used to store fuel oil for the furnace equipment. Minor staining in the vicinity of the AST was observed on the dirt ground surface. However, no hydrocarbon odour was noted in the basement. The associated fill and vent pipes were observed on the south exterior of the house.

Minor oil staining was also observed in the basement of Building A in the vicinity of the AST and oil-fired furnace. The ground surface below the AST was bare earth.

Photograph No. 11
AST in basement of Building A.

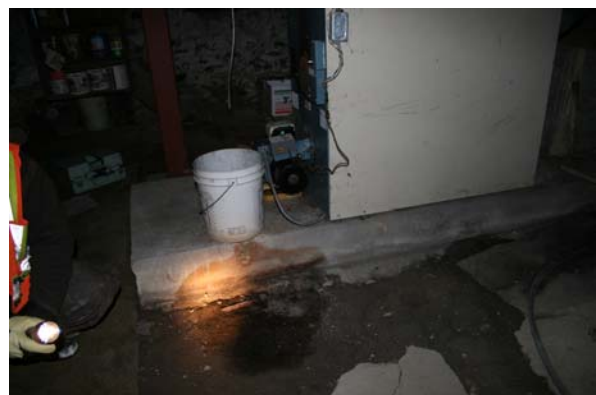
Photograph No. 12
Oil-fired furnace in basement of Building A.
