# McWilliam & Associates

**Project:** Mississauga Road Environmental Assessment Study  
From Financial Drive to Queen Street, Peel Region

## INTRODUCTION

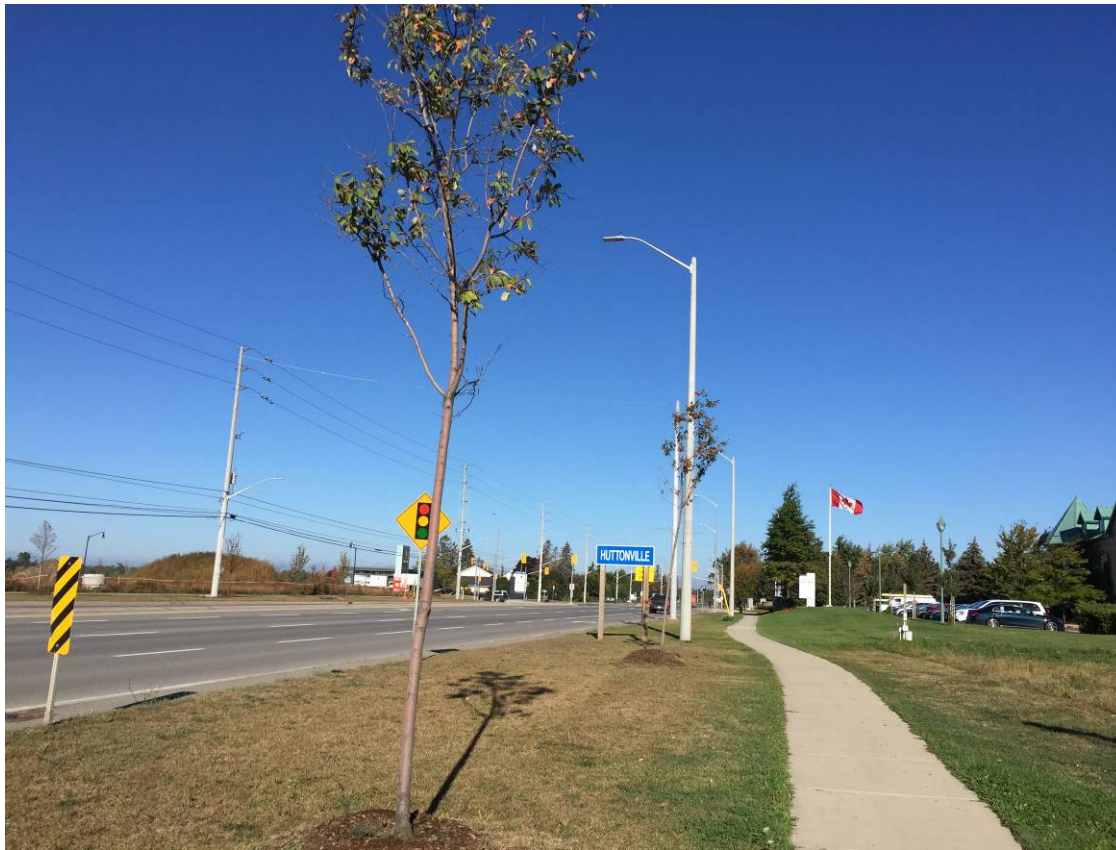
The only existing trees on this side of the roadway are a row of newly planted street trees, including Basswood (*tilia*), Honeylocust (*gleditsia*) and Maple (*acer*) species.

The dominant existing vegetation on this side of Mississauga Road are a row of mature and mostly health Silver Maple (*acer saccharinum*) trees located along the frontage of the existing residences located at the crest of the Credit River Valleylands. These trees are very significant landscape feature. In addition to these trees there are some recently planted street trees which include Servicberry (*amelanchier*) and Maple (*acer*) species.

**Photograph #1: View looking north along the east side of Mississauga Road, just north of Financial Boulevard showing recently planted street trees.**

The road improvements may require the removal of some of the young street trees along both sides of this section of Mississauga Road. It should be noted that the new road corridor has been shifted to the east to minimize impacts to the row of Silver Maple trees.

- Street trees are to be planted on 15 m. spacing along both sides of the roadway where space is available and existing street trees are either missing or dead.
- All efforts should be made to minimize impacts to the root zone of the row of mature Silver Maples.

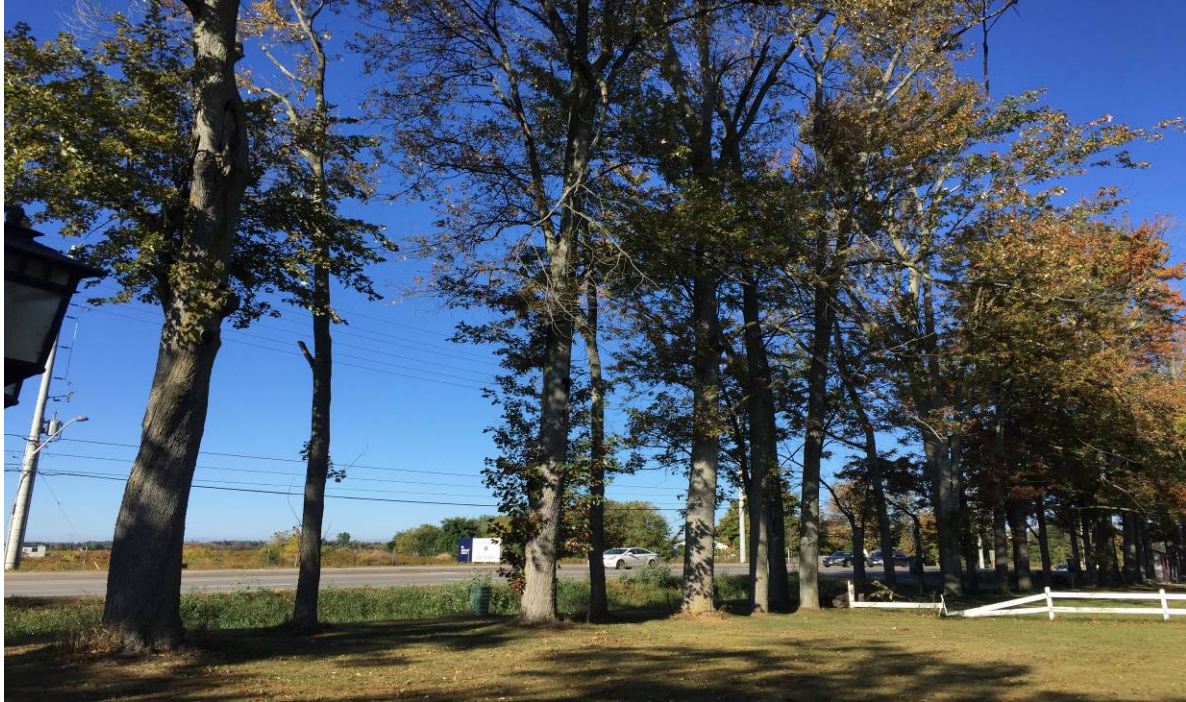
**Photograph #2: A view of the row of Silver Maple trees located along the east side of Mississauga Road.**

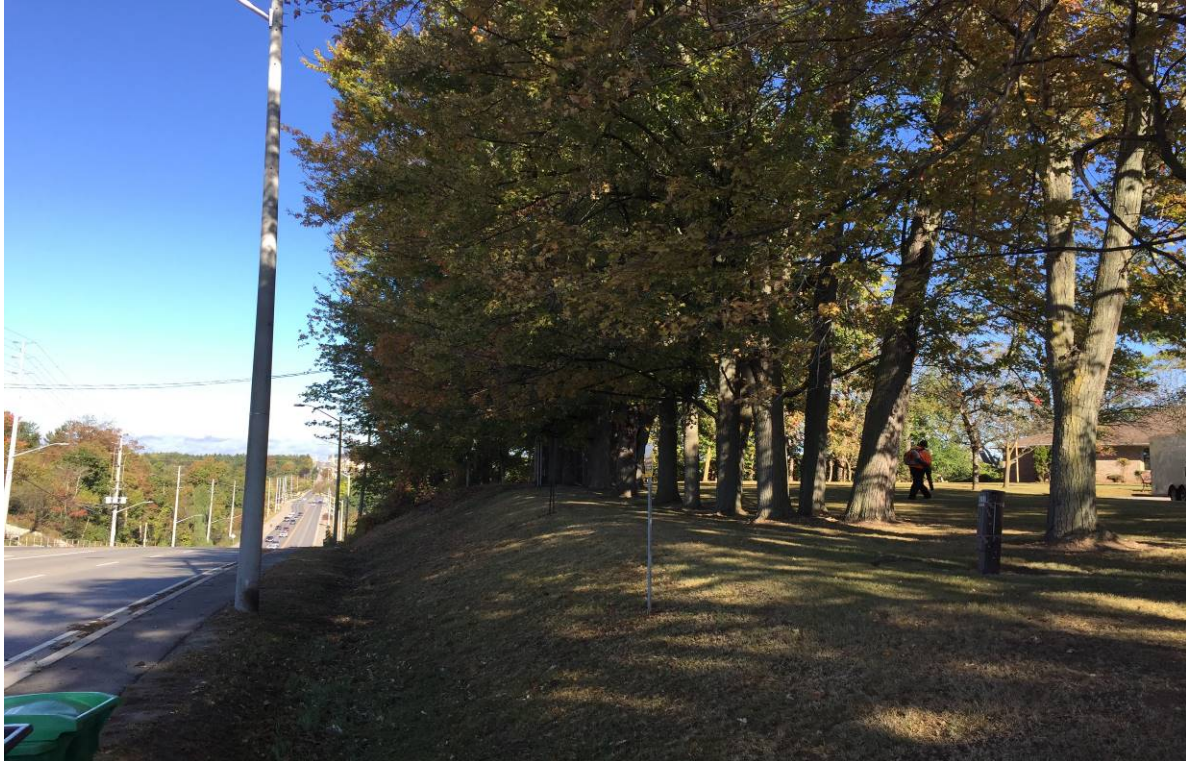
**Photograph #3: A view of the same row of mature Silver Maple trees along the east side of Mississauga Road.**

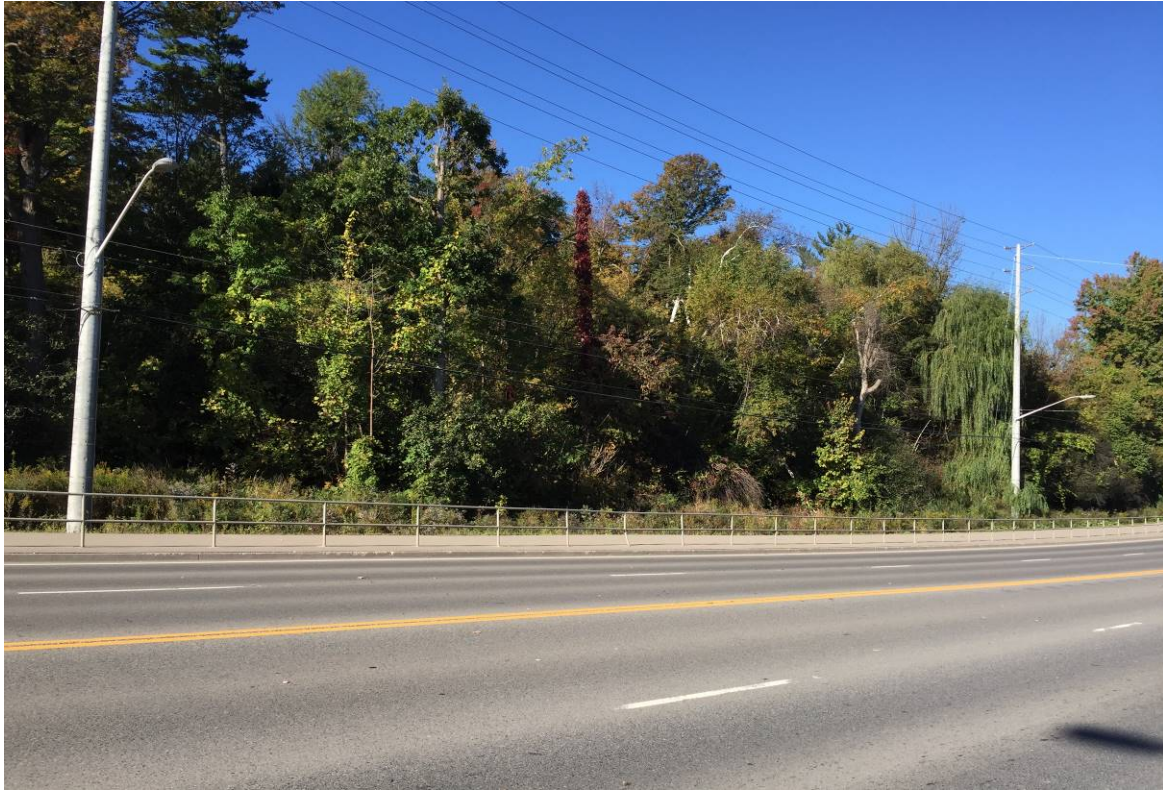
The wooded slope on this side of Mississauga Road is dominated by White Oak (*quercus alba*), White Pine (*pinus strobus*), Basswood (*tilia*), Birch (*betula*), Willow (*salix*), Sugar Maple (*acer saccharum*) and Cedar (*thuja*).

It is anticipated that the road improvements will have an impact to the existing wooded areas on both sides of the road corridor

**Photograph #4: A view looking north west showing the wooded slope on the west side of Mississauga Road.**

- Woodland edge restoration plantings
- Slope stabilization plantings

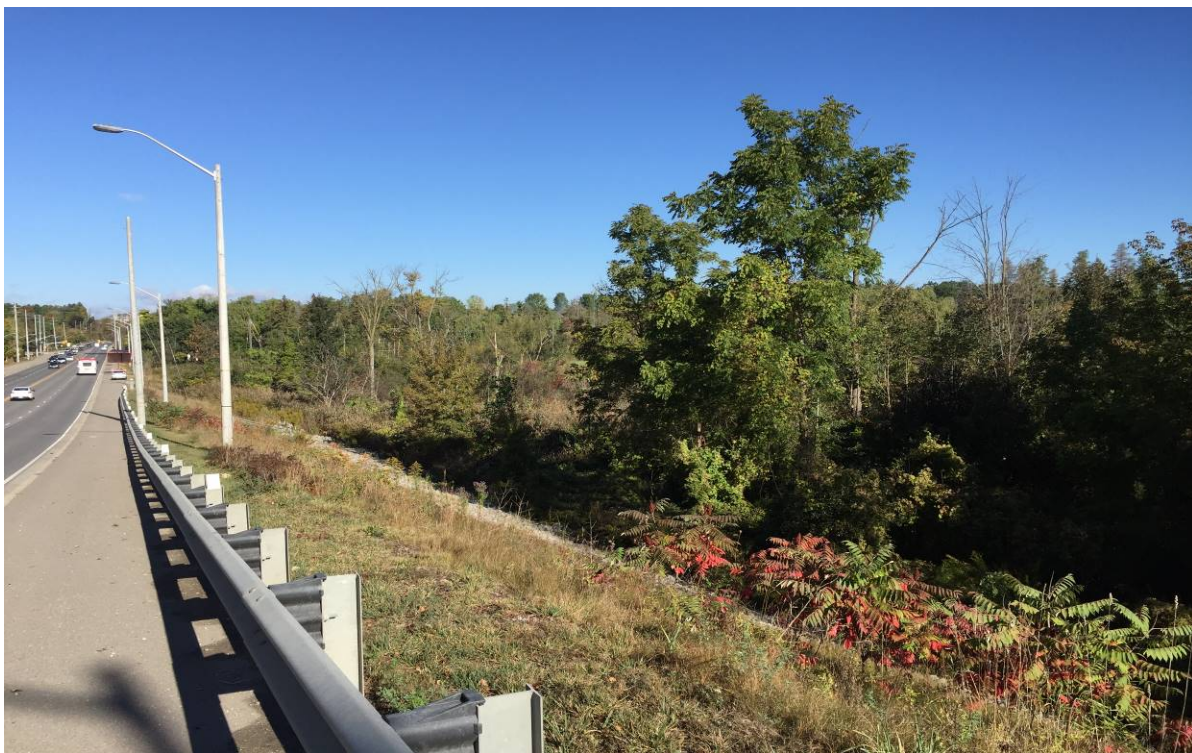
The wooded slope on this side of Mississauga Road is dominated by Ash (*fraxinus*), Walnut (*juglans*), Cedar (*thuja*) and Poplar (*populus*)

**Photograph #5: A view looking north along the east side of Mississauga Road showing the wooded area associated with the valley slope.**

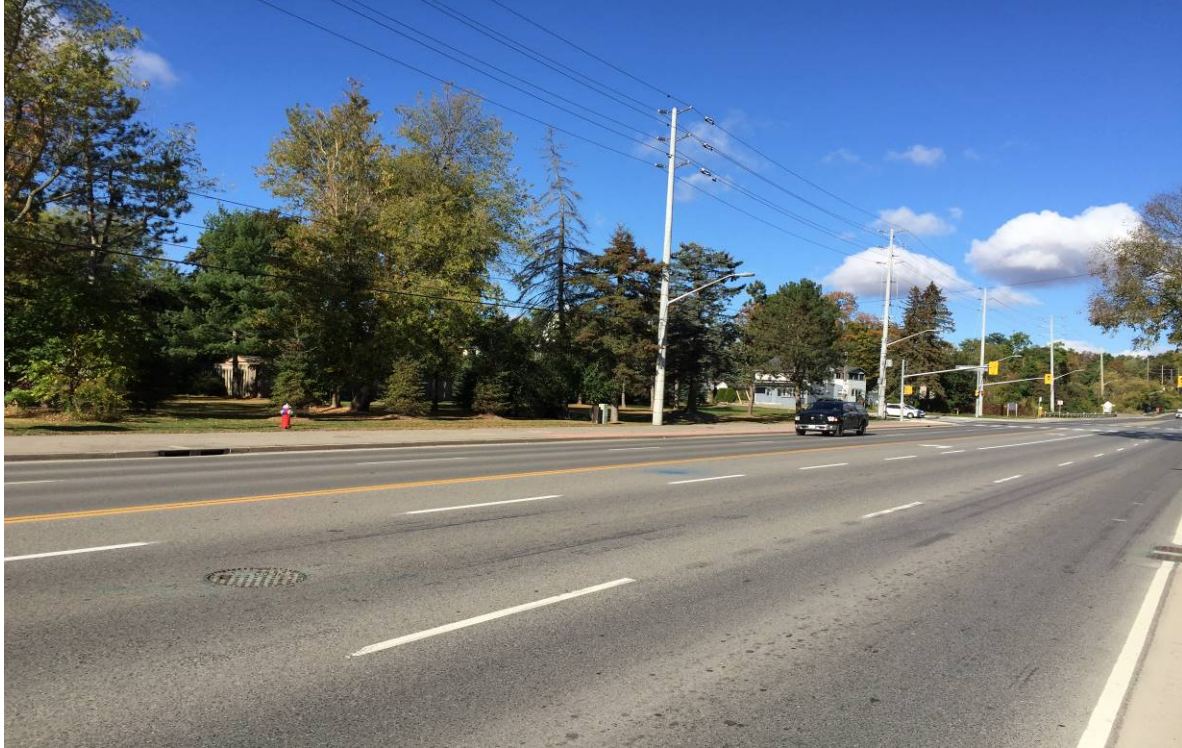
There are a few scattered mature trees located along the road corridor, south of Embleton Road, including mature Silver Maples (*acer saccharinum*), Manitoba Maples (*acer negundo*) and Spruce (*picea*). North of Embleton Road the Credit River bank is heavily wooded with Black Locust (*robinia*), Manitoba Maple (*acer negundo*), Ash (*fraxinus*), Willow (*salix*) and Sumac (*rhus typhina*).

Many of these existing trees and wooded areas will be impacted by the roadway improvements.

**Photograph #6: A view looking north-west, showing the scattered mature vegetation along the west side of Mississauga Road, south of Embleton Road.**

- Tree/shrubs are to be planted where required to replace trees/landscaped areas removed/disturbed due to construction activities.
- Street trees are to be planted on 15 m. spacing along both sides of the roadway
- Woodland edge restoration plantings
- Slope stabilization plantings

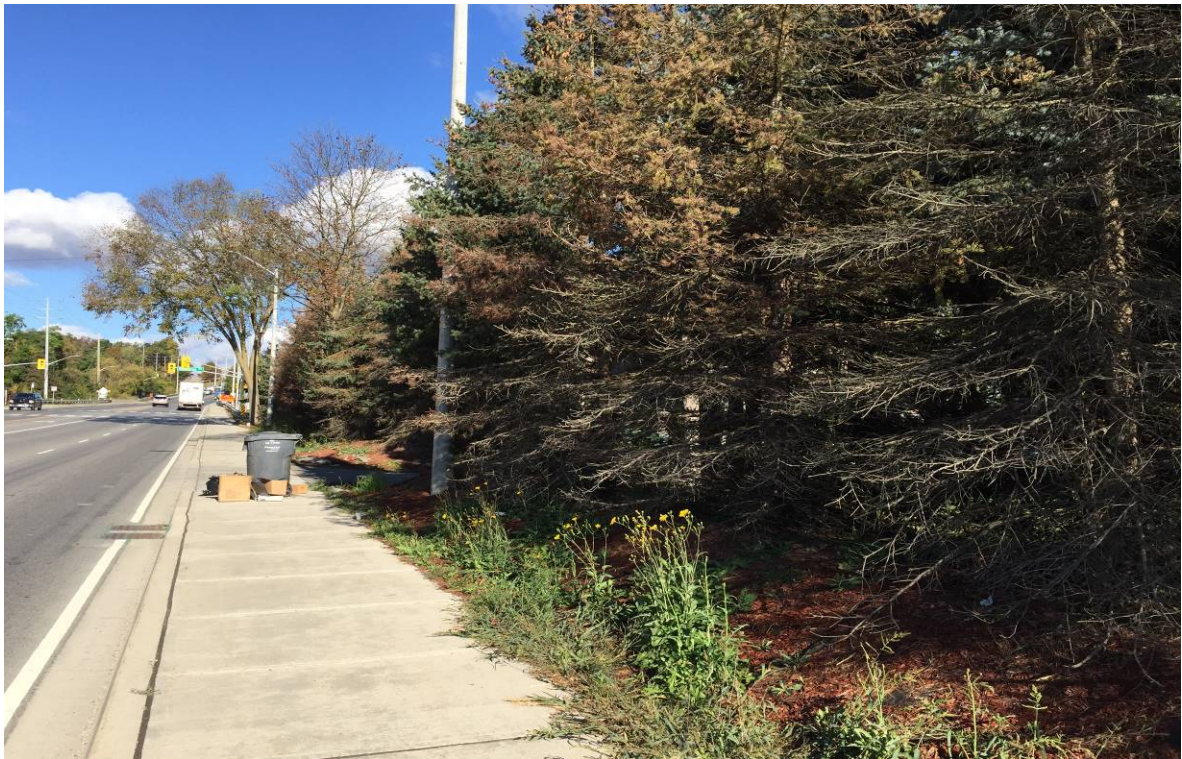
There are some densely planted Blue Spruce (*picea glauca*), functioning as a visual buffer between Mississauga Road and two adjacent residences. In addition to these trees there are some scattered Maple (*acer*) and Elm (*ulmus*) trees along the road corridor. The river bank area is populated with a variety of Sumac (*rhus typhina*), Alder (*alnus*), and Buckthorn (*rhamnus*).

**Photograph #7: A view looking north down the east side of Mississauga Road, showing the row of Spruce trees along the residential frontage**

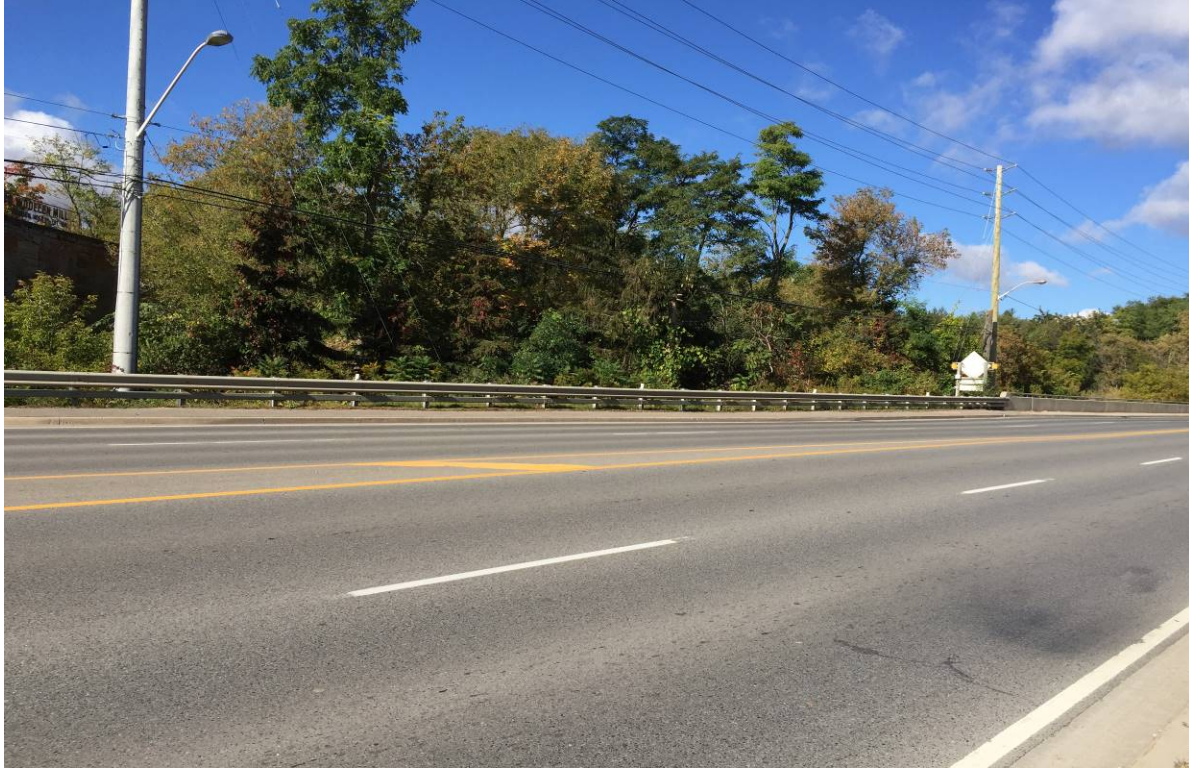
**Photograph #8: A view looking north-west, along the west side of Mississauga Road, of the wooded area located on the south bank of the Credit River.**

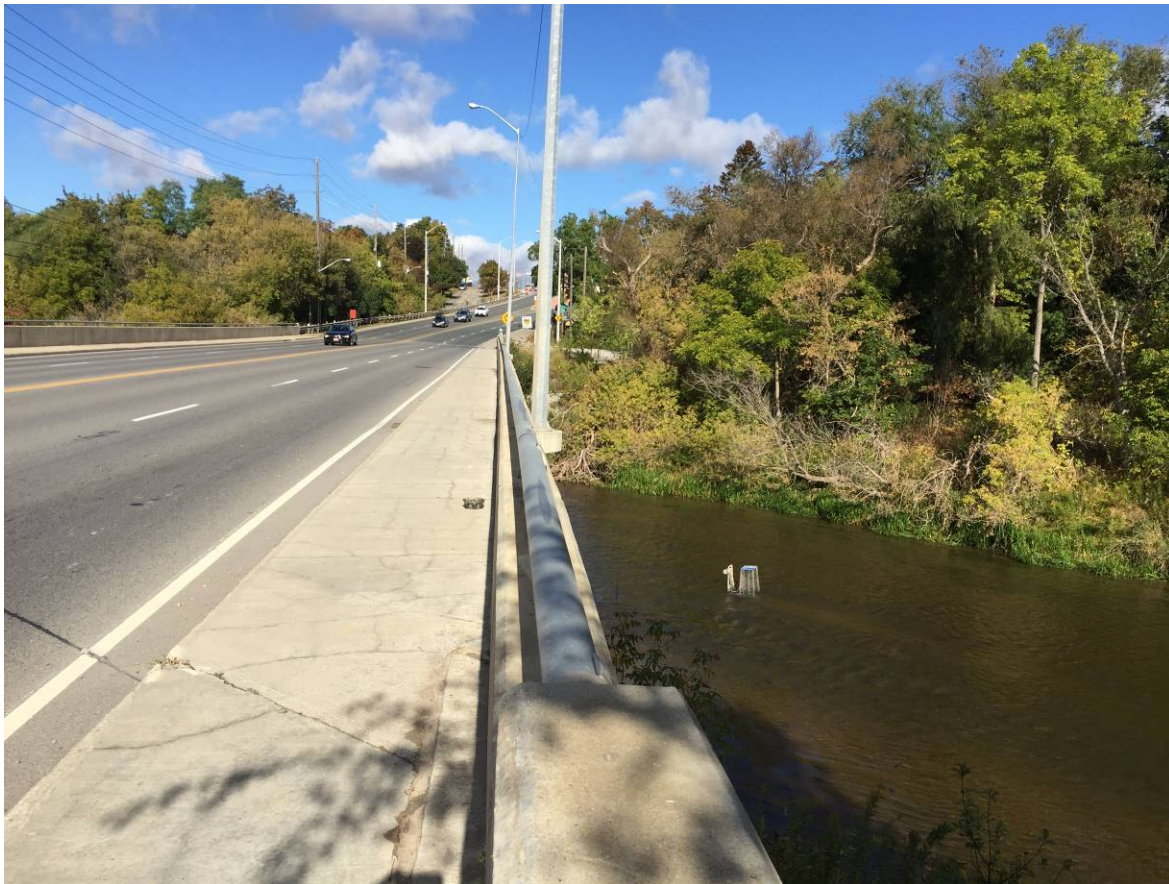
The road improvements will impact some of the existing trees, primarily along the east side of the Mississauga Road corridor.

**Photograph #9: A view looking north along the east side of Mississauga Road, showing the wooded slopes along the Credit River.**

- Tree/shrubs are to be planted where required to replace trees/landscaped areas removed/disturbed due to construction activities.
- Street trees are to be planted on 15 m. spacing along both sides of the roadway

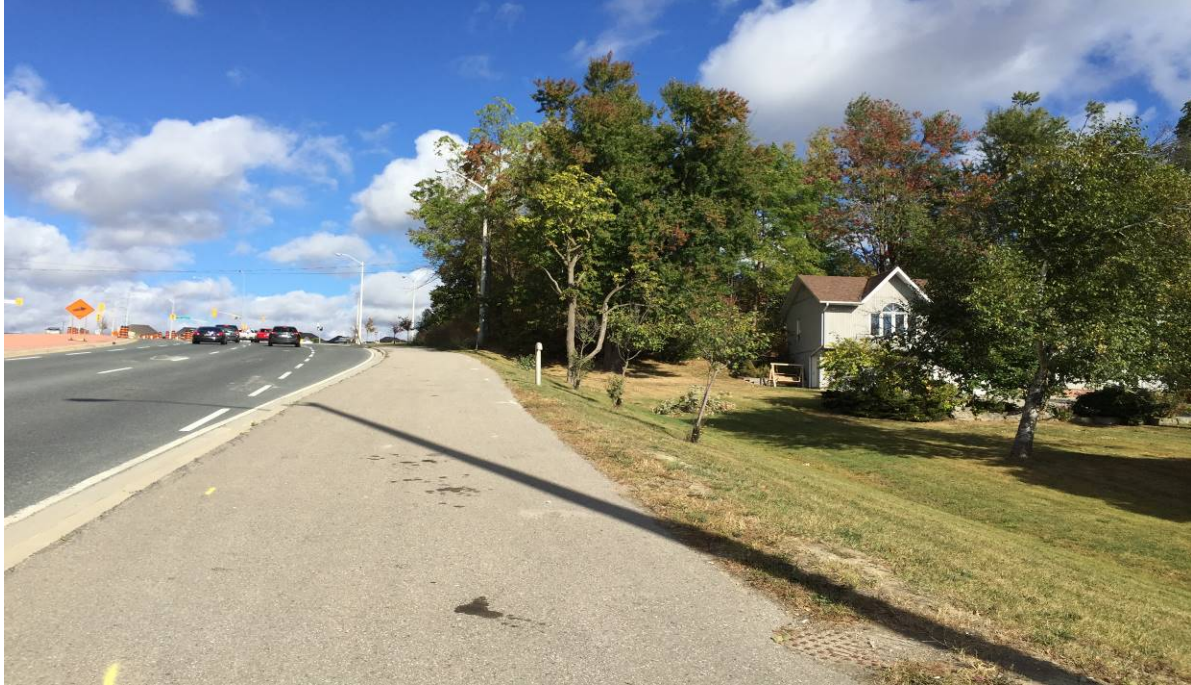
There are some scattered mature trees scattered along the road corridor including, Walnut (*juglans*), Catalpa (*catalpa*), and Red Maple (*acer rubrum*). In addition to these mature trees there are some newly planted street trees including Serviceberry (*amelanchier*) and Maple (*acer*).

**Photograph #10: A view looking north along the east side of Mississauga Road, showing some recently planted street trees and a wooded area in the background**

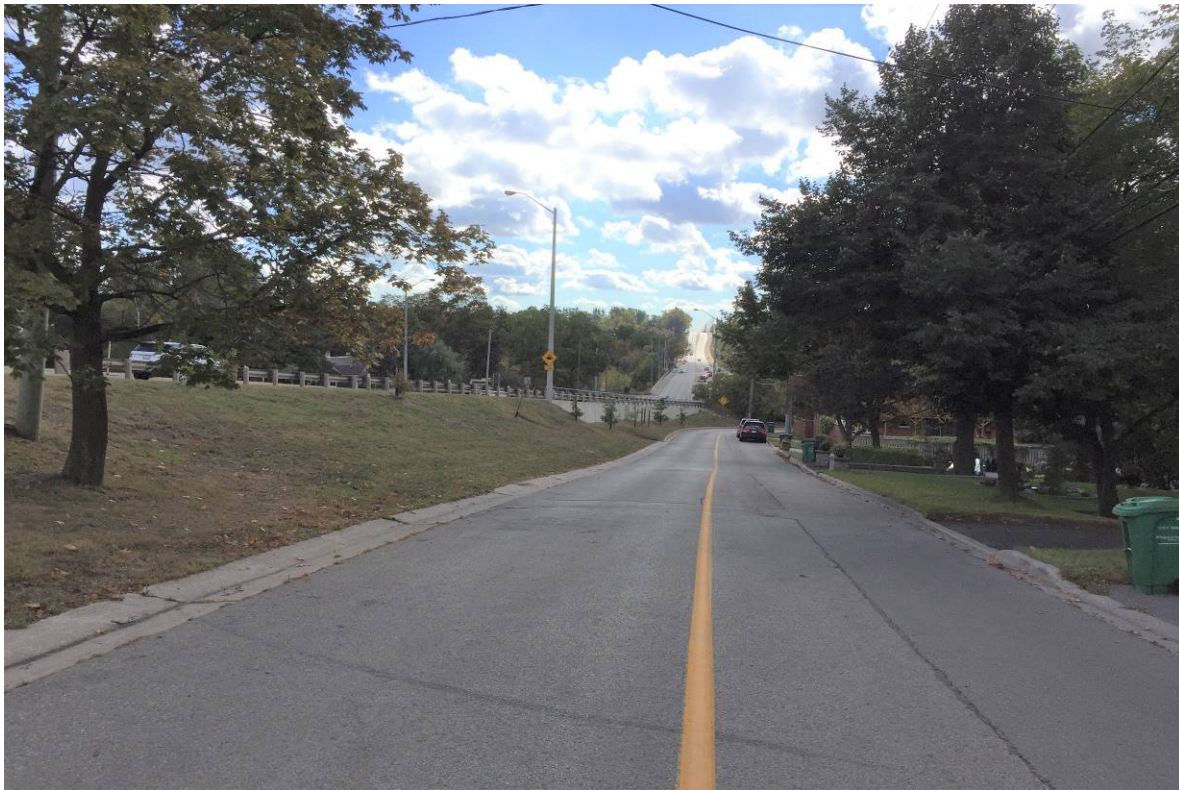
At the base of the slope, adjacent to the Credit River, there is a wooded area dominated by Manitoba Maple (*acer negundo*), Elm (*ulmus*), and Ash (*fraxinus*). Further up the slope between River Road and Mississauga Road, there are a row of young street trees, mostly Oak (*quercus*), many of which are dead or in poor condition, and some more mature Norway Maples (*acer platanoides*).

**Photograph #11: A view looking south along River Road with Mississauga Road in the background, showing the recently planted street trees on the bank.**
