Scoped Subwatershed Study, Part B: Detailed Studies and Impact Assessment (Preliminary Draft)

Settlement Area Boundary Expansion
Region of Peel
Project # 198127

Region of Peel

11/24/2020

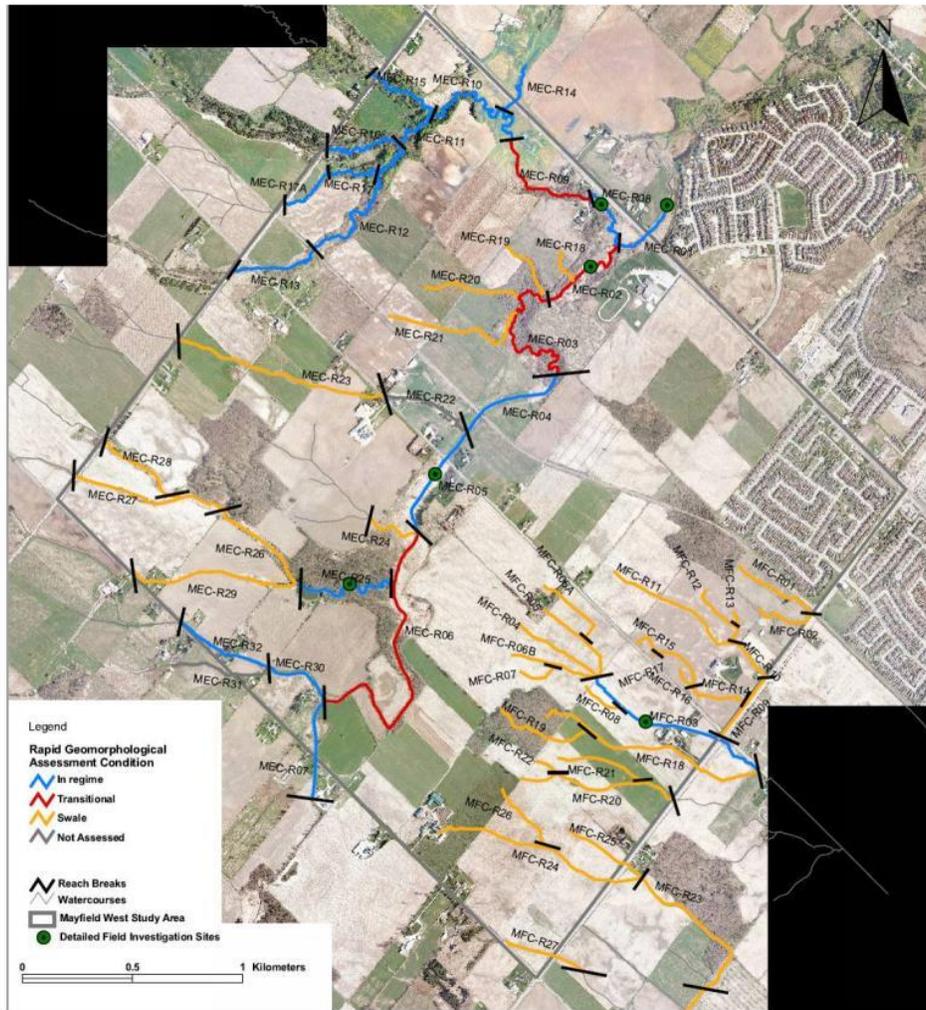
Figure 4.4.2: Rapid assessment results for reaches within the Mayfield West Study Area

Town Caledon
Mayfield West, Phase 2 Secondary Plan
Comprehensive Environmental Impact Study & Management Plan
Part A: Existing Conditions and Characterization
Final Report
December 2014

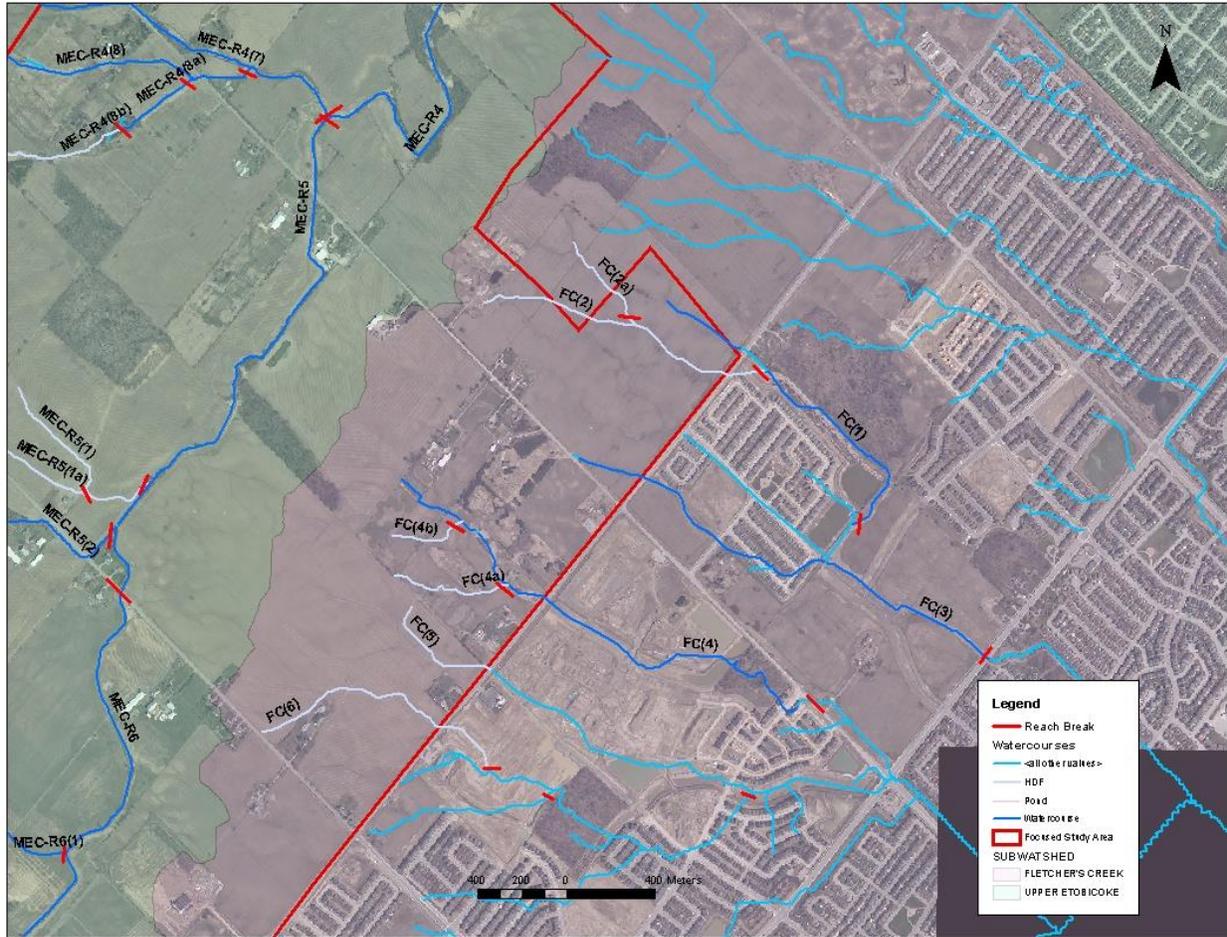
Figure 2.3.4.3.1 Watercourse and HDF Reaches, Fletcher's Creek Subwatershed

Figures 2.3.4.3.1 and 2.3.4.3.2 present the watercourse and HDF mapping and erosion hazard corridors outside of the NHS limits for the Fletcher's Creek subwatershed, respectively. HDF and management recommendations for the subwatershed will be determined in future studies. Additional field assessments will need to be completed in future studies to evaluate potential impacts at the reach scale.

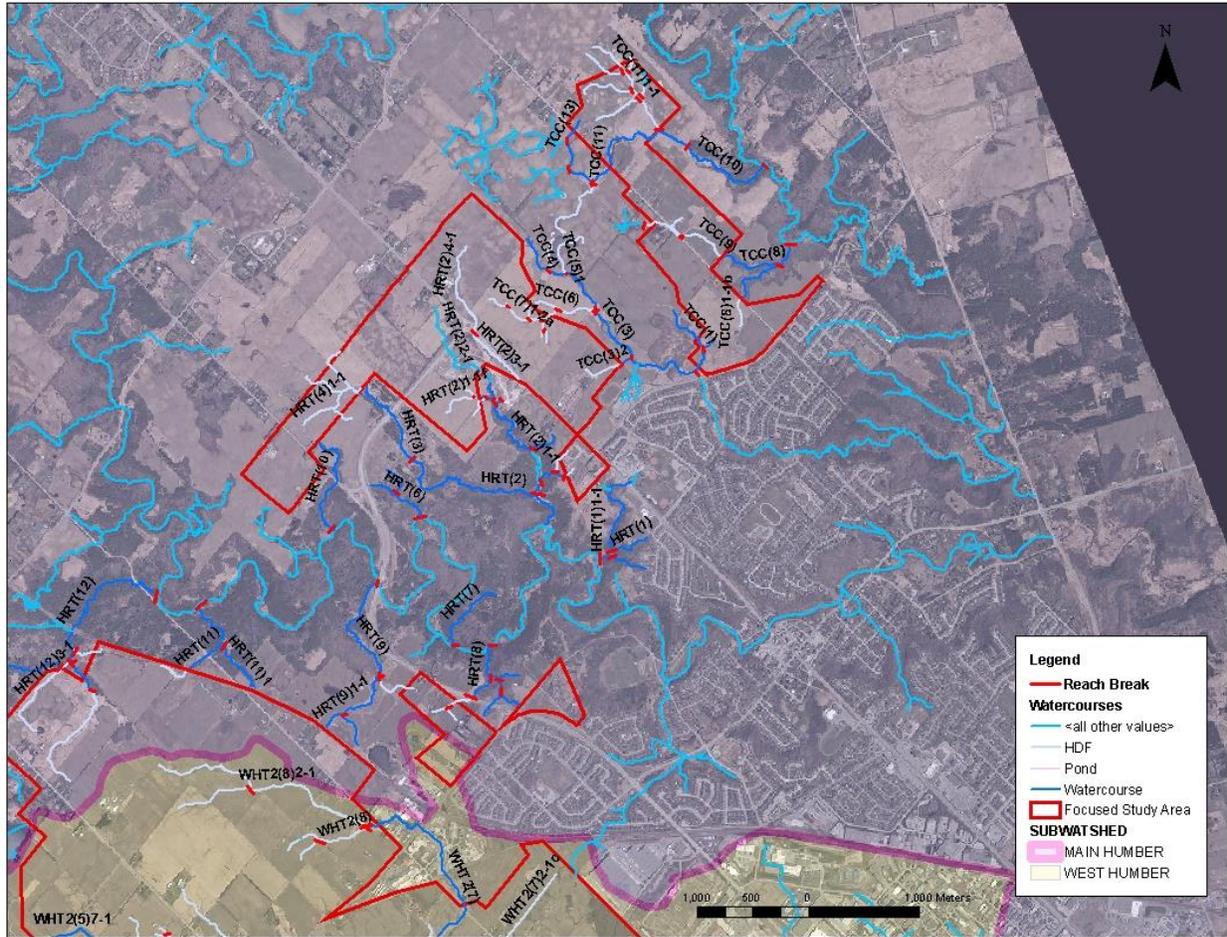
Figure 2.3.4.4.1 Watercourse and HDF Reaches, Main Humber Subwatershed

Figures 2.3.4.4.1 and 2.3.4.4.2 present the watercourse and HDF mapping and erosion hazard corridors outside of the NHS limits for the Main Humber River subwatershed, respectively. HDF and management recommendations for the subwatershed will be determined in future studies. Additional field assessments will need to be completed in future studies to evaluate potential impacts at the reach scale.

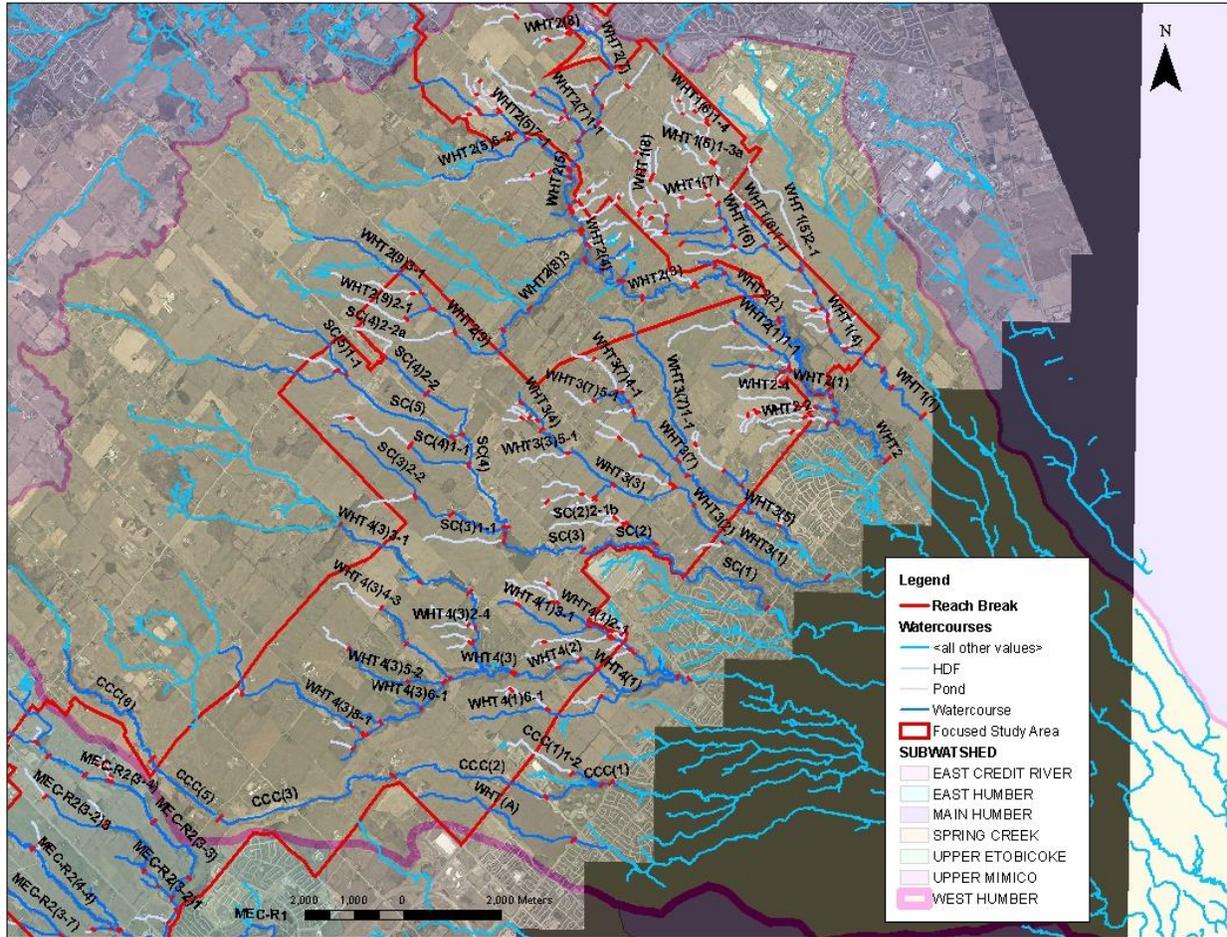
Figure 2.3.4.5.1 Watercourse and HDF Reaches, West Humber Subwatershed

Figures 2.3.4.5.1 and 2.3.4.5.2 present the watercourse and HDF mapping and erosion hazard corridors outside of the NHS limits for the West Humber subwatershed, respectively. HDF and management recommendations for the subwatershed will be determined in future studies. Additional field assessments will need to be completed in future studies to evaluate potential impacts at the reach scale.
