**Region of Peel**

# Addendum to Environmental Study Report

Improvements to Bovaird Drive, from Lake Louise Drive/Worthington Avenue to 1.45 km west of Heritage Road in the City of Brampton

May 2015

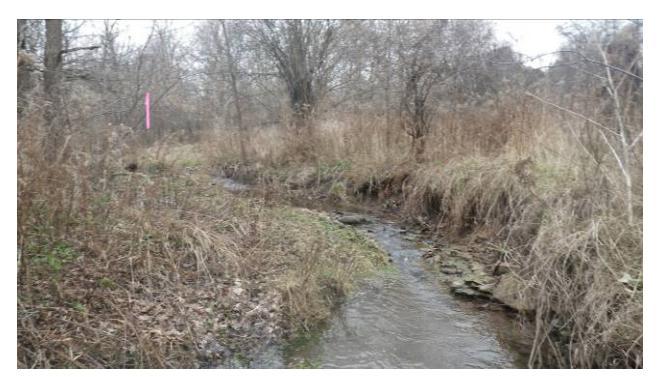
XS 10: View facing upstream.

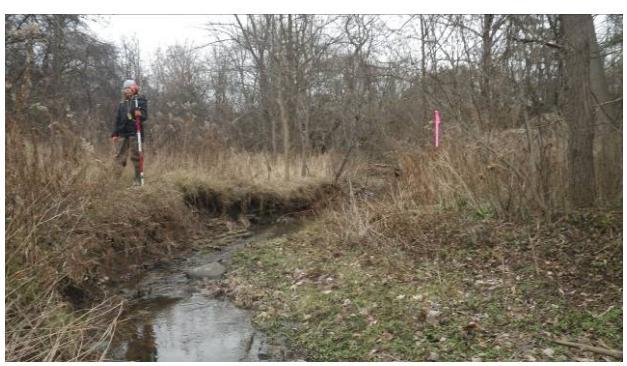
**XS 10:** View facing downstream. Note bank erosion along outside meander bend (left bank). Right bank has gradual slope.

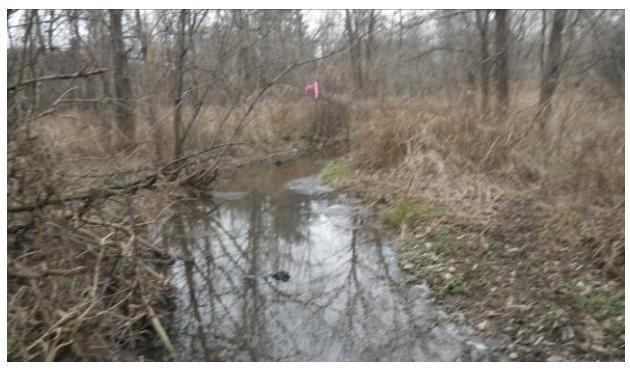
**XS 9:** View facing downstream.

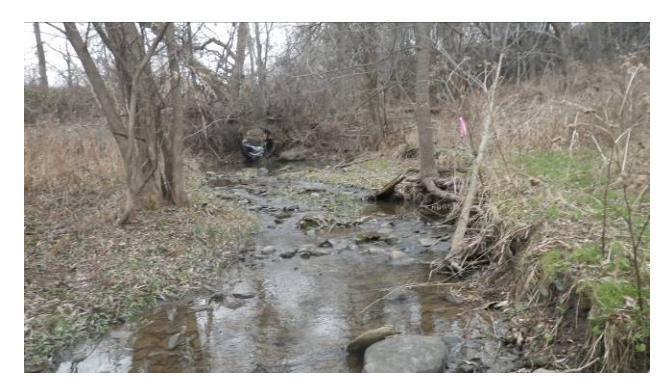
**XS 8:** View facing upstream. XS located downstream of culvert, approximately 200m from downstream extent of reach (Bovaird Drive)

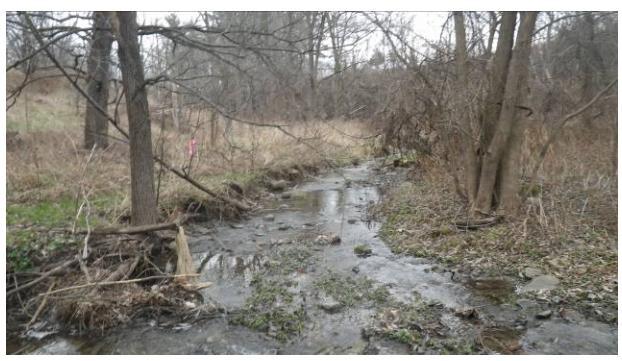
**XS 8:** View facing downstream. Minor woody debris accumulating around tree on left bank. Left bank also experiencing erosion.

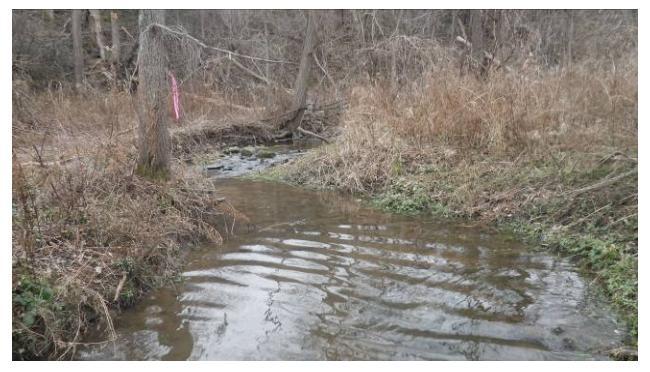
**XS 7:** View facing upstream.

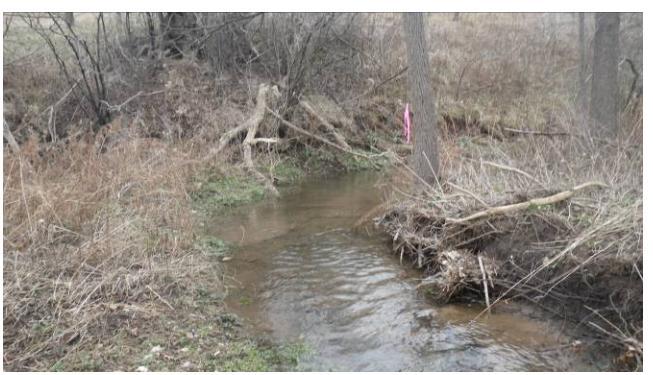
**XS 7:** View facing downstream. Bank erosion present along outside meander bends.

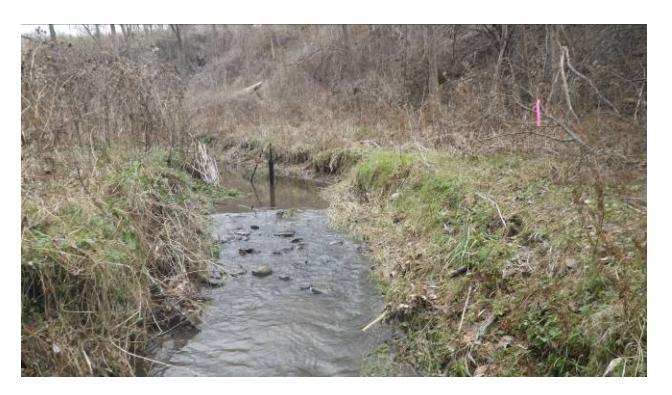
**XS 6:** View facing upstream. Bank erosion can be seen along both banks.

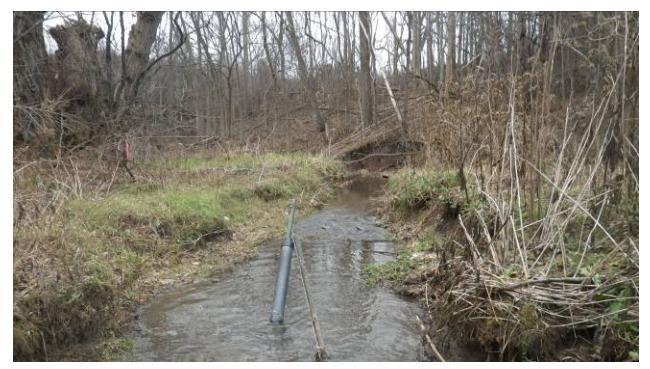
**XS 6:** View facing downstream. Slightly more substantial bank erosion along right bank. Valley constraints appearing at the downstream extent of the reach.

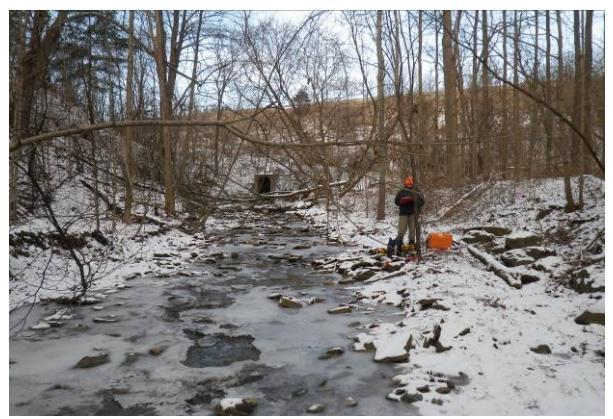
**XS 5:** View facing upstream. Located at the upstream extent of reach BV-A2. Bovaird Drive culvert outlet seen in the distance.

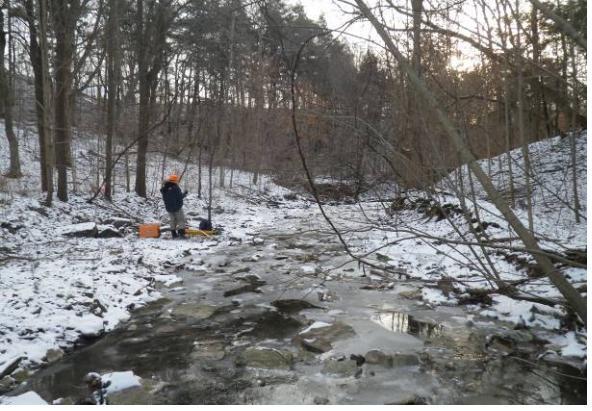
**XS 5:** View facing downstream. Channel slightly wider than downstream XS's. Scour along right bank resulting in leaning trees and exposure of roots.

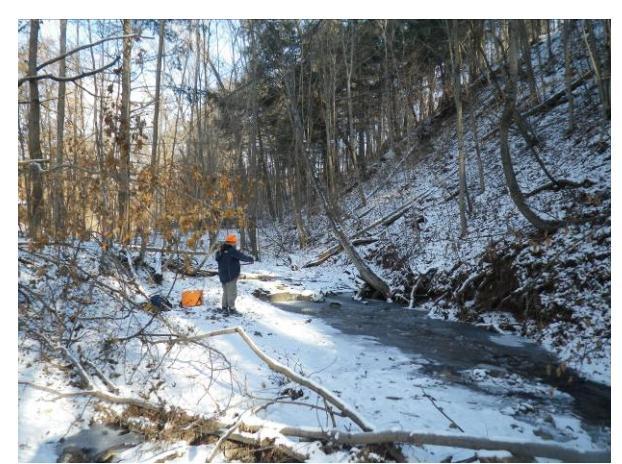
XS 3: View facing upstream.

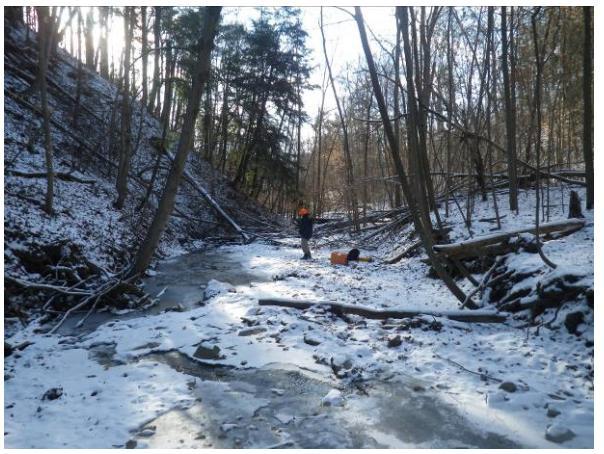
**XS 3:** View facing downstream. Valley wall contact on left bank. Exposed roots and J-shaped trees located on banks, indicative of widening.

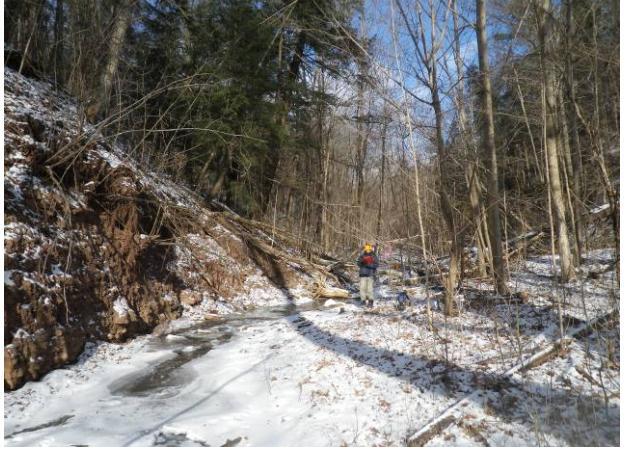
**XS 2**: View facing upstream. Valley wall contact on right bank with a near vertical bank. Left bank has a gradual slope.

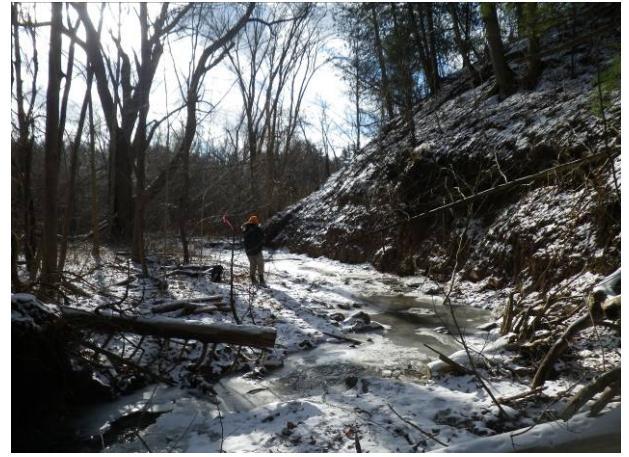
**XS 2:** View facing downstream. Note the valley wall contact on the right bank. Valley wall contact consists of shale material.

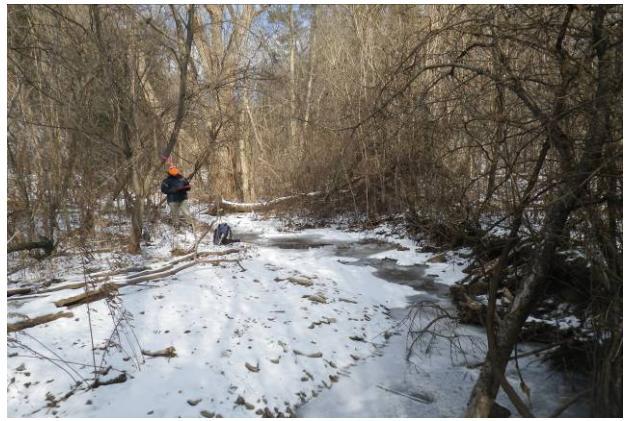
**XS 1:** View facing upstream. Located approx. 15m from Credit River confluence. Banks are much lower with some scouring occurring along outside meander bend (left bank).

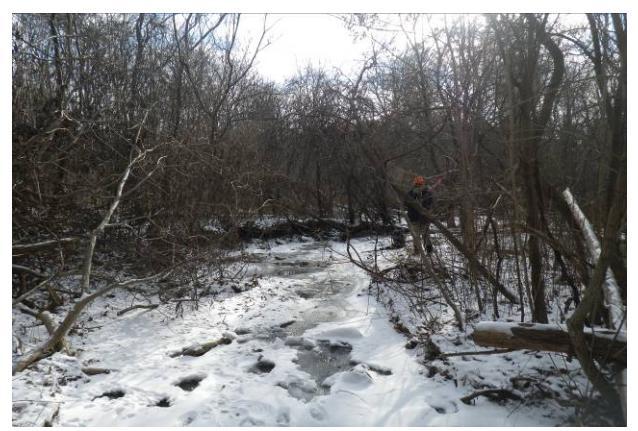
XS 1: View facing downstream.

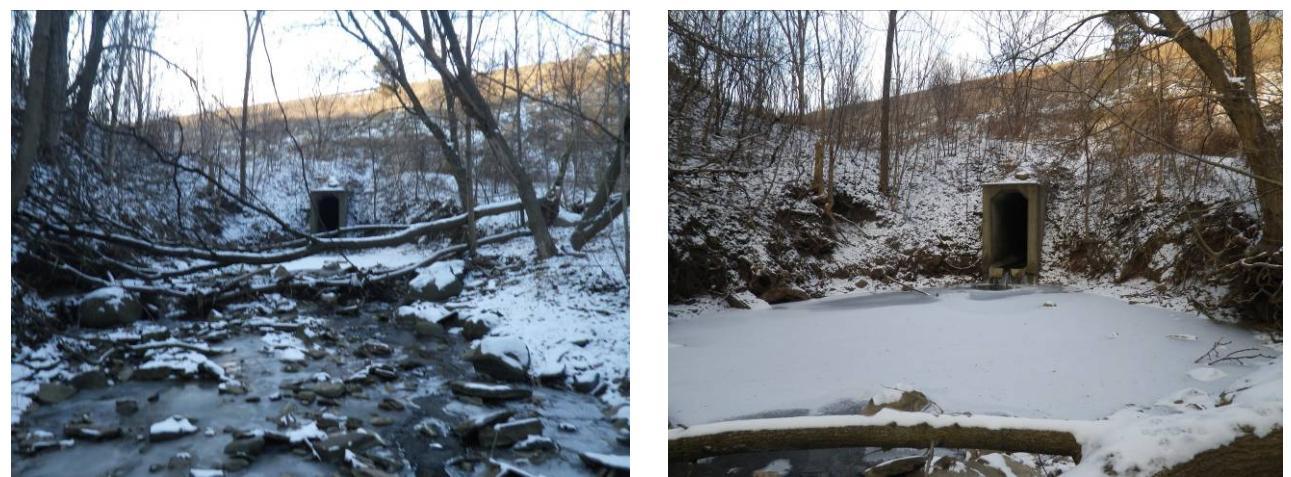
The most significant channel disturbance within the reach is the undersized culvert which conveys flows under Bovaird Drive (**Figure 4.4**). Immediately downstream of the Bovaird Drive culvert, a large scour pool has formed leaving the culvert invert perched creating a barrier for fish passage. Bed and bank scour, resulting from elevated flow velocities released from the culvert during high flows, have caused increases in channel width and depth immediately downstream of the culvert. Approximately 60m downstream of the Bovaird Drive culvert the remnants of a relic weir structure was observed (**Figure 4.4**). At this location, a sudden drop in elevation of approximately 1.2m was recorded with large pieces of concrete present creating a small cascadelike feature. This features impedes fish migration to upstream areas potentially reducing available habitat for fish species. Additional channel disturbances noted include, valley wall contacts which confine the channel and restrict lateral migration at various locations, and accumulations of large woody debris which were a common occurrence within the reach.

From a geomorphic perspective, it is evident that the existing culvert is inadequately sized to effectively convey flows and permit efficient sediment transport leading to issues related to excessive scour and fish passage. Ideally, the proposed structure should span the meander belt width, although in most cases this is cost-prohibitive. Based on the geomorphic assessment of the watercourse, an ultimate crossing structure size of 14m is recommended for the existing watercourse. The ultimate crossing structure would consist of a free spanning bridge providing adequate space for natural channel processes to operate while also accommodating minor channel adjustments and improving fish passage.

View facing upstream at the Bovaird Drive culvert outlet. It is evident that the culvert is undersized in relation to the existing watercourse. Scour along bed and banks of channel have resulted.
