FINAL REPORT

Caledon Road Improvements EA – Geomorphic Assessment

Date: May 2014

Client: HDR Inc.

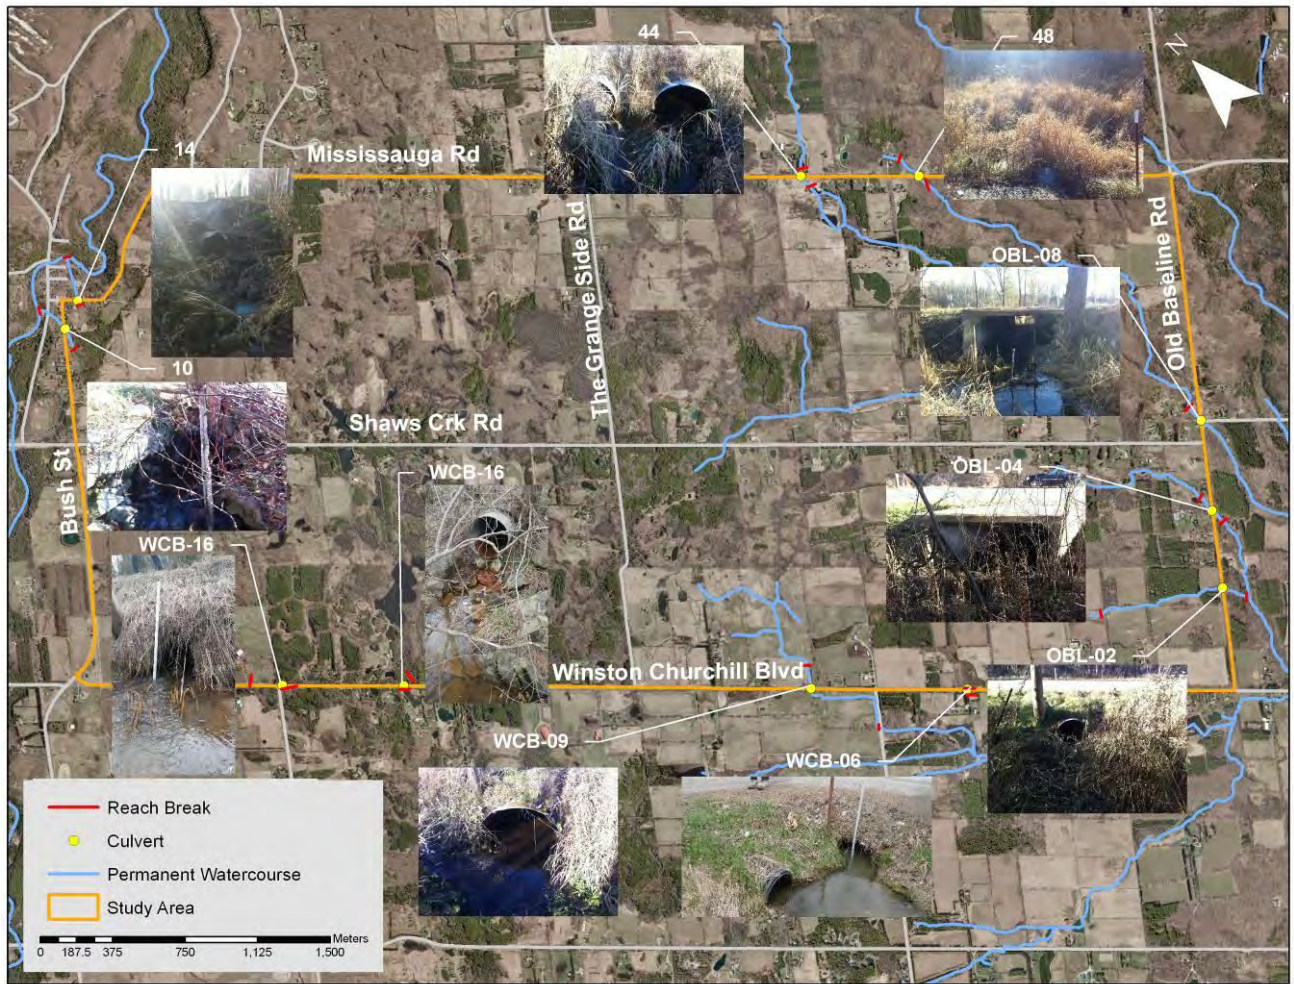
Figure 5.1: Culvert structures photographed at each crossing location.

Crossing	Structure		Bankfull Dimensions (m)		Relative Crossing Size			Gradient	Valley Setting	Flow Restriction
	Type	Opening Width (m)	Width	Depth	Channel Width < Opening	Channel Width = Opening	Channel Width > Opening			
OBL-02	CSP	0.6	~1.25	~0.23			√	low	Partially confined	Woody debris
OBL-04	Concrete Box	3.25	~3.5	~0.3			√	low	Partially confined	Woody debris
OBL-08	Concrete Box	4.5	~4.5	~0.5		√		low	Partially confined	vegetation
44	Double CSP	0.75	~2.0	~0.6			√	low	unconfined	vegetation
48	CSP	0.5	n/a	n/a				low	unconfined	vegetation
10	Plastic Pipe	0.45	~2.75	~0.3			√	moderate	unconfined	Concrete debris
14	CSP	0.6	~1.1	~0.3			√	high	unconfined	none
WCB-06	CSP	0.6	~0.8	~0.36			√	low	unconfined	vegetation
WCB-09	CSP	1.34	~1.9	~0.35			√	high	Partially confined	vegetation
WCB-14	CSP	0.45	~0.63	~0.12			√	low	Partially confined	none
WCB-16	CSP	0.9	~0.76	~0.41		√		high	Partially Confined	Bank failure
