NINTH LINE STREAM MORPHOLOGY INTERIM REPORT
137960 - 20947 - 522

Report Prepared for:
AMEC FOSTER WHEELER

Prepared by:
PARISH AQUATIC SERVICES
A DIVISION OF MATRIX SOLUTIONS

June 2016
Mississauga, Ontario

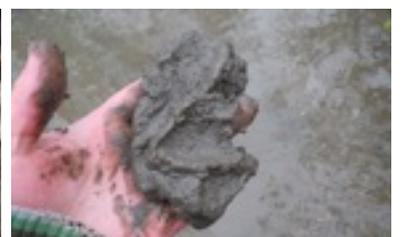
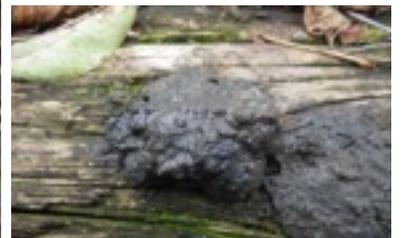
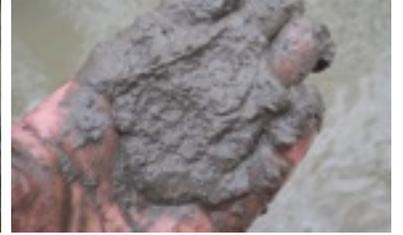
Typical substrate found within reach was soft and unconsolidated with high organic content. Substrate consisted of fine textured material, typically silt, clay, fine sand and coarse sand.

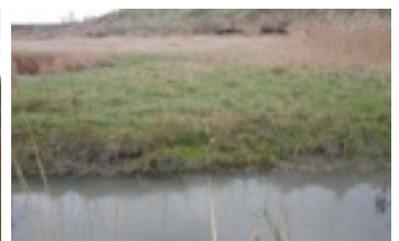
Typical channel cross-section displaying shallow banks which frequently overtop onto the broad, flat floodplain. The floodplain is vegetated with short to long grasses and some shrubs. Note the Britannia Bridge crossing in the bottom photo delineating the upstream reach extent. Ninth Line and HWY 407 confine the watercourse to the east and west delineating the Ninth Line Corridor.

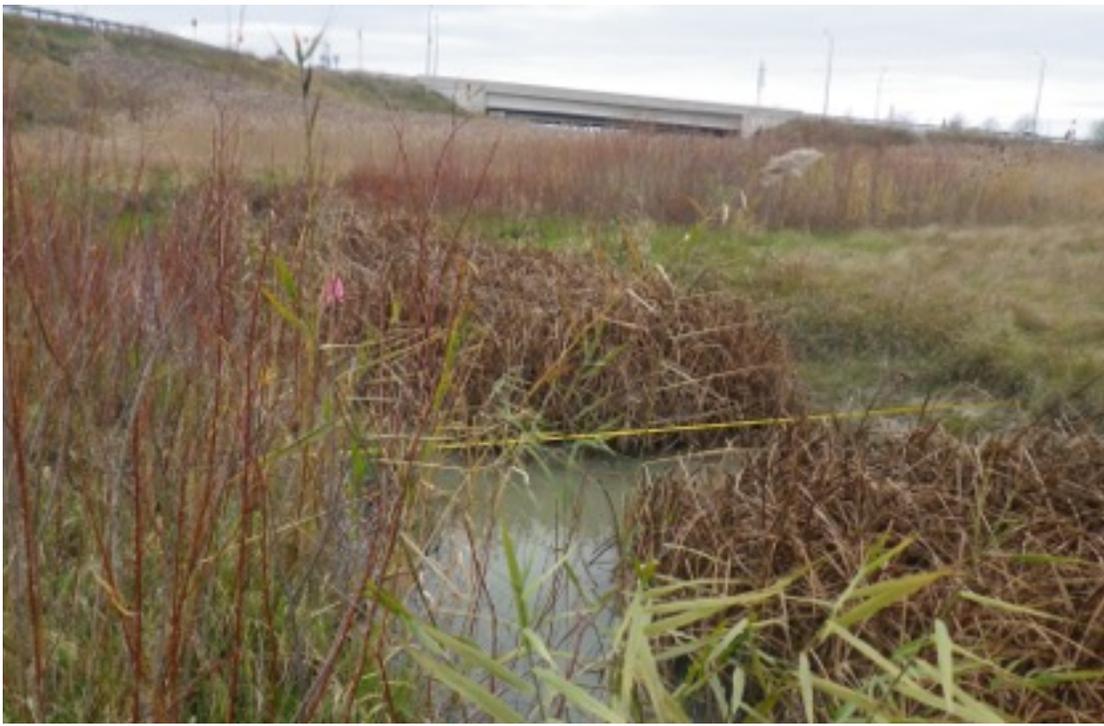
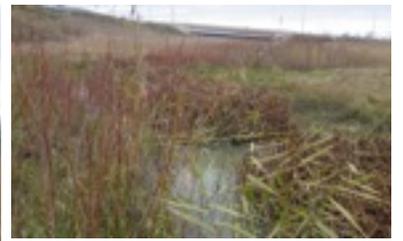
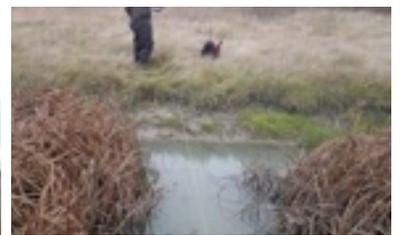
The presence of instream vegetation was typically observed within the watercourse, commonly found in mid channel areas. Wet meadow grasses and cattails were the dominant types of instream vegetation noted.

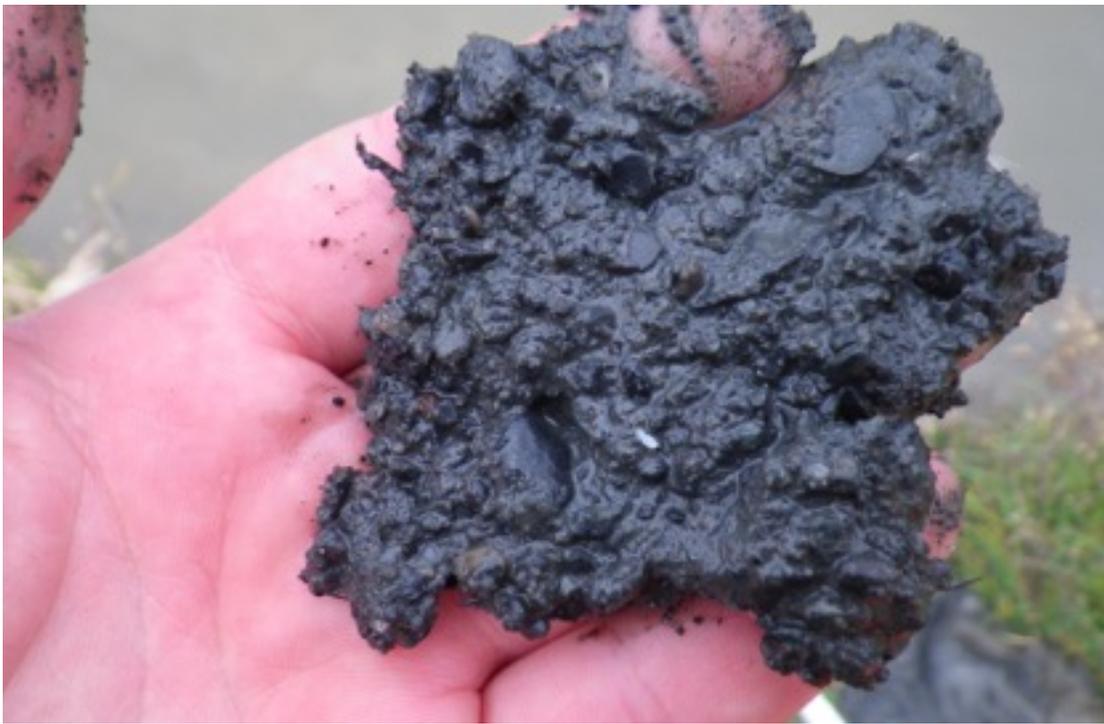
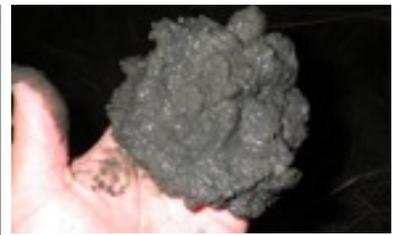
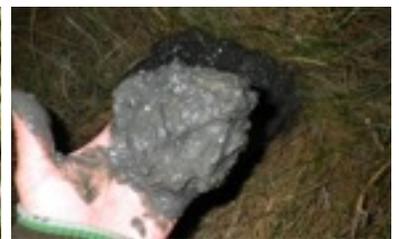
Channel bed substrate was soft and unconsolidated with high organic content. The substrate consists of fine textured materials (silt, clay, fine sand) with inclusions of coarser materials (coarse sand, pebbles and small gravels) found within the mix. The subpavement is representative of the typical geology of the area consisting of stiff silty-clay till.
