# F VEGETATION AND AESTHETICS ASSESSMENT

Highway 427 Industrial Secondary Plan Area Environmental Assessment  
Existing Vegetation/Aesthetic Assessment  
**Section B**

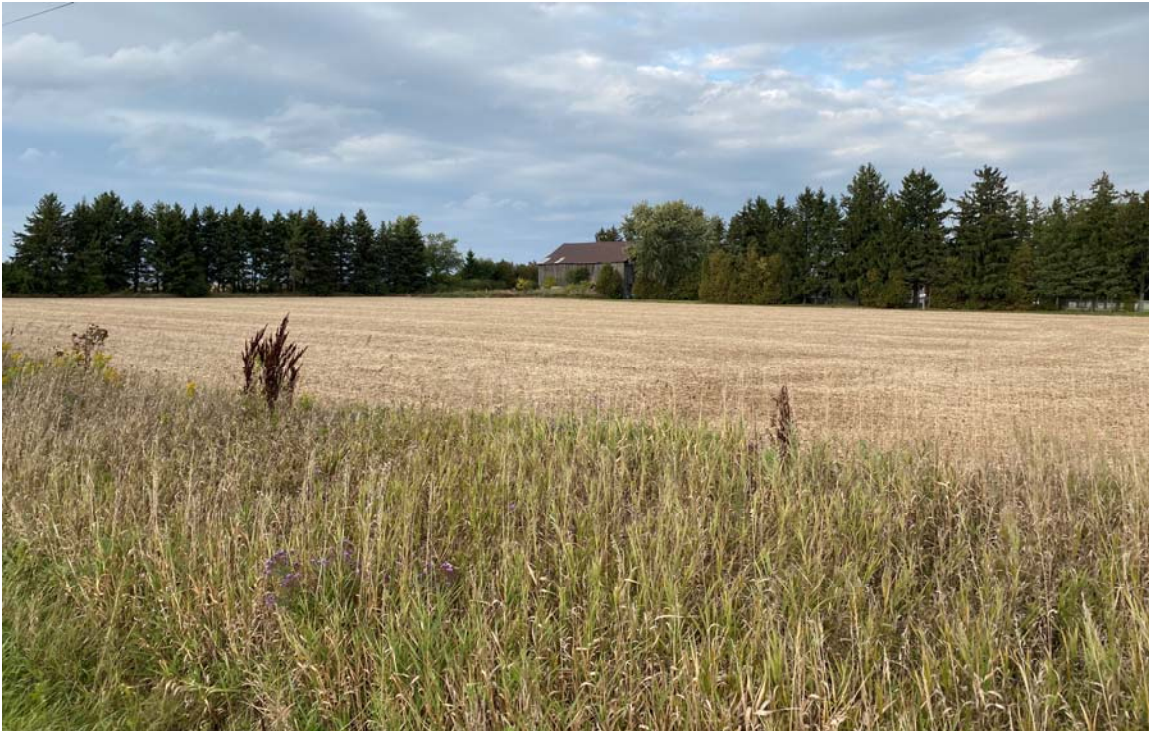
*Image 1: Site/Rural Character – Looking east from Coleraine Drive*

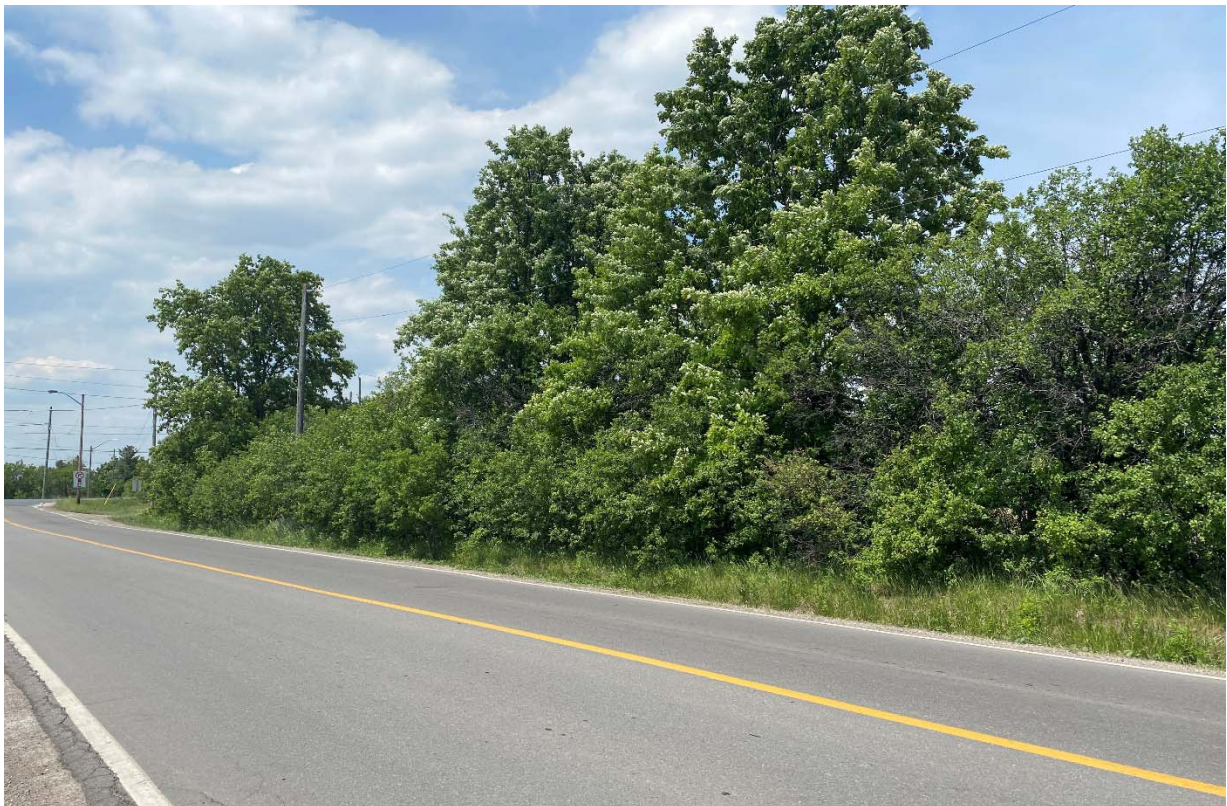
**Image 1:** Clarkway Drive – Looking north to the intersection with Mayfield Road. Buckthorn hedgerow begins. Three *Quercus* spp. can be seen in the background, established well outside the proposed ROW.

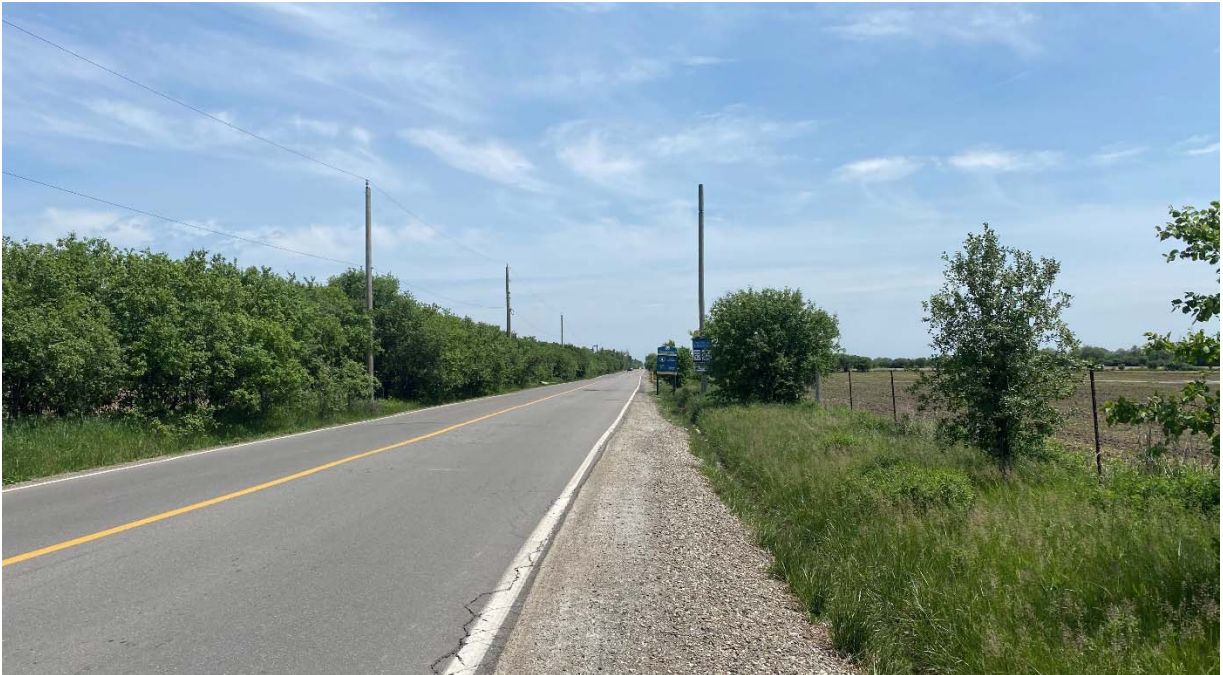
**Image 2:** Clarkway Drive – Looking south from just beyond the intersection with Mayfield Road. Buckthorn hedgerow on the eastern roadside extending into the distance. Level agricultural land exists on both sides of the road.

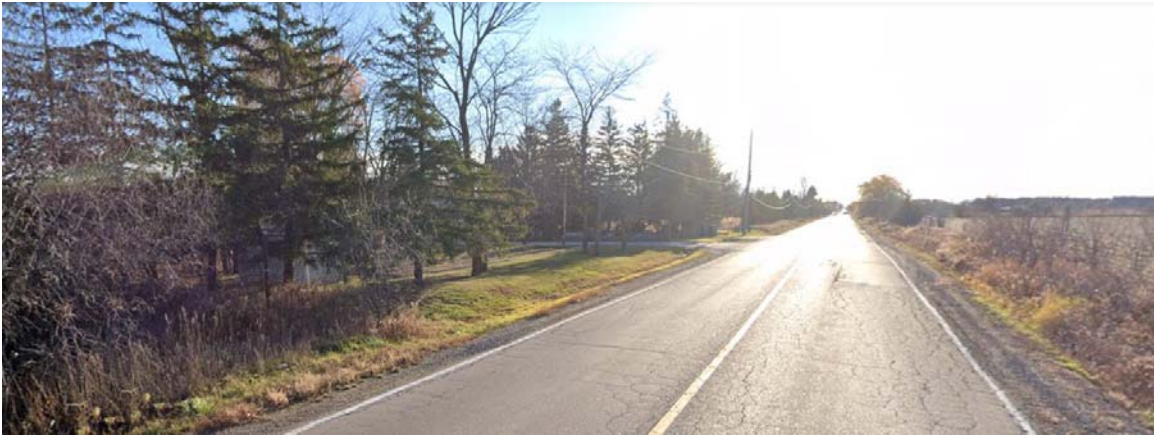
**Image 3:** Clarkway Drive – Looking south at the first encountered residential site. Deciduous trees exist in a manicured lawn but appear to be well beyond the site work needed for the proposed ROW.

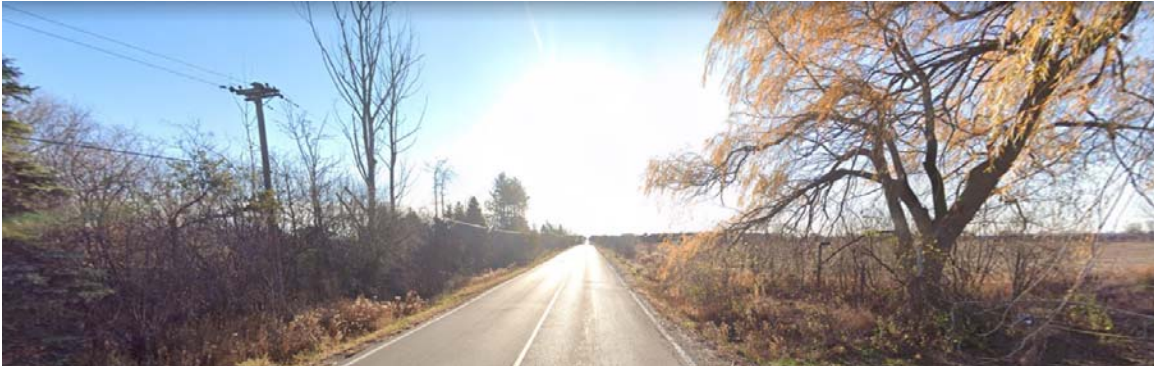
**Image 4:** Clarkway Drive – Looking south beyond the first encountered residential site. Naturalistic landscape exists to the east containing invasive Buckthorn Hedgerow remnants. Large existing trees appear dead as observed throughout several points of the year. A large Willow can be seen at the western side of Clarkway Drive.

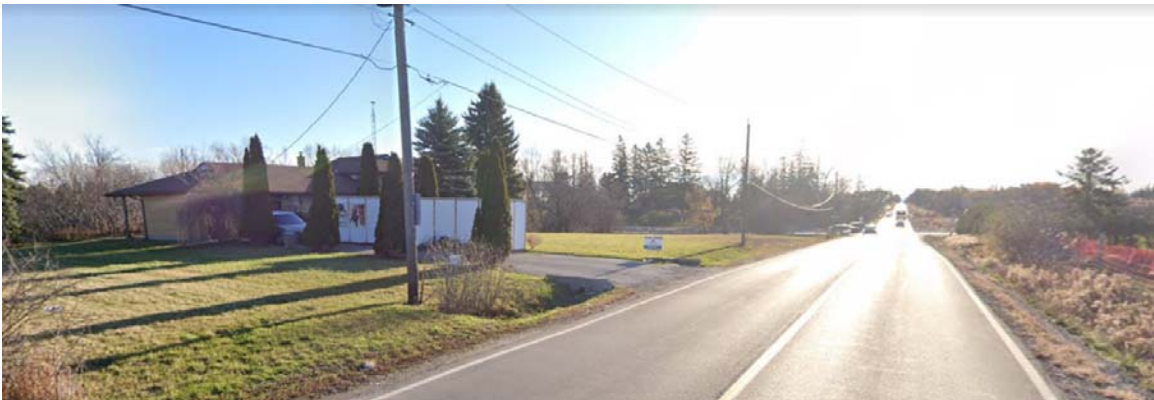
**Image 4:** Clarkway Drive – Looking south to the intersection of Clarkway and Countryside Drive. Residential sites lie on both sides of the road but pose no conflict with the proposed ROW.

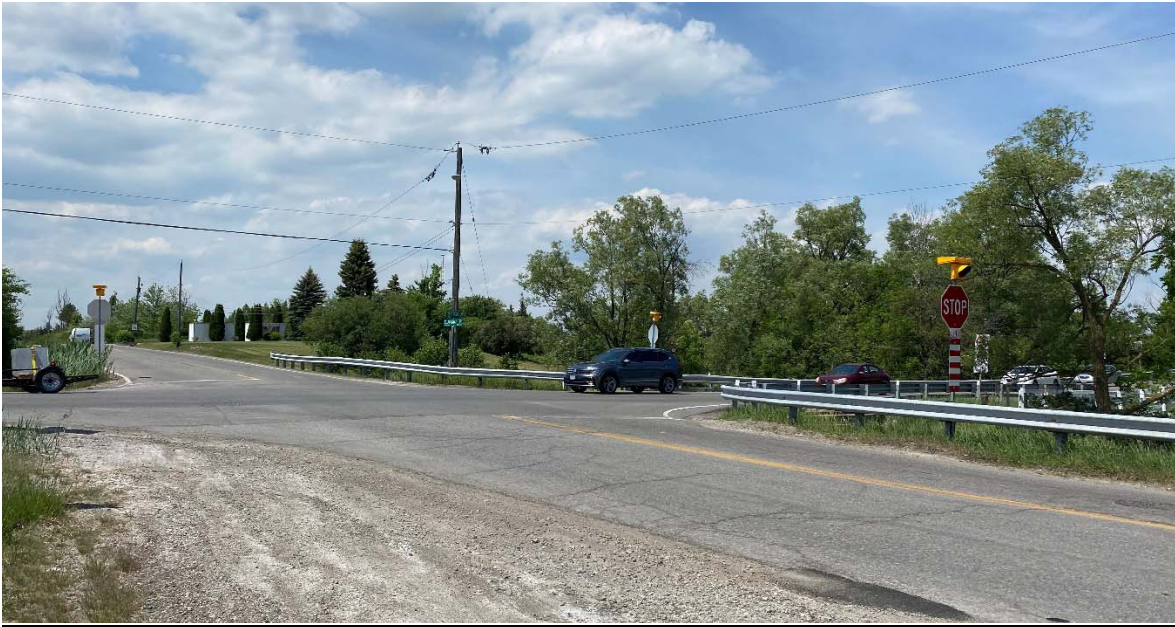
**Image 5:** Intersection of Clarkway Drive and Countryside Drive – Looking north.

As previously noted, the intersection of Countryside Drive and Clarkway Drive dips into the landscape at a relative low point, where Countryside Drive Crosses the Clarkway Tributary. See Image 5, and Image 6.

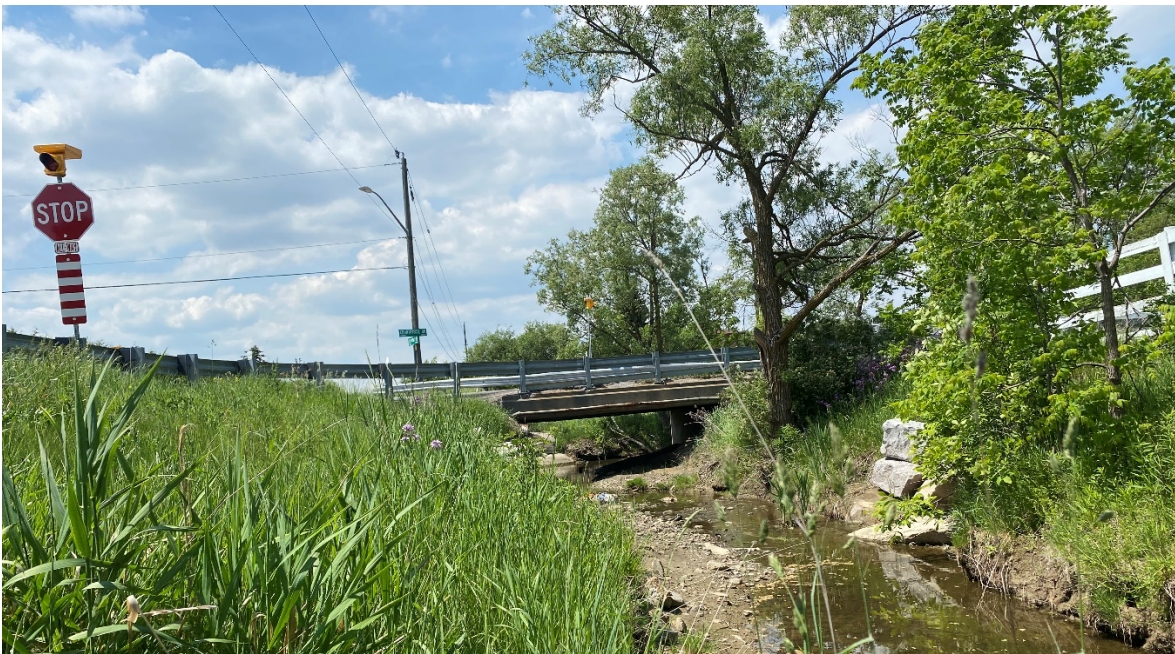
**Image 6:** Looking north on east side of Clarkway Drive – Clarkway Tributary passes beneath Countryside Drive. Riparian zone is dominated with seasonally maintained roadside grasses and forbs.

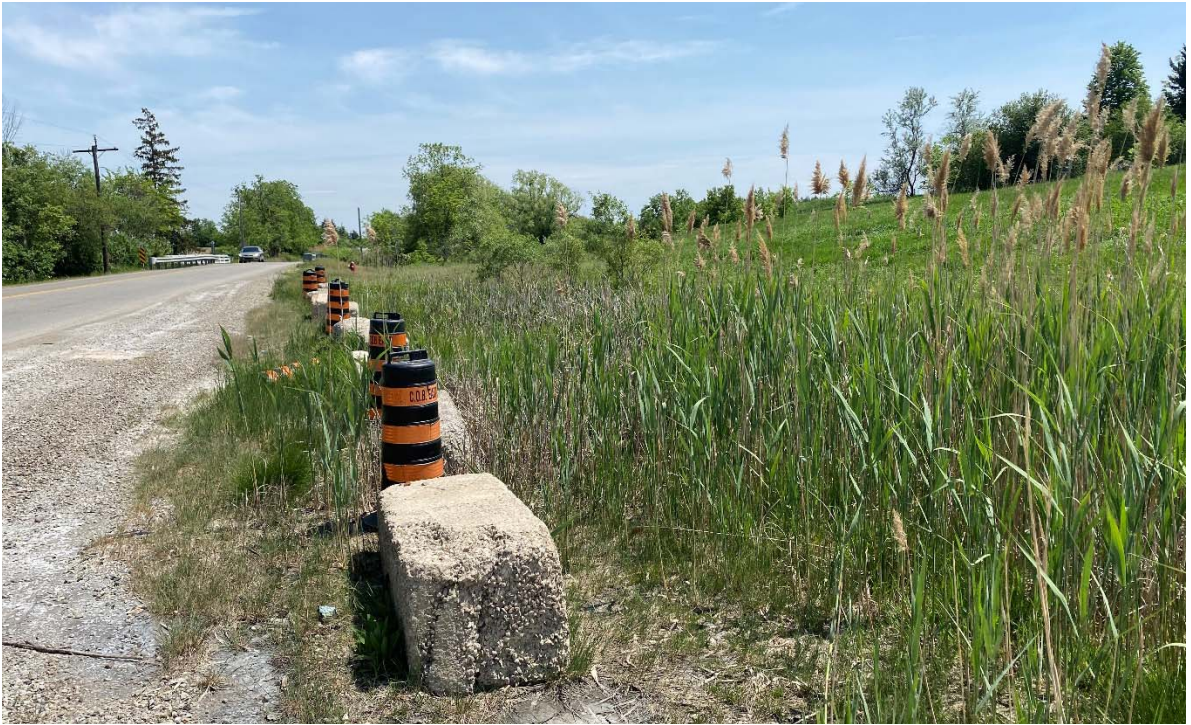
**Image 7:** Intersection of Clarkway Drive and Countryside Drive – Looking south. Road work and adjacent manipulation of the landscape mixed with the naturally occurring topography/drainage patterns has led to the beginnings of confined and limited wetland establishment. In the distance the guardrails indicate the crossing of Clarkway Tributary to the West Side of Clarkway Drive.

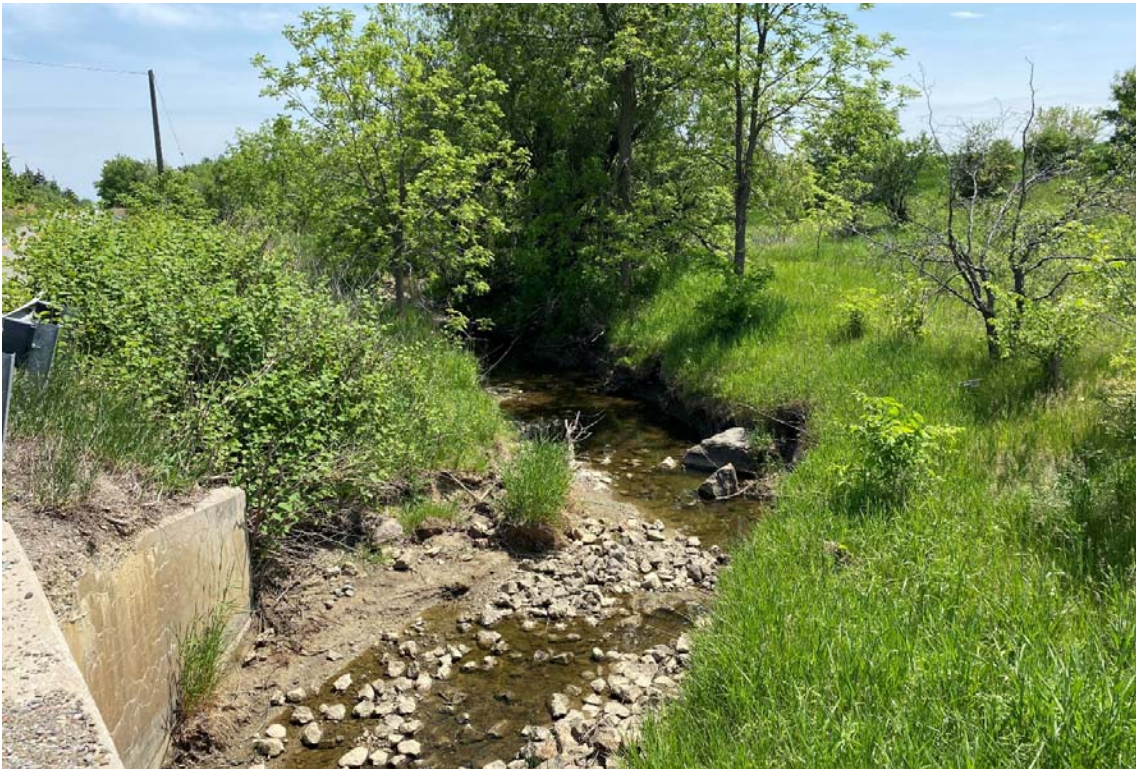
**Image 8:** Looking south. – Clarkway Tributary as it enters to the west side of Clarkway Drive. Riparian vegetation and cross section of creek are in much better condition with an increased localized capacity for both aquatic and terrestrial ecological function.

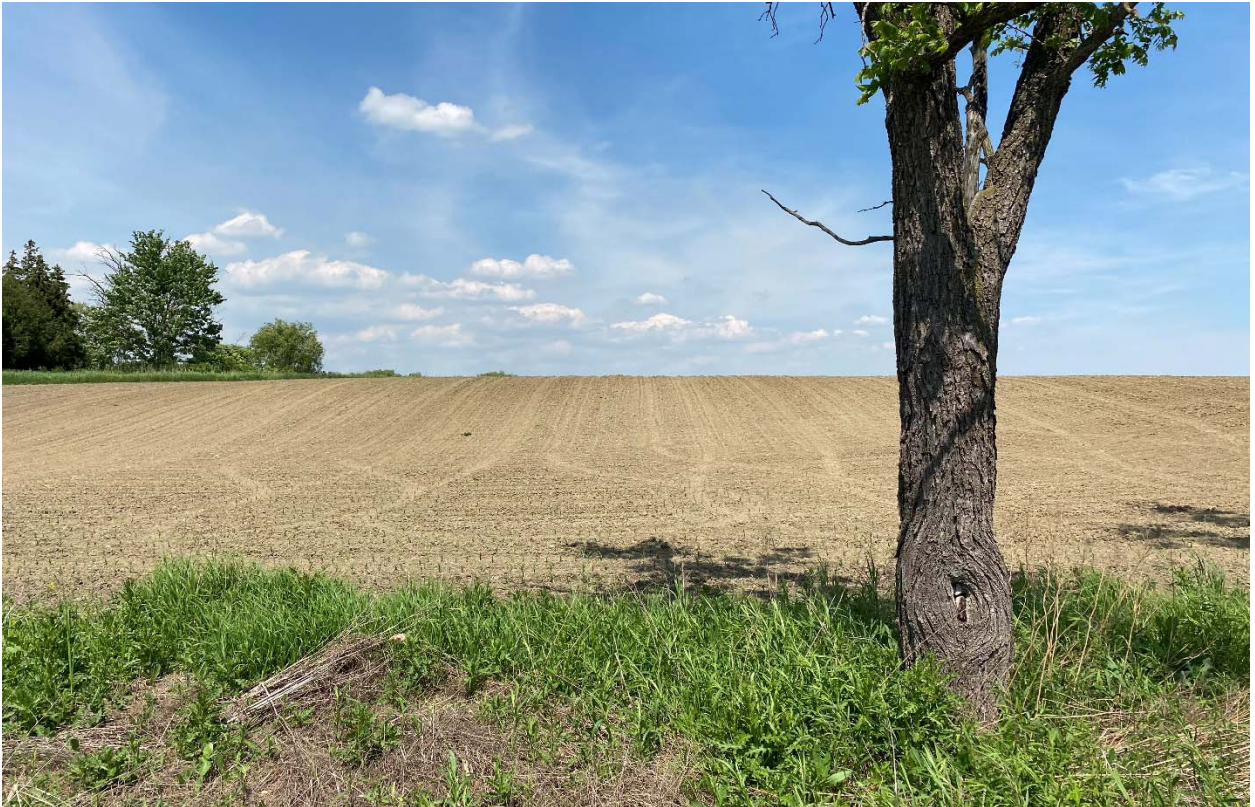
**Image 9:** Looking east - View from Clarkway Drive south of intersection with Countryside Drive. Open agricultural lands.

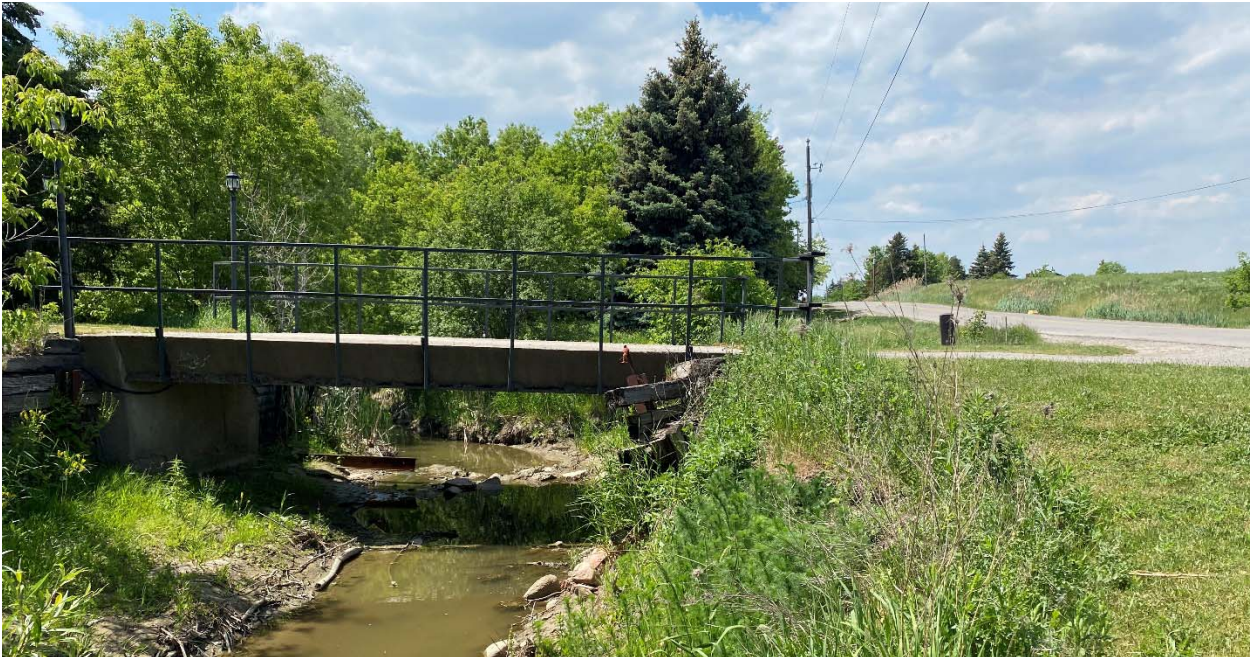
**Image 10:** Looking north on the east side of Clarkway Drive. – Clarkway Tributary swings easterly towards Clarkway Drive. The roughly 700 metre stretch between this point and the tributaries crossing of Clarkway Drive to the North represent the most intake riparian conditions thus far.

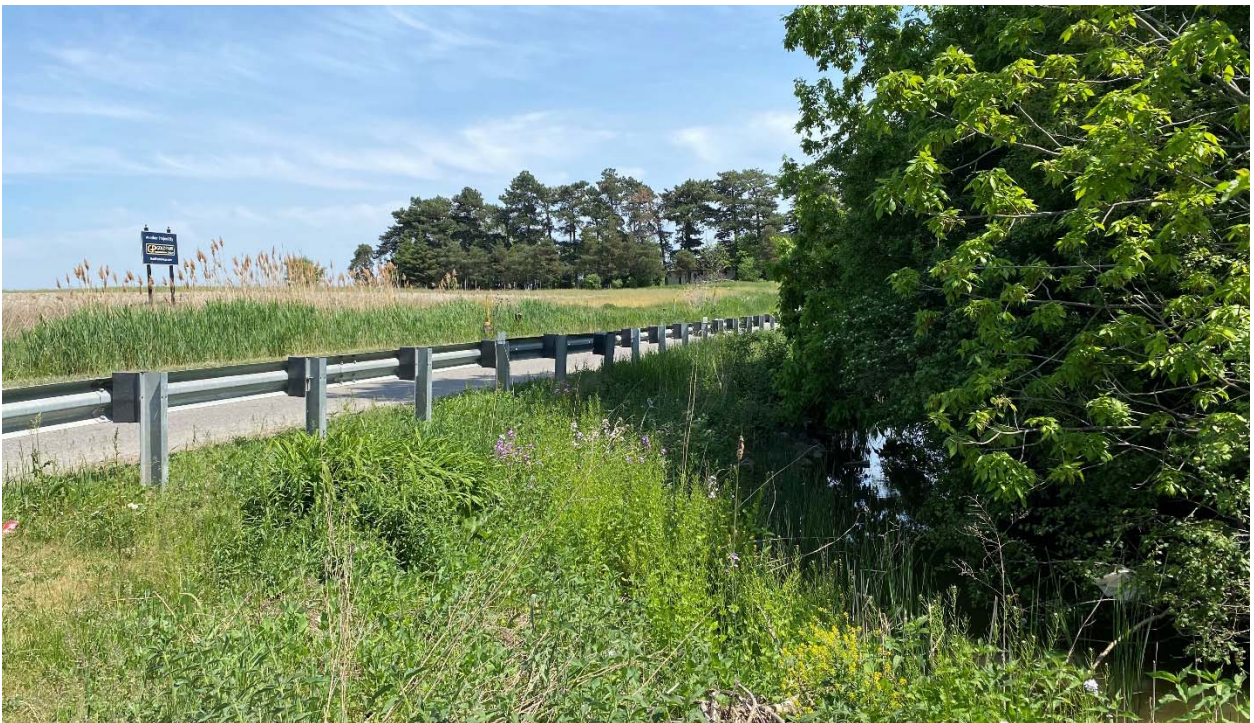
**Image 11:** Looking south on the east side of Clarkway Drive. – The reflection of Clarkway Tributary can be seen beneath the shadows of overhanging trees. From this point south 400 metres the tributary clings to the roadside necessitating steel guardrails. It is assumed significant channel protection, alignment, and restoration will be needed for the proposed corridor improvements to take place.

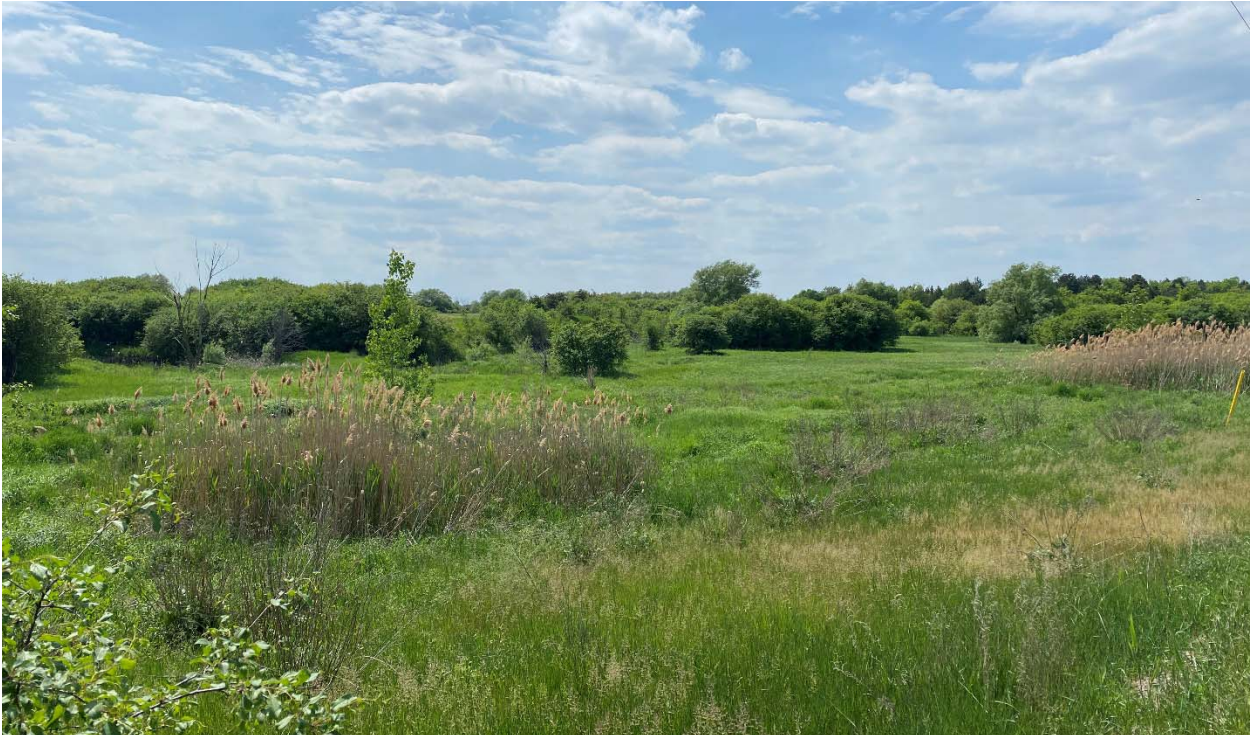
**Image 12:** Looking east of Clarkway Drive – A stretch of rolling lowlands of the Clarkway Tributary corridor. Diverse shrubs and a mix of wet meadows are most prominent, representing one of the largest perceivable patches of non-anthropocentric landscape in the Clarkway Drive corridor.

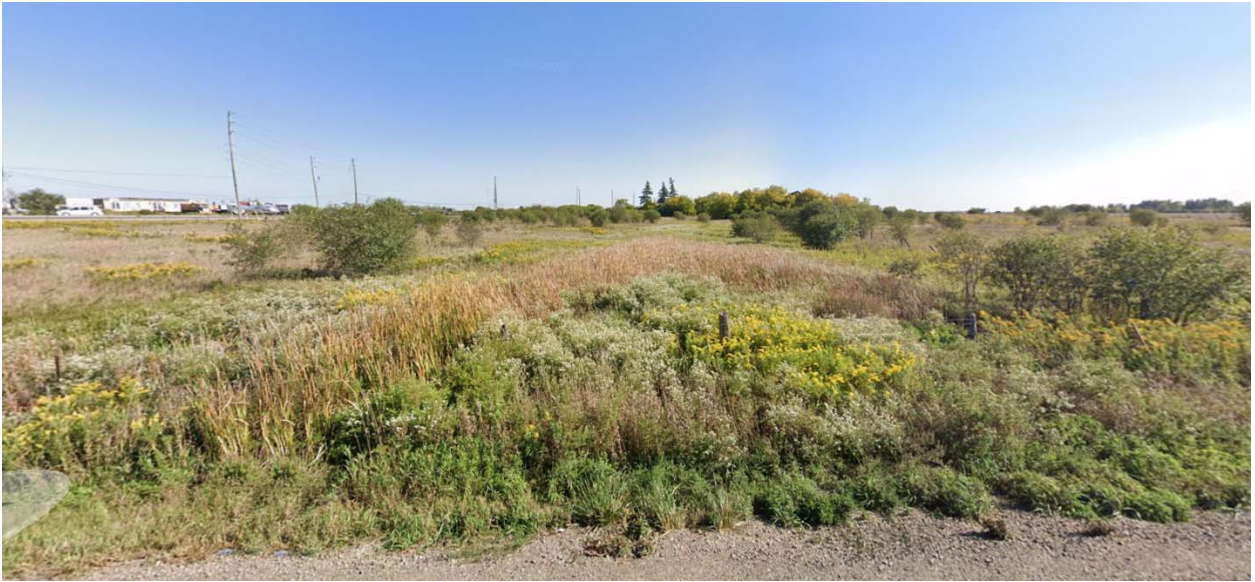
**Image 14:** East end of Countryside Drive – Looking south to naturalizing abandoned agriculture land. Highway 50 can be seen to the east.

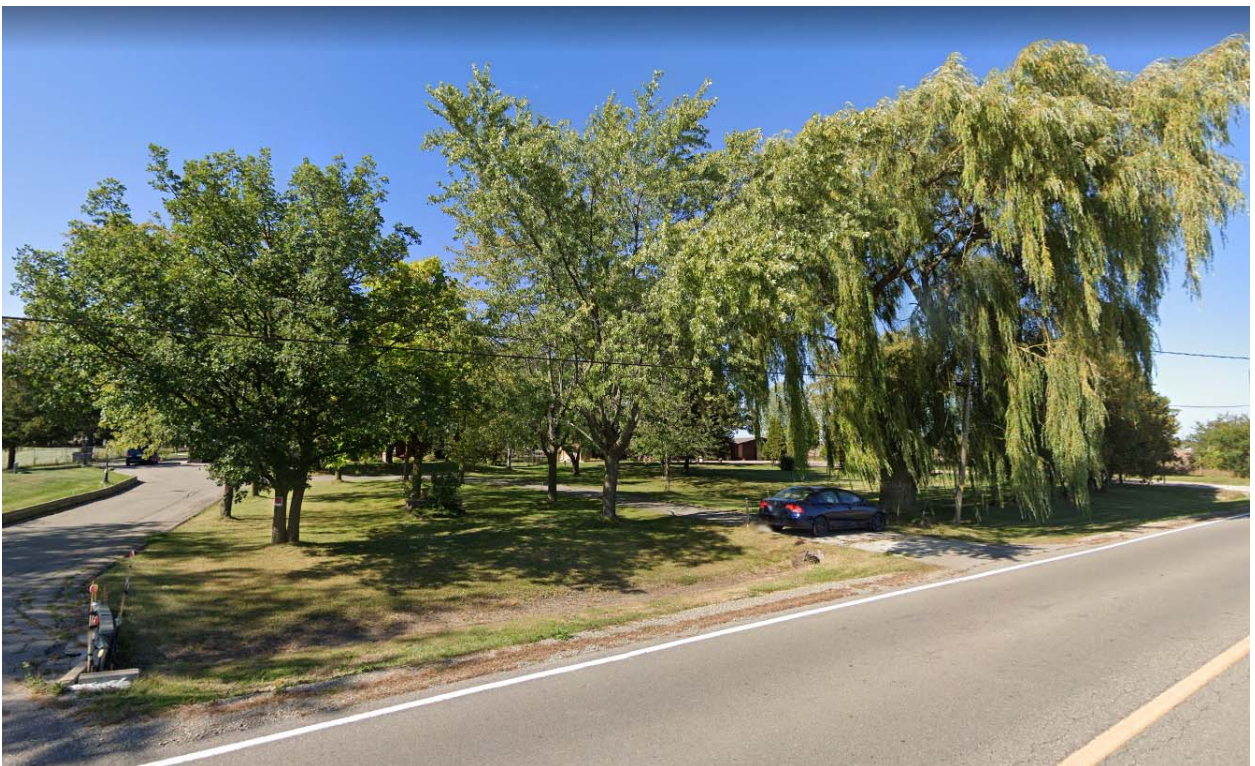
**Image 15:** East of intersection of Countryside Drive and Coleraine Drive – Looking north. Clustering of three residential sites with landscapes recessed from the proposed ROW. The exception, due to its size, is this large Weeping Willow (*Salix babylonica*).

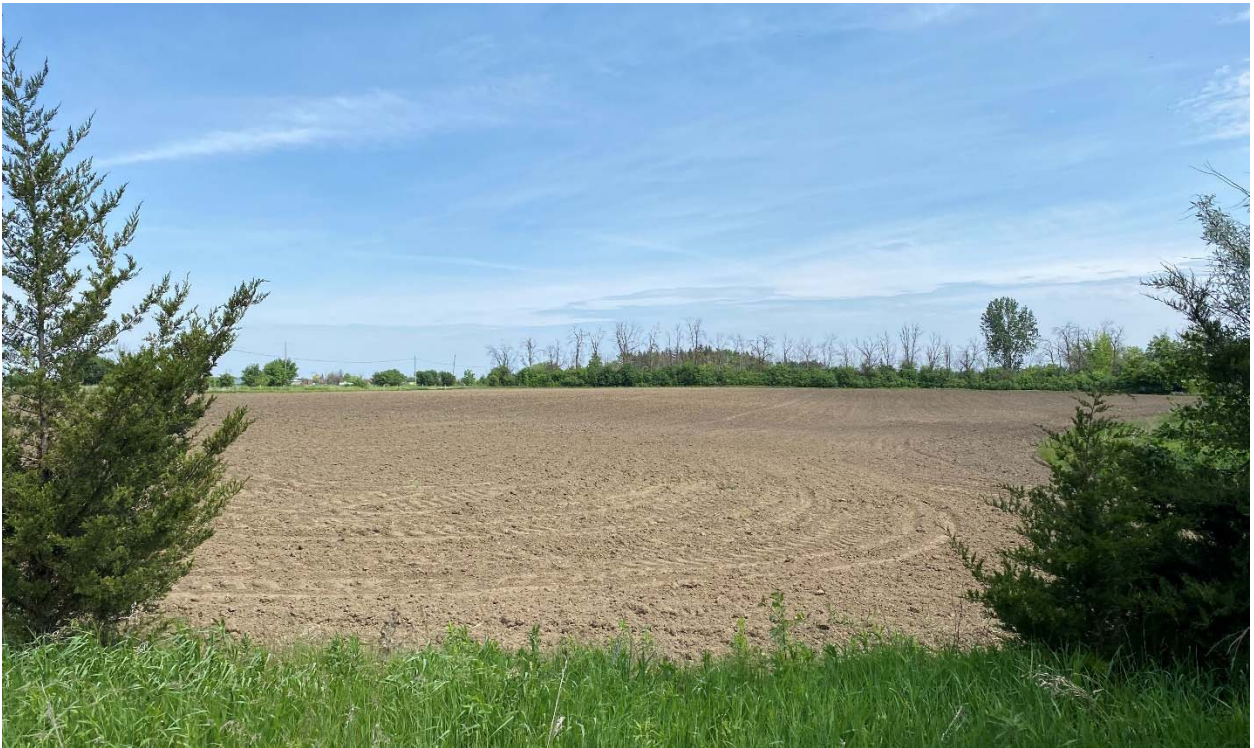
**Image 16:** Just west of intersection of Countryside Drive and Coleraine Drive – Looking south. Open Farmland with abandoned treed farmstead in the distance. Most large trees in this portion are dead, as observed throughout several points in the growing season.

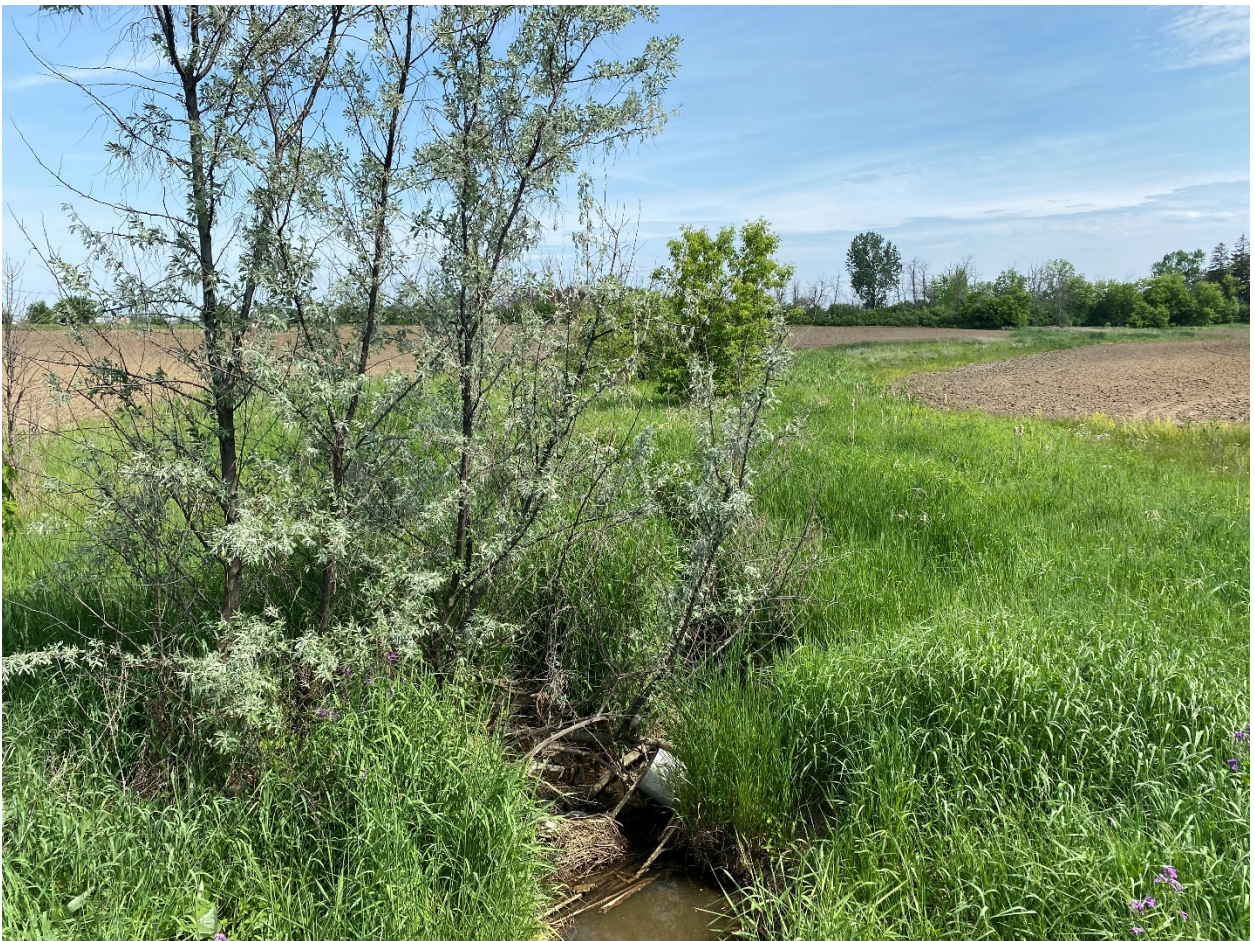
**Image 18:** Rainbow Creek Crossing – Looking south. Rainbow Creek meanders through the agricultural landscape. Wolf Willow (*Elaeagnus commutate*) can be seen growing on the bank, with a young maple in the distance. The abandoned farmstead in the background appears as a residual forest patch.

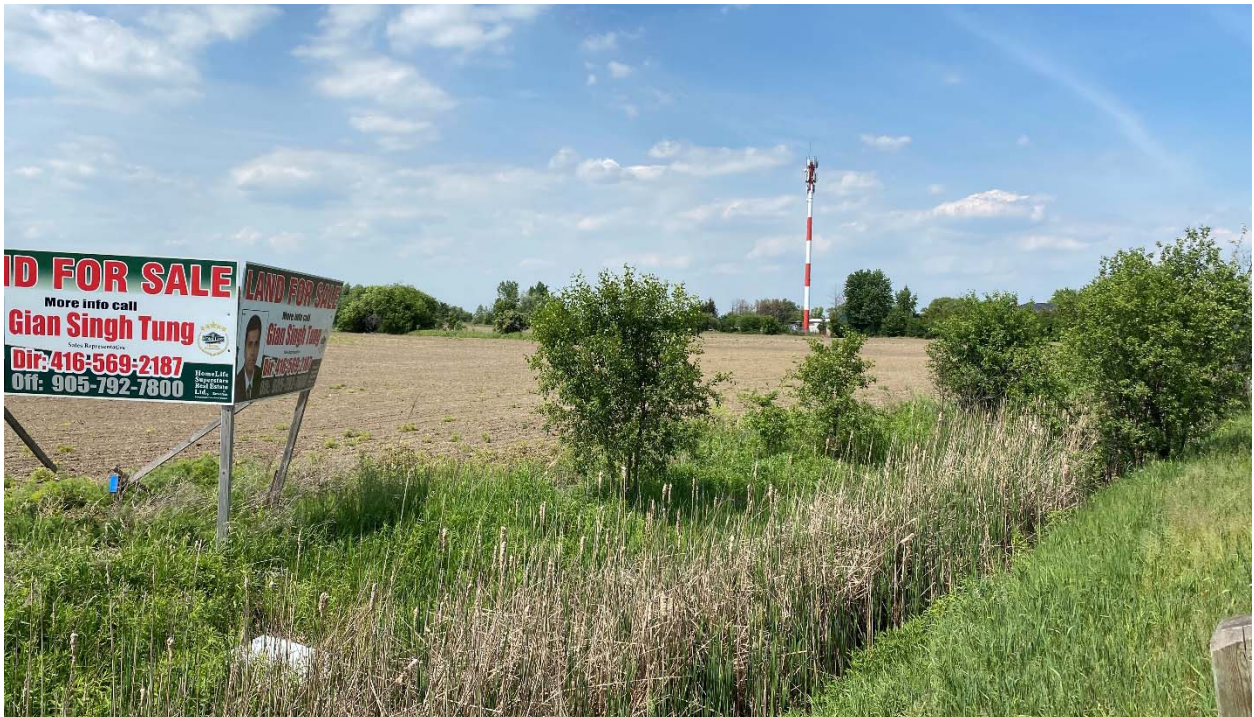
**Image 19:** Countryside Drive – Looking north. After passing a cluster of residential sites the land once again opens to large agricultural fields. On the north side the land drops sharply from the shoulder to a stormwater ditch containing wetland vegetation.

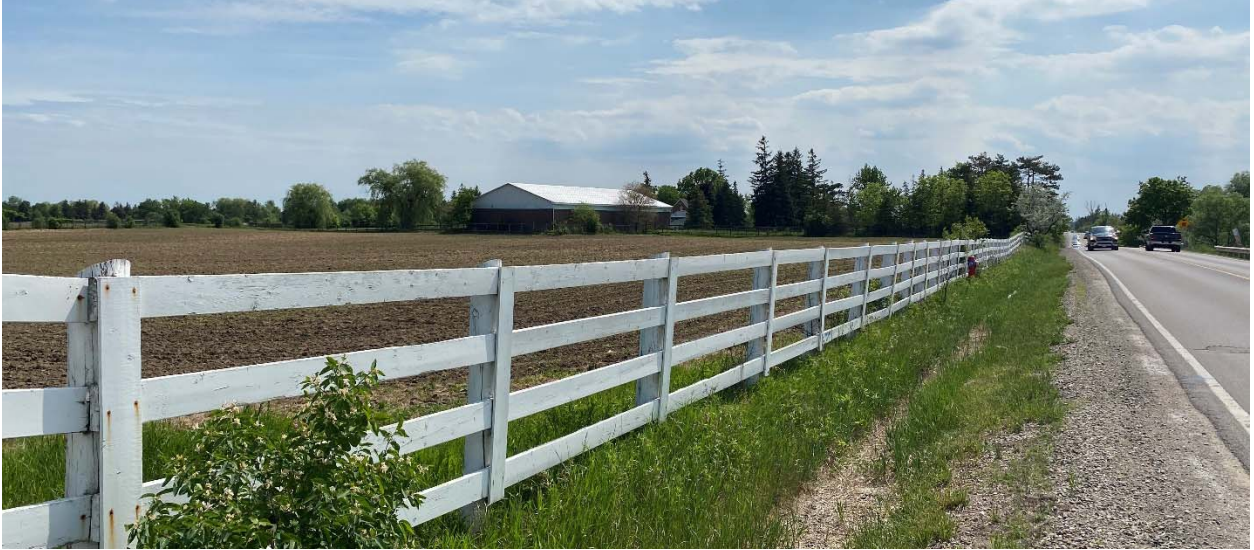
**Image 20:** *Countryside Drive – Looking south. After passing a cluster of residential sites the land once again opens to large agricultural fields. On the south side a 270 metre long white wooden fence runs parallel to the road. This fence continues to the intersection of Countryside Drive and Clarkway Drive.*

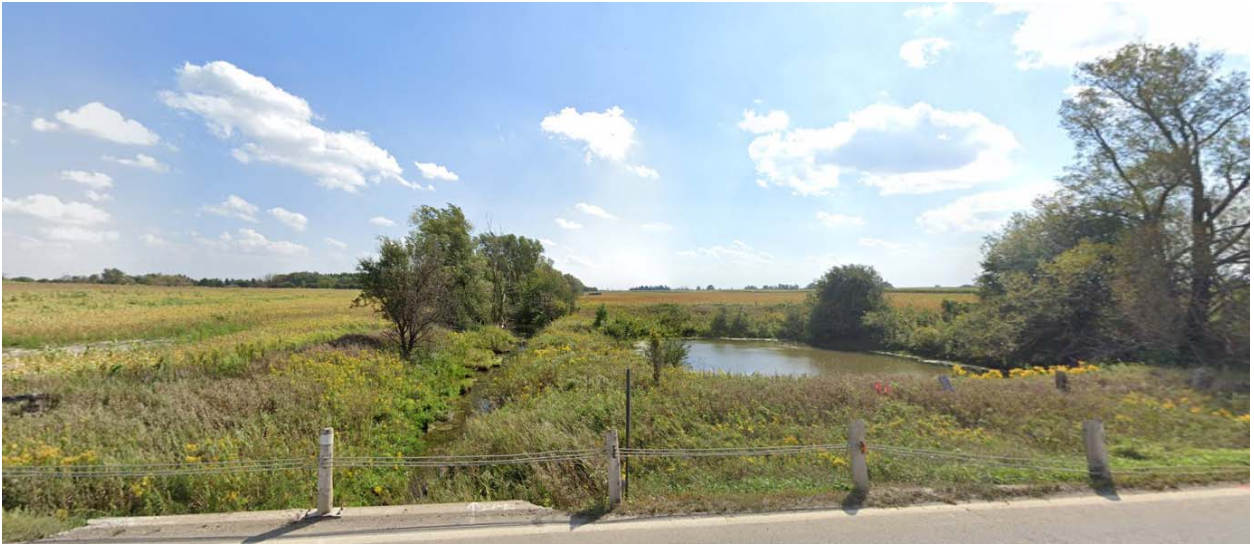
**Image 21:** *The Gore Road Tributary – Carving a defined path through the landscape, The Gore Road tributary maintains a somewhat functioning riparian corridor throughout this stretch. To the west is the old stock pond, connected, and providing diverse habitat to the system.*

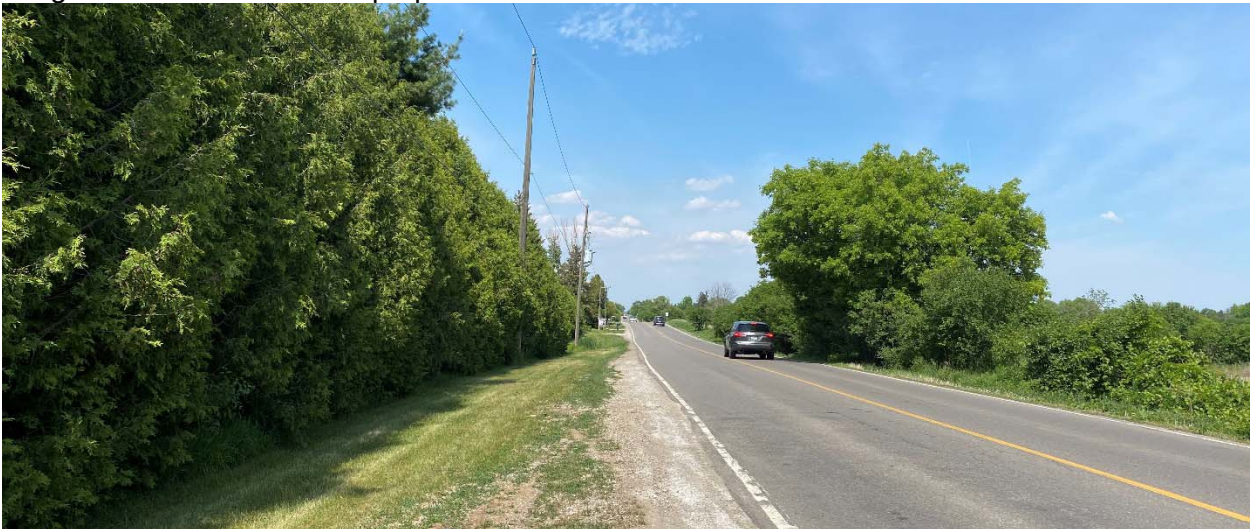
**Image 22:** *Countryside Drive – Looking east. Tall evergreen privacy hedge can be seen on the north side. To the south; remnant buckthorn shrubs and a multi-stemmed small tree, Clearing of the south side will likely be necessary.*

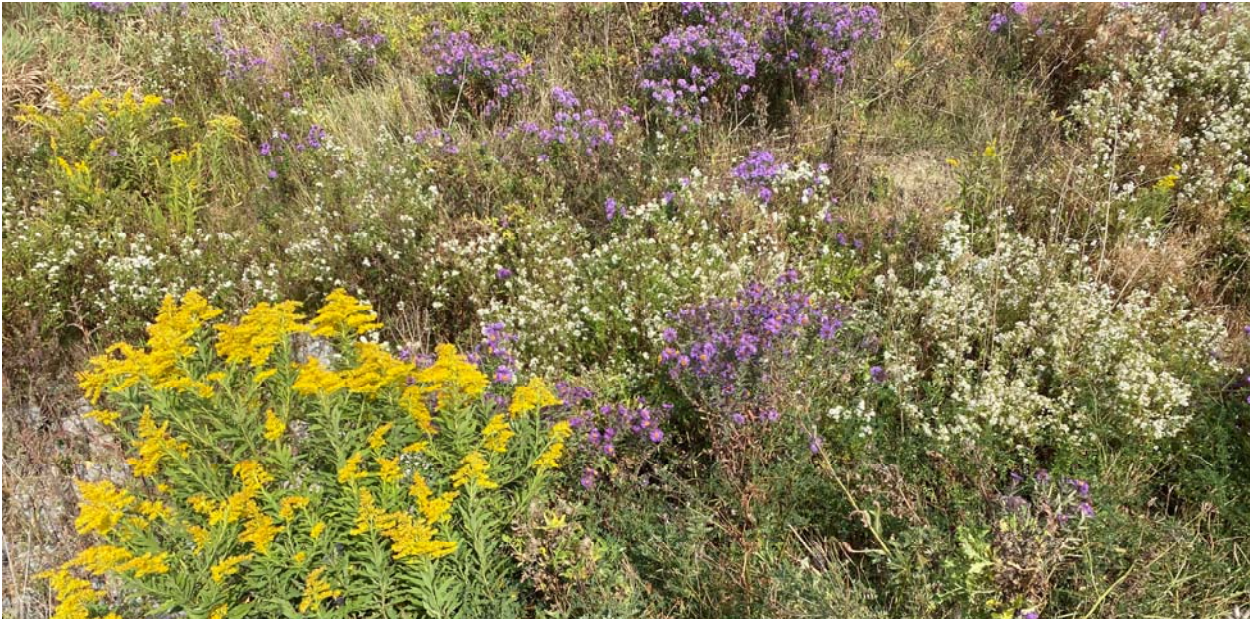
**Image 23:** Typical roadside vegetation observed consistently throughout the project zone. Asters, Goldenrod, native and European grasses, and the occasional cluster of Ragweed.

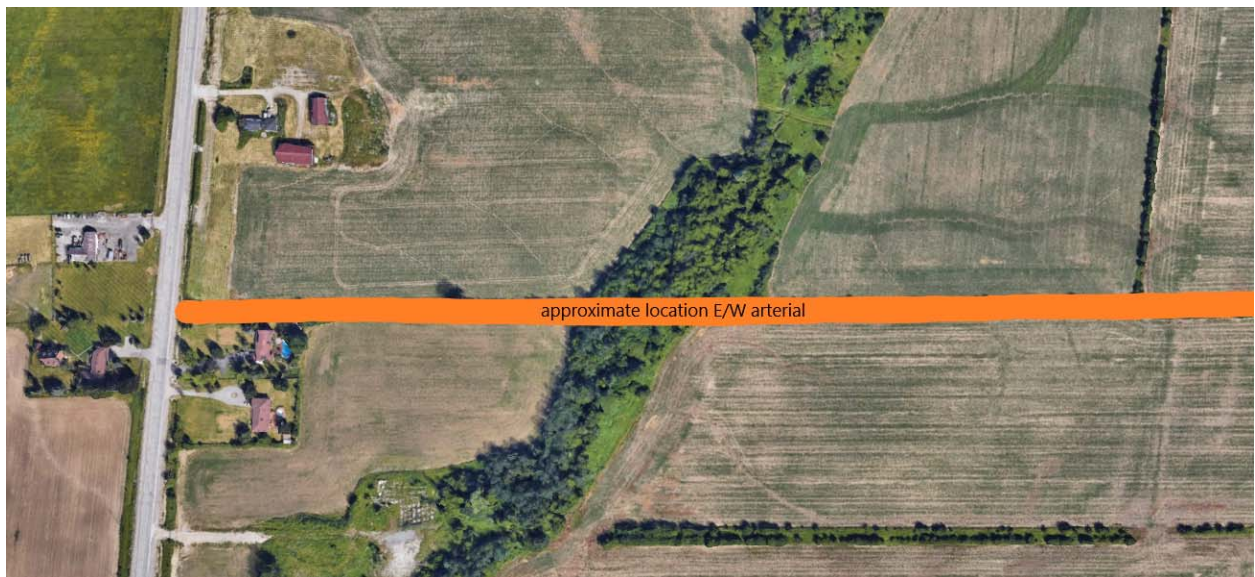
**Image 24:** Approximate location of proposed East – West Arterial as it departs from The Gore Road, seen here crossing The Gore Road Tributary.

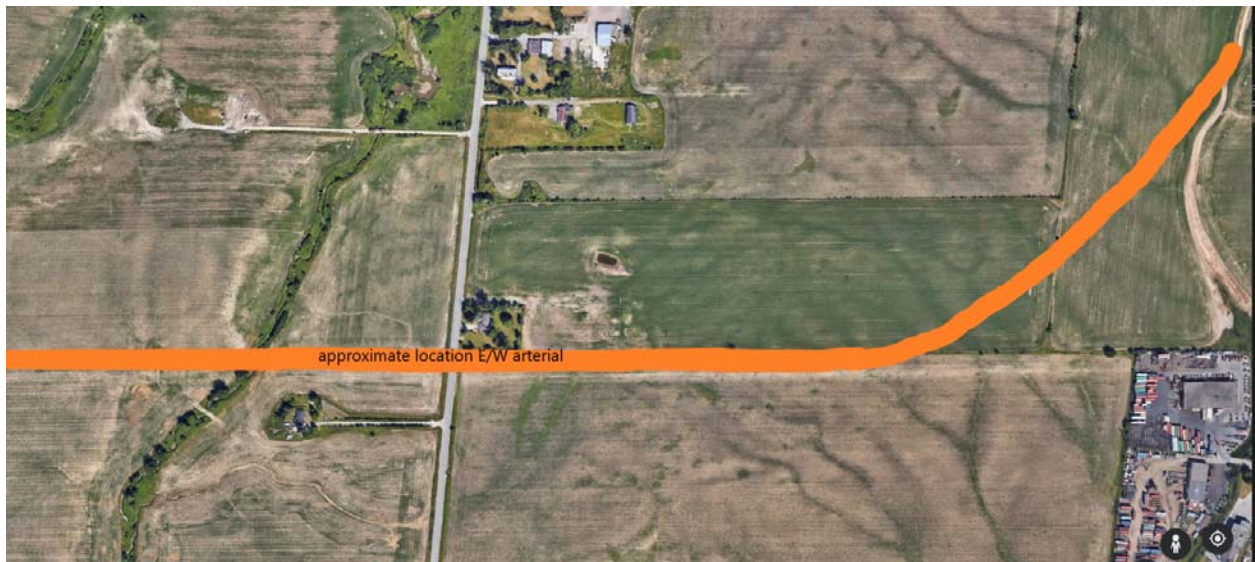
*Image 25: Approximate location of proposed East – West Arterial as it continues east to the intersection with proposed Arterial A2, seen here first crossing the Clarkway Tributary, Clarkway Drive, and intersecting with Rainbow Creek.*
